Feasibility Report

Emerson Ave Street Improvements
City of Mendota Heights, Minnesota

City Project No. 202306
TKDA Project No. 20210.000
November 3, 2023

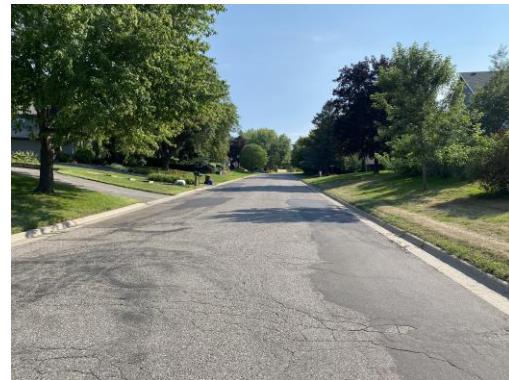
Figure 1: Emerson Ave (east)

Street: The road width is approximately 35' from the back of curb (BOC) to BOC. Curb and gutter exist on the roadway. The pavement was observed to have widespread fatigue cracking and signs of frost cracking indicated by the large longitudinal cracking seen along the alignment. The road has been patched in many places due to utility repairs or pavement distress.

Curb and Gutter: Emerson Ave currently utilizes B618 concrete curb and gutter. Curb is in good to fair condition with some settling.

Streets: Considering the existing condition, deterioration factors, and geotechnical investigation, pavement reclamation is proposed for all streets. Pavement reclamation is recommended as a 7-ton design. Reclamation is recommended because the aggregate base beneath this roadway section is in good condition and no roadway width changes are proposed. Full reconstruction was also evaluated, but because majority of the utilities and concrete curb are in fair condition, this option is not necessary.

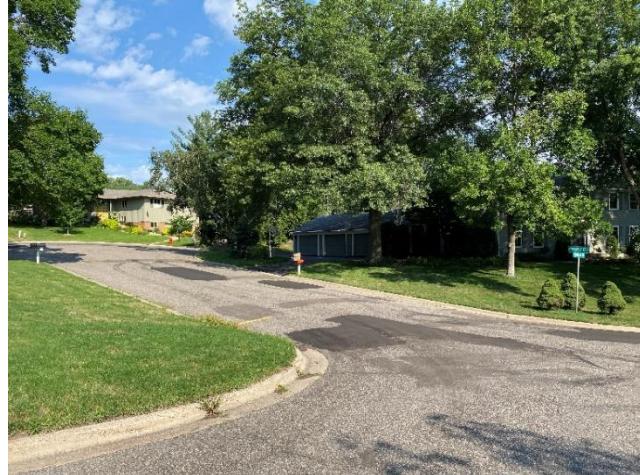
Figure 2: Sylvandale Court S

Street: The road width is approximately 35' from the BOC to BOC. Curb and gutter exist on the roadway. The pavement was observed to have fatigue cracking and has been patched multiple times.

Drainage: The street section currently drains to catch basins and storm sewer along the road. The road slopes from west to east and drains to Sylvandale Road.

Curb and Gutter: Sylvandale Court S currently utilizes B618 concrete curb and gutter. Curb and gutter is in fair condition with a few panels that should be replaced during construction.

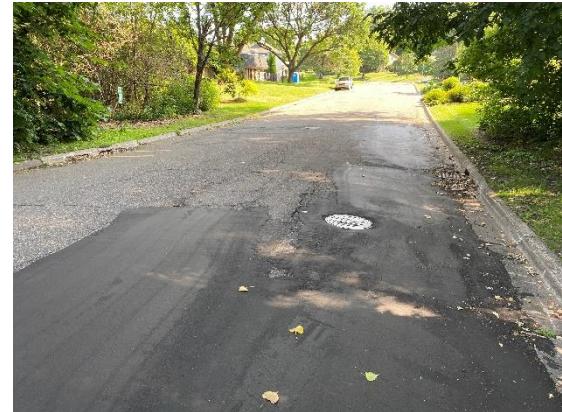
Drainage: Since no significant changes to the roadway width are proposed we recommend continued usage of the existing storm system. Drainage concerns were noted at the intersection of Laura Court and Laura Street, near the intersection of Sylvandale Road and Maple Park Drive and at the roadway low point along Sylvandale Road west of Laura Street. These areas will be evaluated for the best solutions that may include grade changes to the road, storm sewer modifications or installation of drain tile below the road surface.

Figure 6: Roadway low point along Sylvandale Road with patching

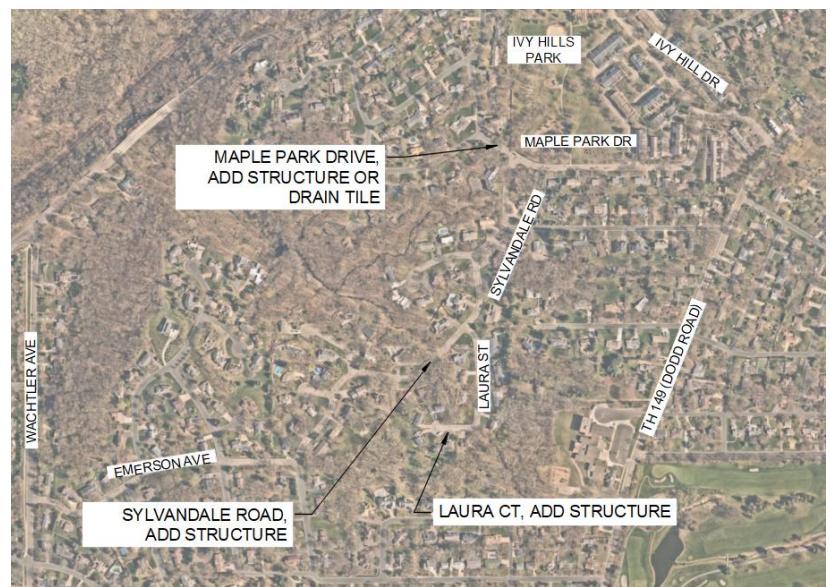
Figure 7: Recommended drainage improvements

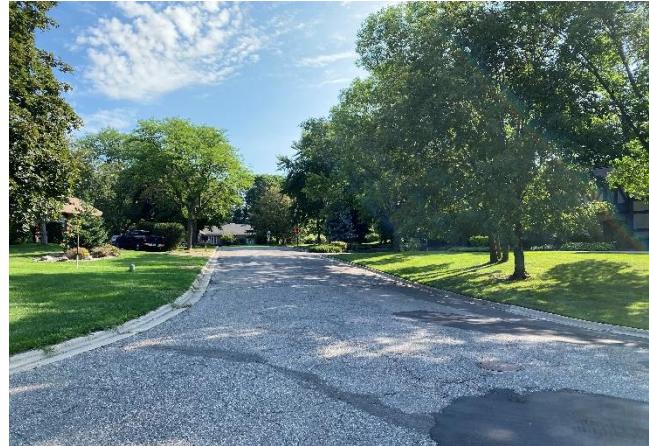
Figure 7 Sylvandale Road and Ivy Falls Ct, looking toward Ivy Falls Ave.

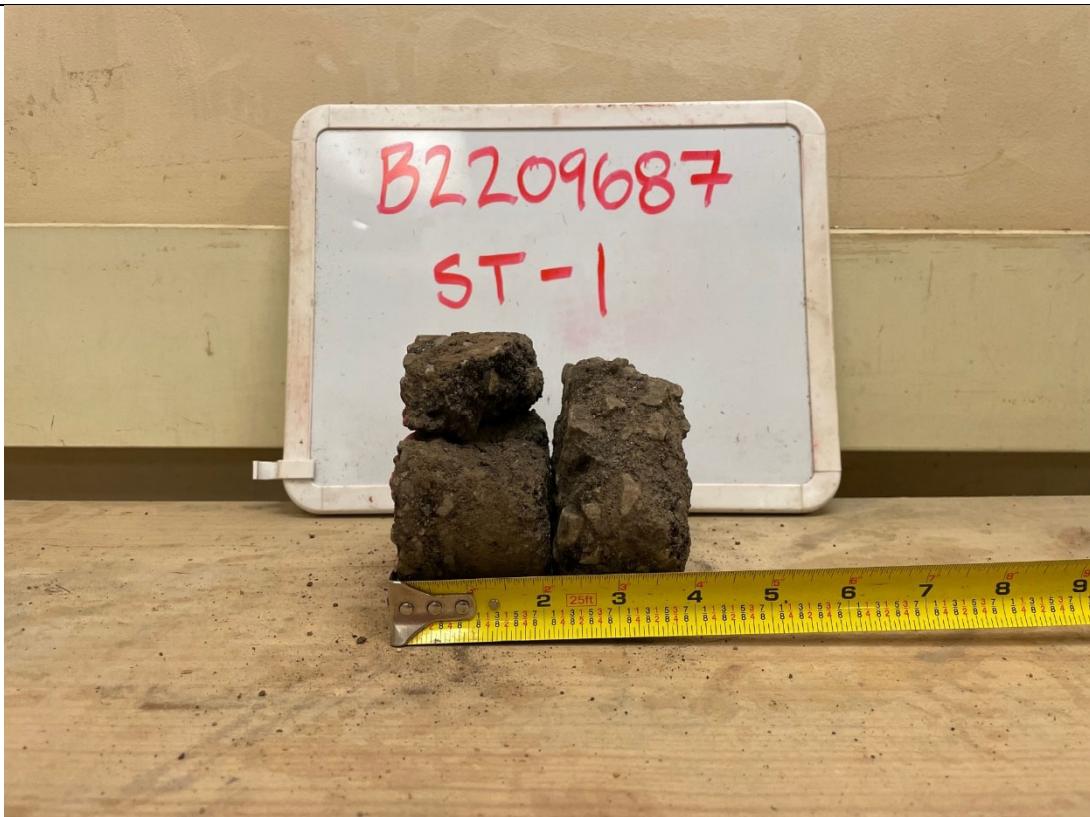
Core #:	ST-1			Project: B2209687		
Pavement thickness:	4 inches	Agg base thickness: 4 1/4 inches		BRAUN INTERTEC		
Location:	Emerson Avenue					
Date:	November 2022					
Notes:	Debonding at 2 1/4, high deterioration throughout.

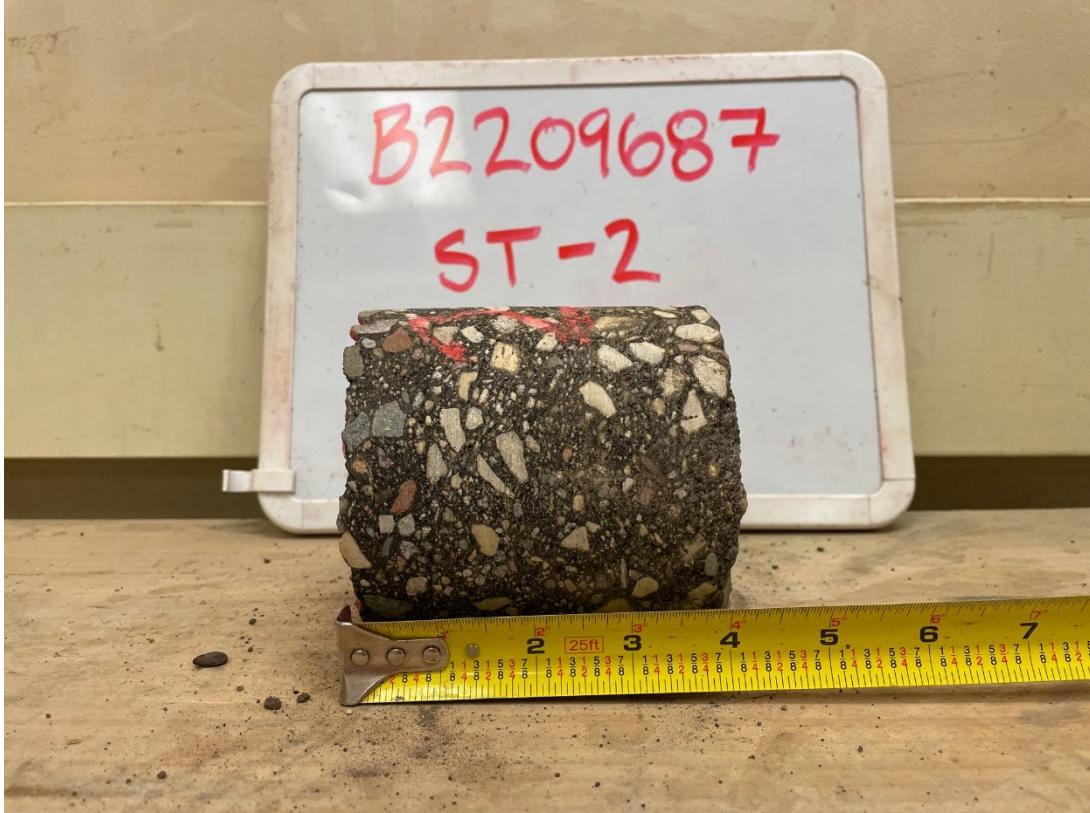
Core #:	ST-2			Project: B2209687		
Pavement thickness	4 inches	Agg base thickness: 6 3/4 inches		BRAUN INTERTEC		
Location:	Emerson Avenue					
Date:	November 2022					
Notes:	Overall good condition

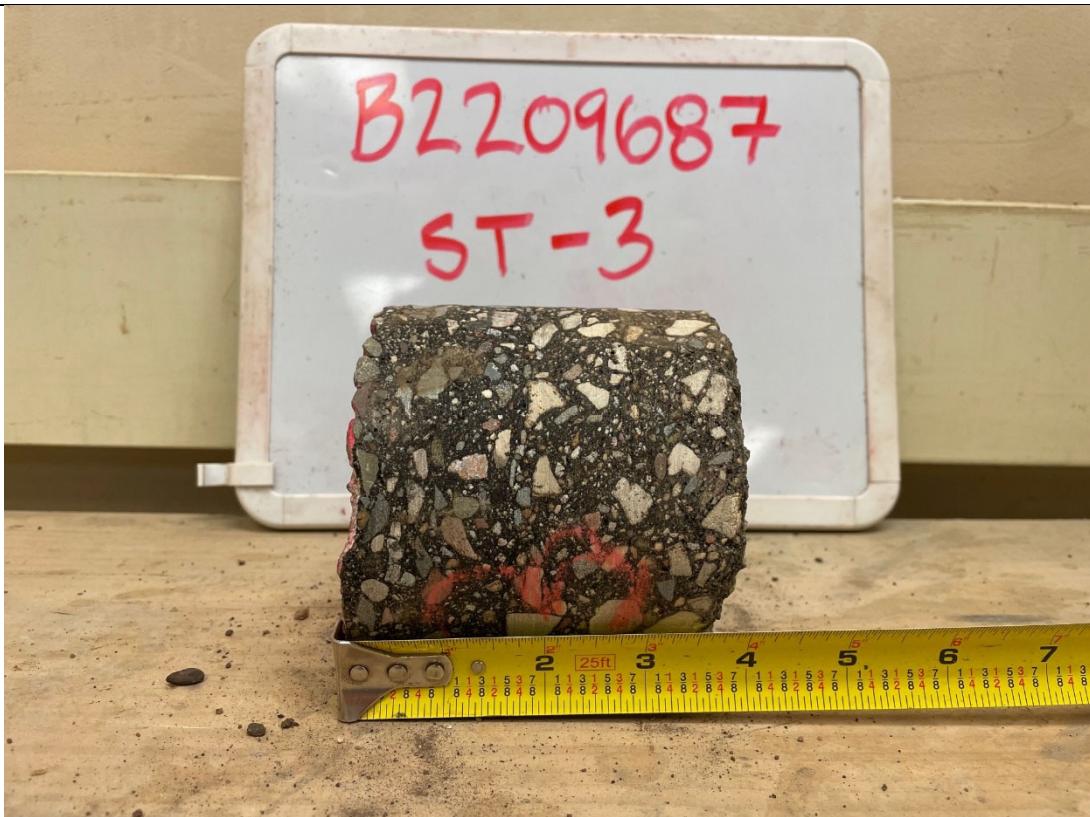
Core #:	ST-3			Project: B2209687
Pavement thickness:	3 1/2 inches		Agg base thickness:	7 3/4 inches
Location:	Emerson Avenue			
Date:	November 2022			
Notes:	Overall good condition

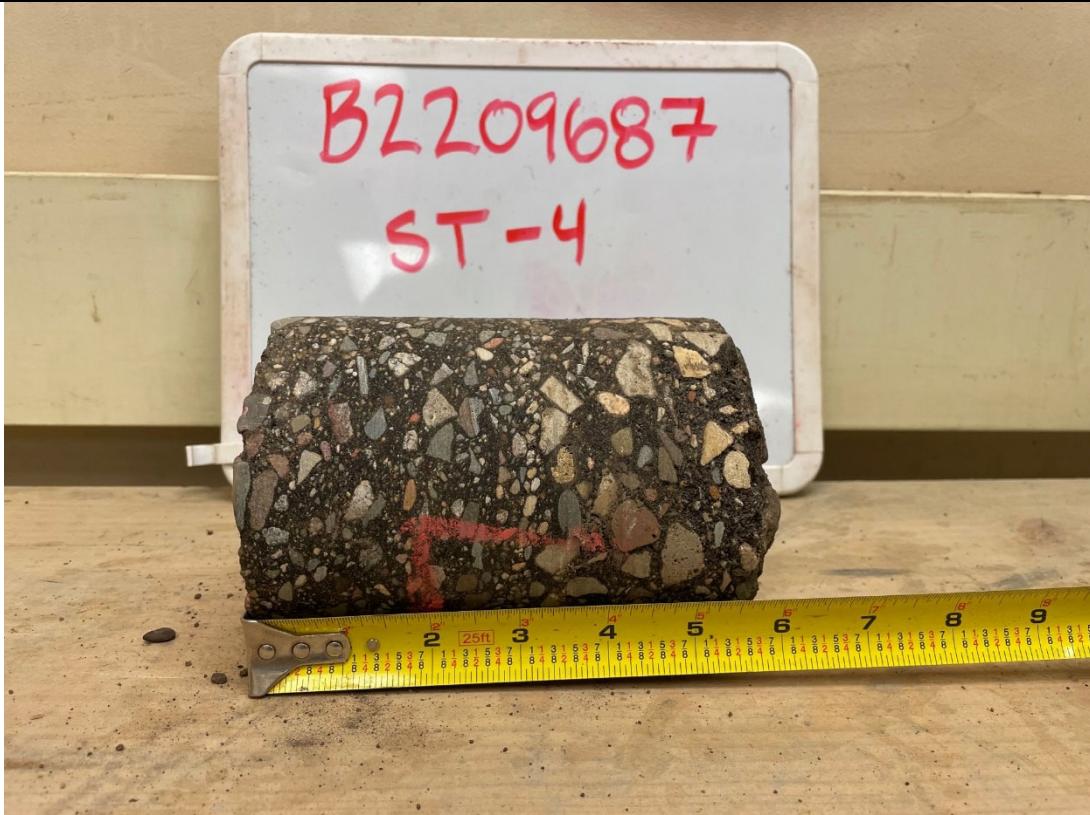
Core #:	ST-4			Project: B2209687
Pavement thickness:	5 1/2 inches		Agg base thickness:	8 3/4 inches
Location:	Clement Street			
Date:	November 2022			
Notes:	Slight stripping in upper 2 inches of core.

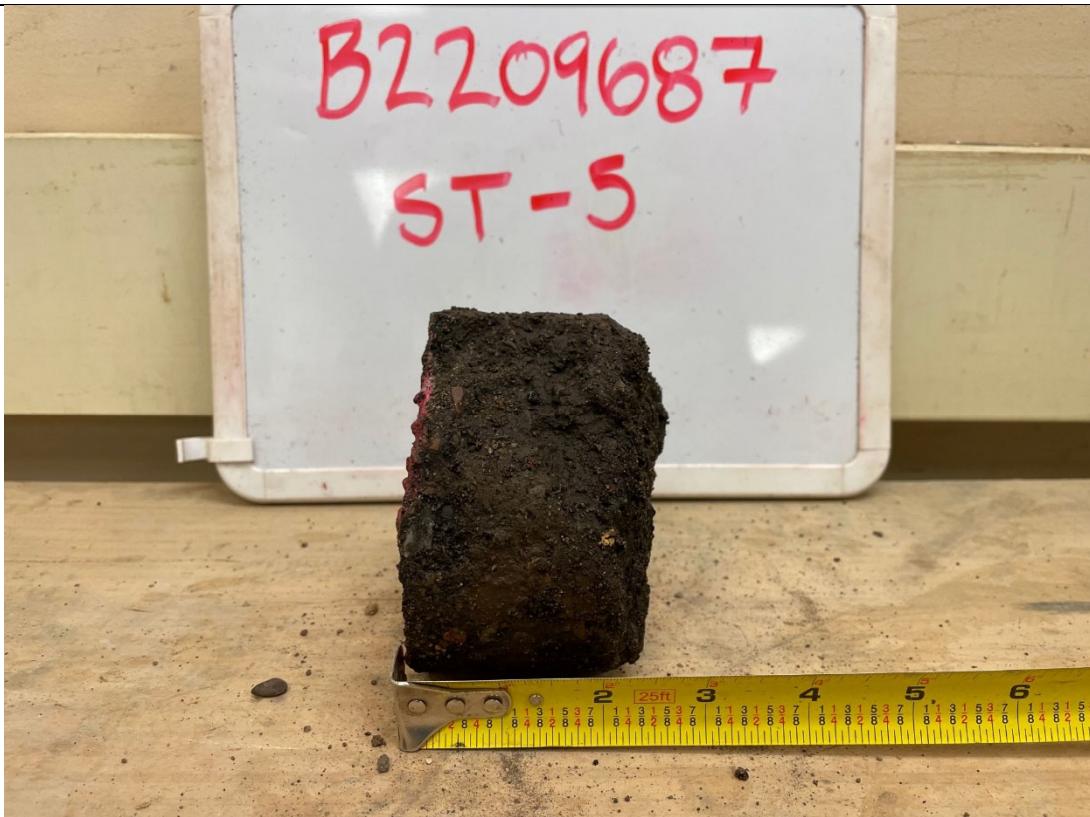
Core #:	ST-5			Project: B2209687
Pavement thickness:	3 3/4 inches	Agg base thickness:	11 1/4 inches	BRAUN INTERTEC
Location:	Sylvandale Court South			
Date:	November 2022			
Notes:	Highly deteriorated, bottom of core crumbled during coring process.

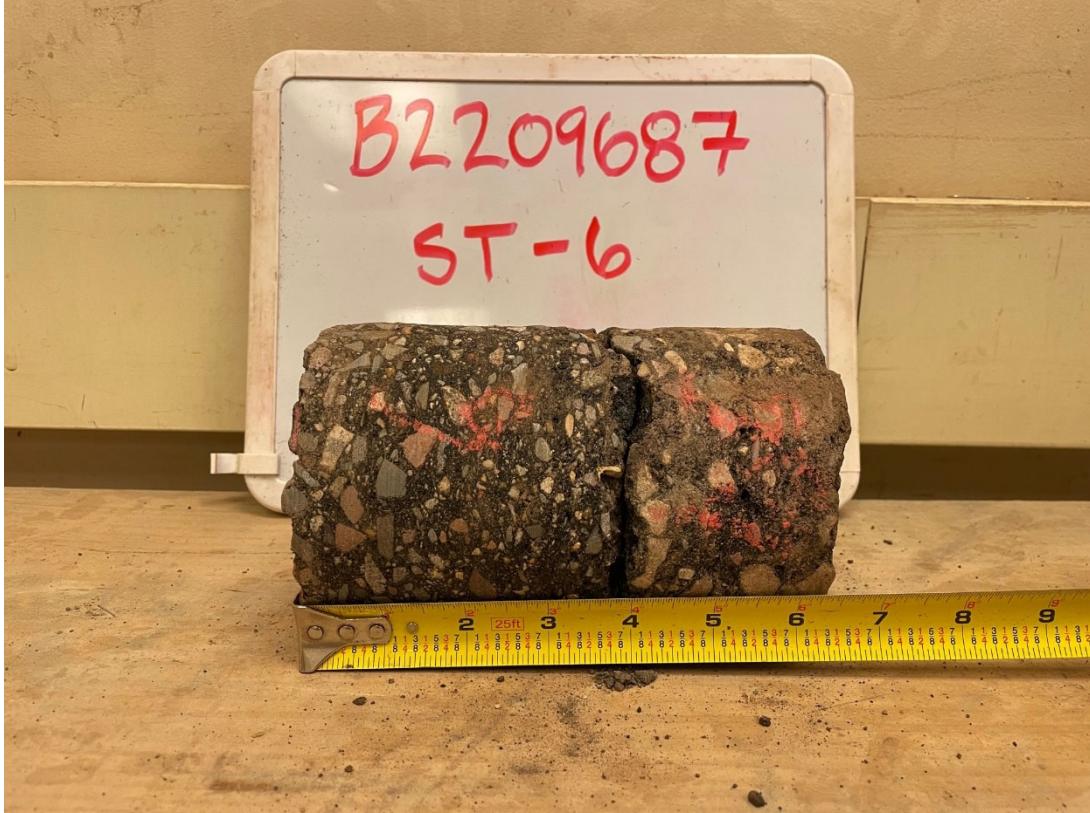
Core #:	ST-6			Project: B2209687
Pavement thickness	6 1/4 inches	Agg base thickness:	10 3/4 inches	BRAUN INTERTEC
Location:	Sylvandale Road			
Date:	November 2022			
Notes:	Slight stripping throughout, debonding at 4 inches

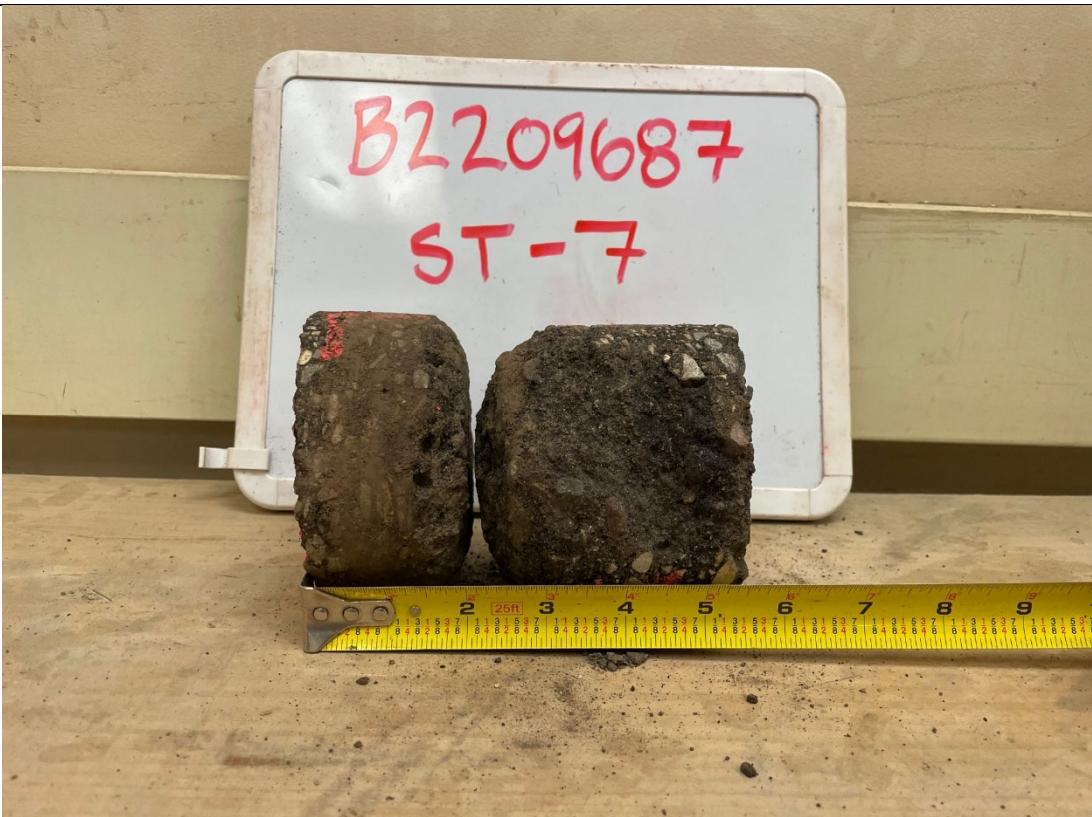
Core #:	ST-7			Project: B2209687
Pavement thickness:	5 1/2 inches		Agg base thickness:	11 1/2 inches
Location:	Sylvandale Court North			
Date:	November 2022			
Notes:	Moderate to high deterioration.

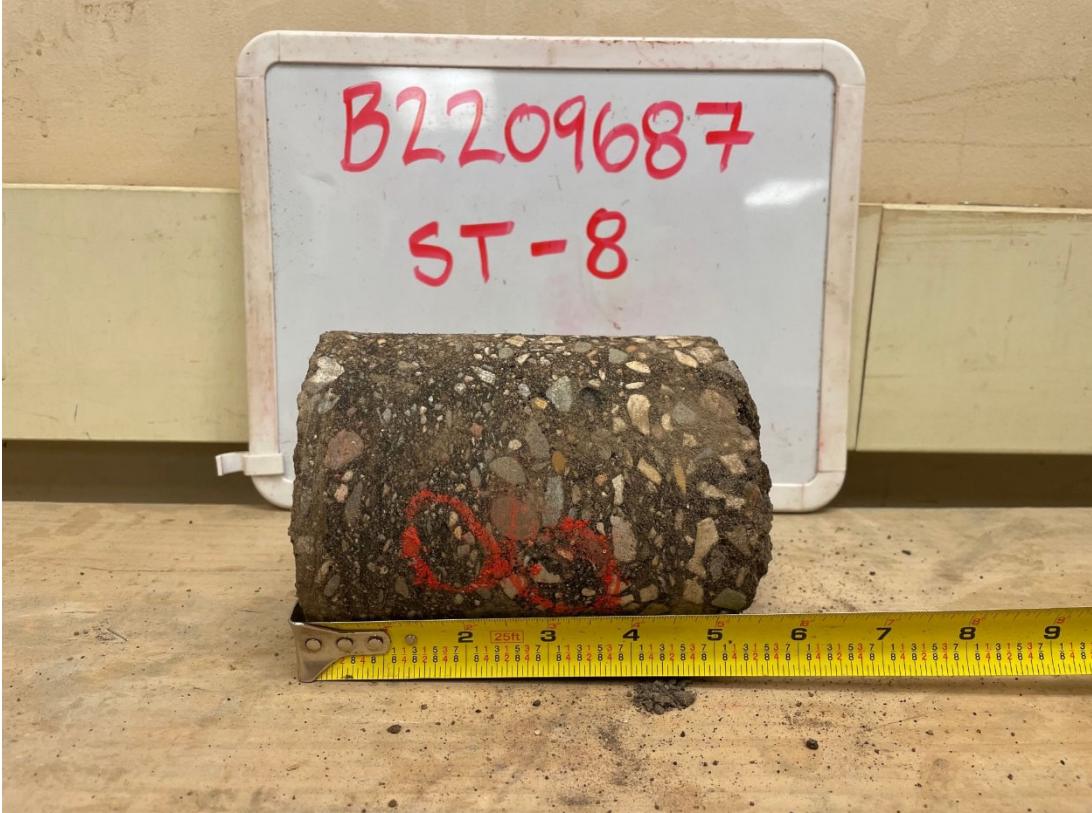
Core #:	ST-8			Project: B2209687
Pavement thickness	5 1/2 inches		Agg base thickness:	6 inches
Location:	Sylvandale Road			
Date:	November 2022			
Notes:	Overall good condition.

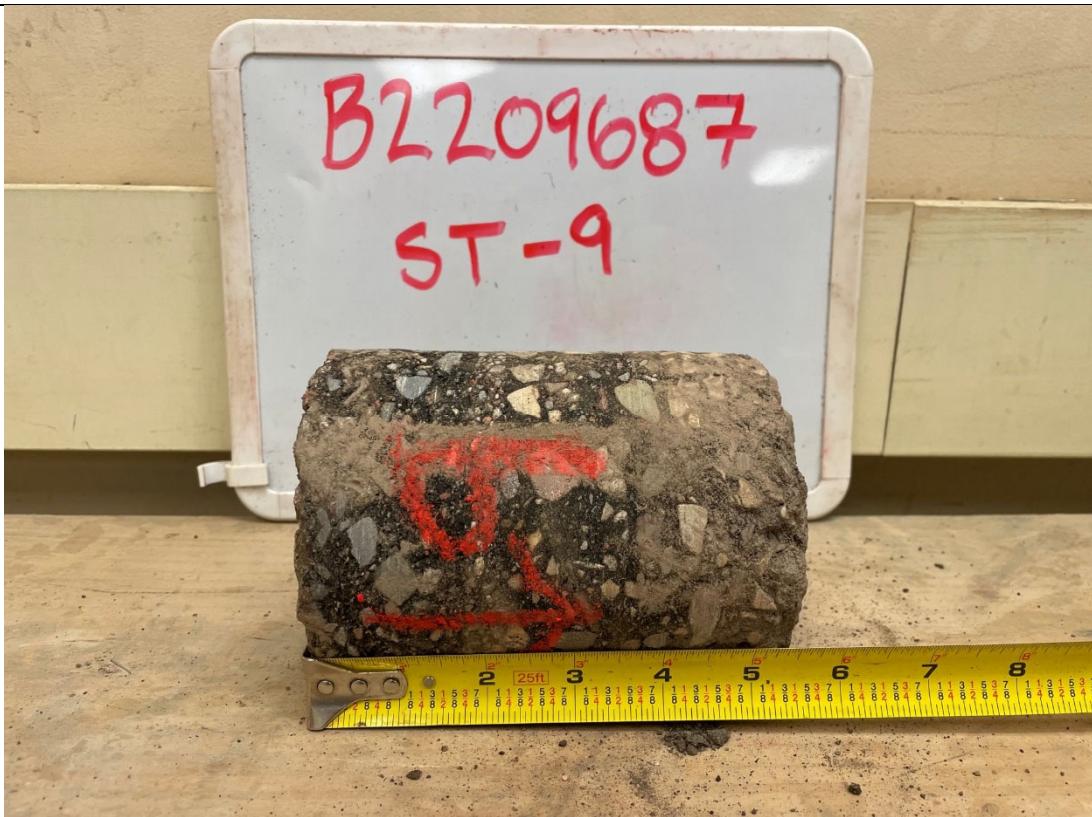
Core #:	ST-9			Project: B2209687
Pavement thickness:	5 1/4 inches		Agg base thickness:	3 3/4 inches
Location:	Laura Street			
Date:	November 2022			
Notes:	Low to moderate stripping throughout.

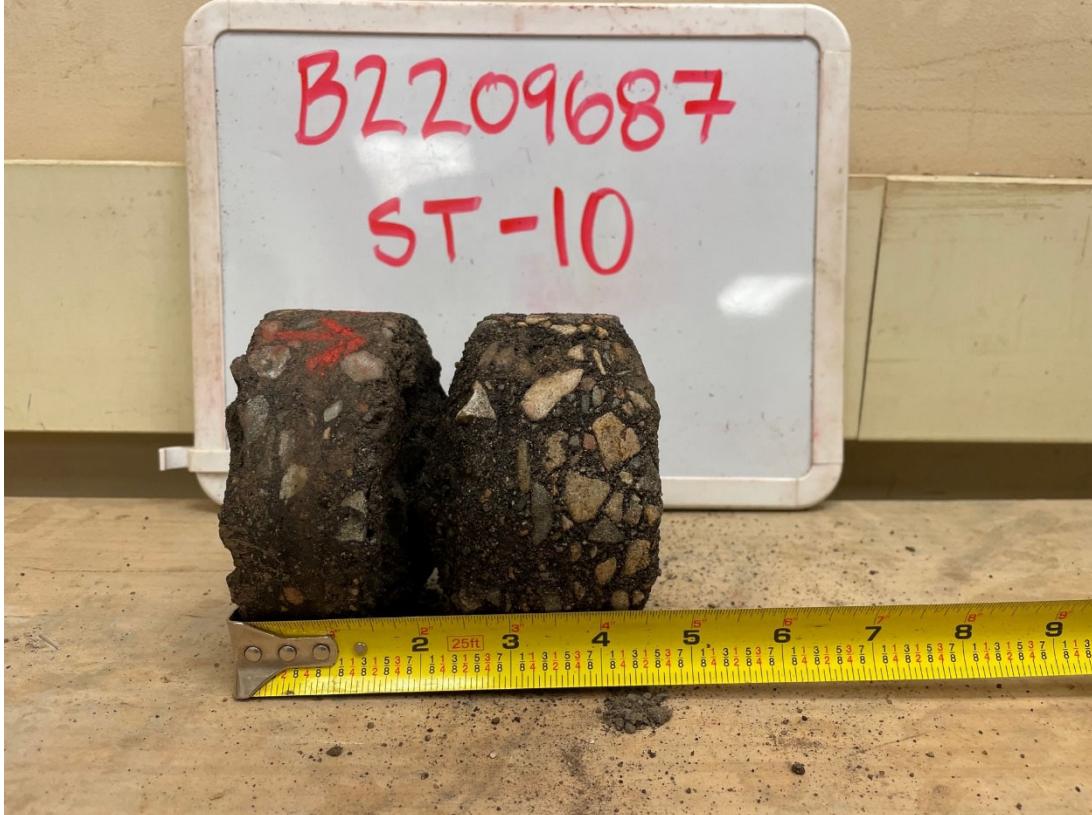
Core #:	ST-10			Project: B2209687
Pavement thickness	4 3/4 inches		Agg base thickness:	9 1/4 inches
Location:	Laura Court			
Date:	November 2022			
Notes:	Debonded at 2-inches, heavy stripping from 1 1/2 to 3 1/2 inches.

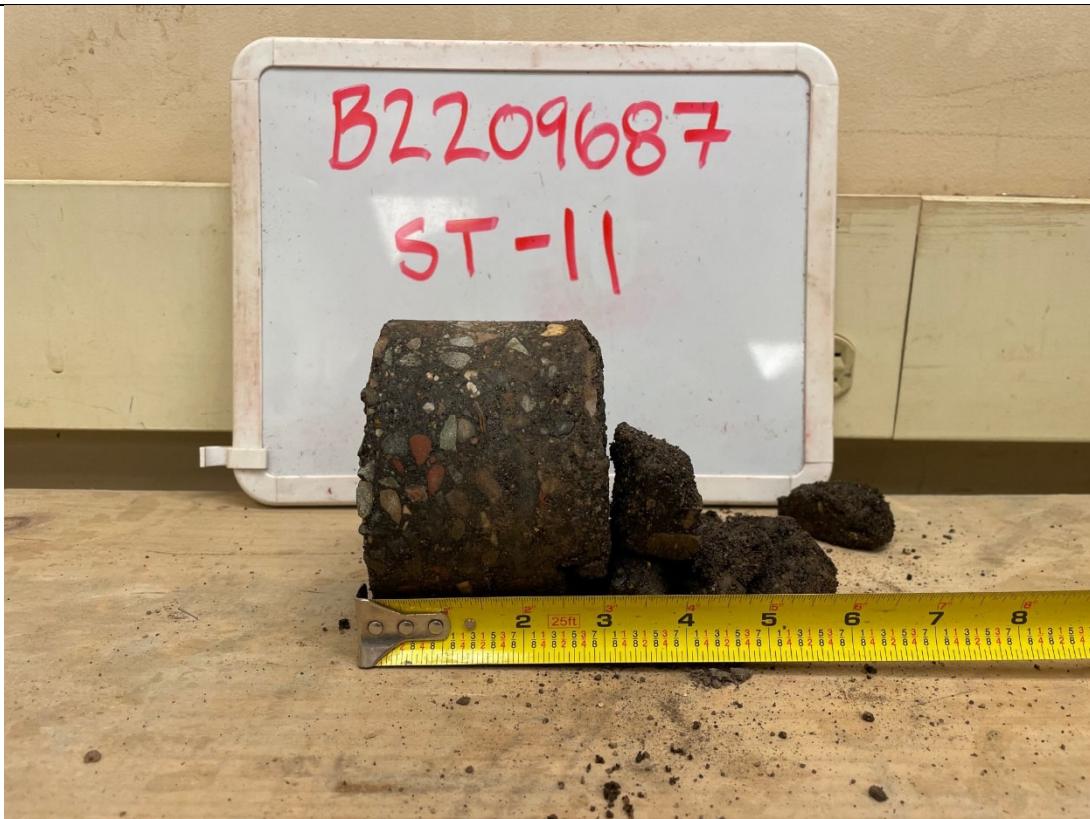
Core #:	ST-11			Project: B2209687 BRAUN INTERTEC	
Pavement thickness:	6 1/2 inches	Agg base thickness:	6 1/2 inches		
Location:	Sylvandale Road				
Date:	November 2022				
Notes:	High deterioration, bottom half of core disintegrated during core retrieval.

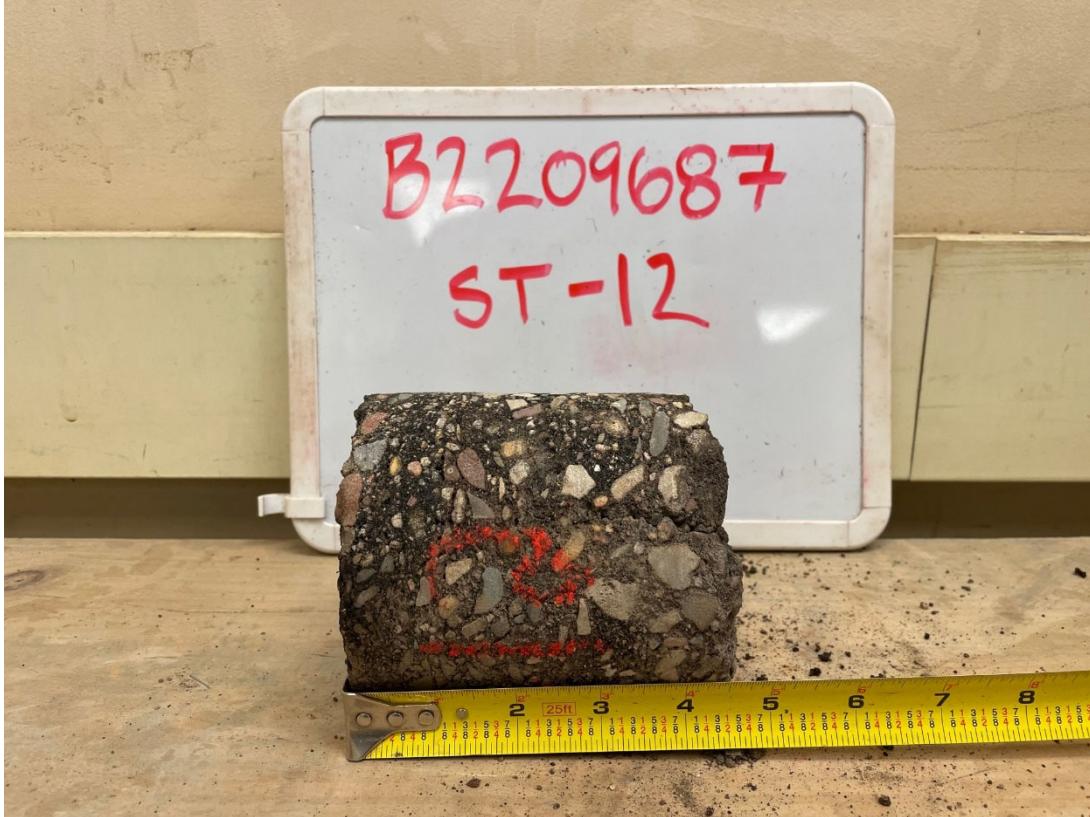
Core #:	ST-12			Project: B2209687 BRAUN INTERTEC	
Pavement thickness	4 1/2 inches	Agg base thickness:	7 1/2 inches		
Location:	Ivy Falls Court				
Date:	November 2022				
Notes:	Moderate stripping throughout.

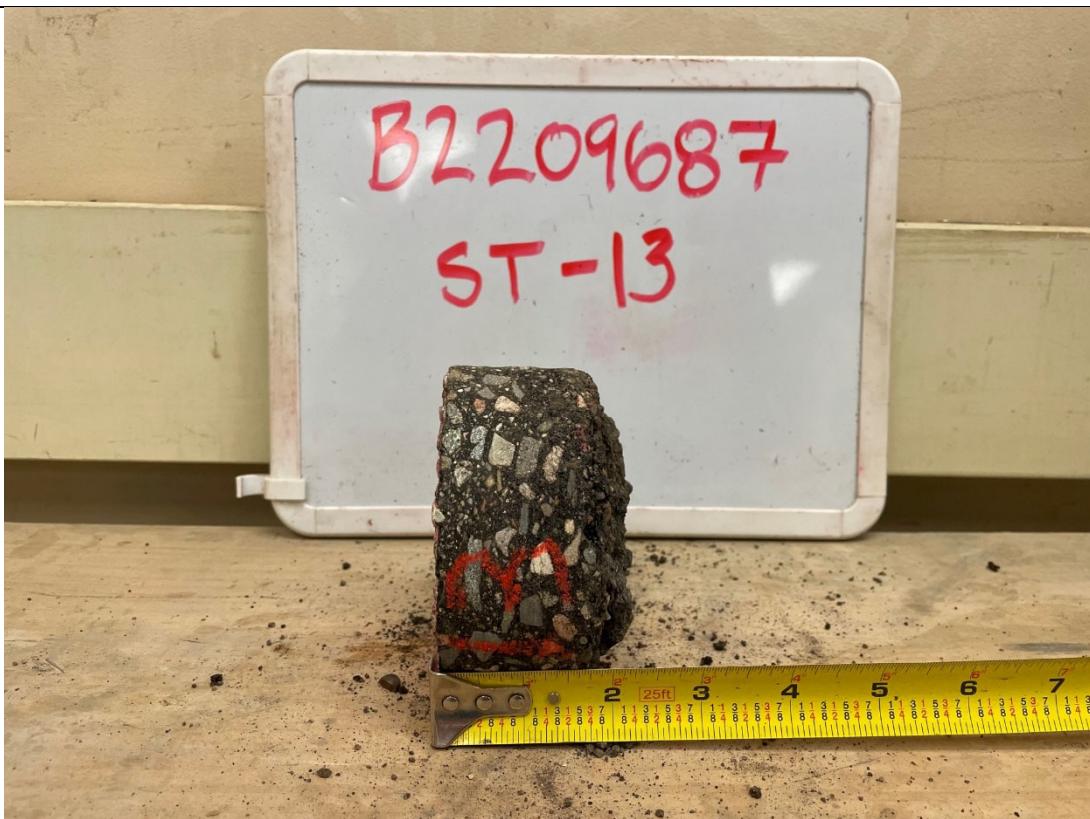
Core #:	ST-13			Project: B2209687
Pavement thickness:	6 inches		Agg base thickness:	5 inches
Location:	Sylvandale Road			
Date:	November 2022			
Notes:	Moderate stripping throughout; Core deterioration 2 inches and below.

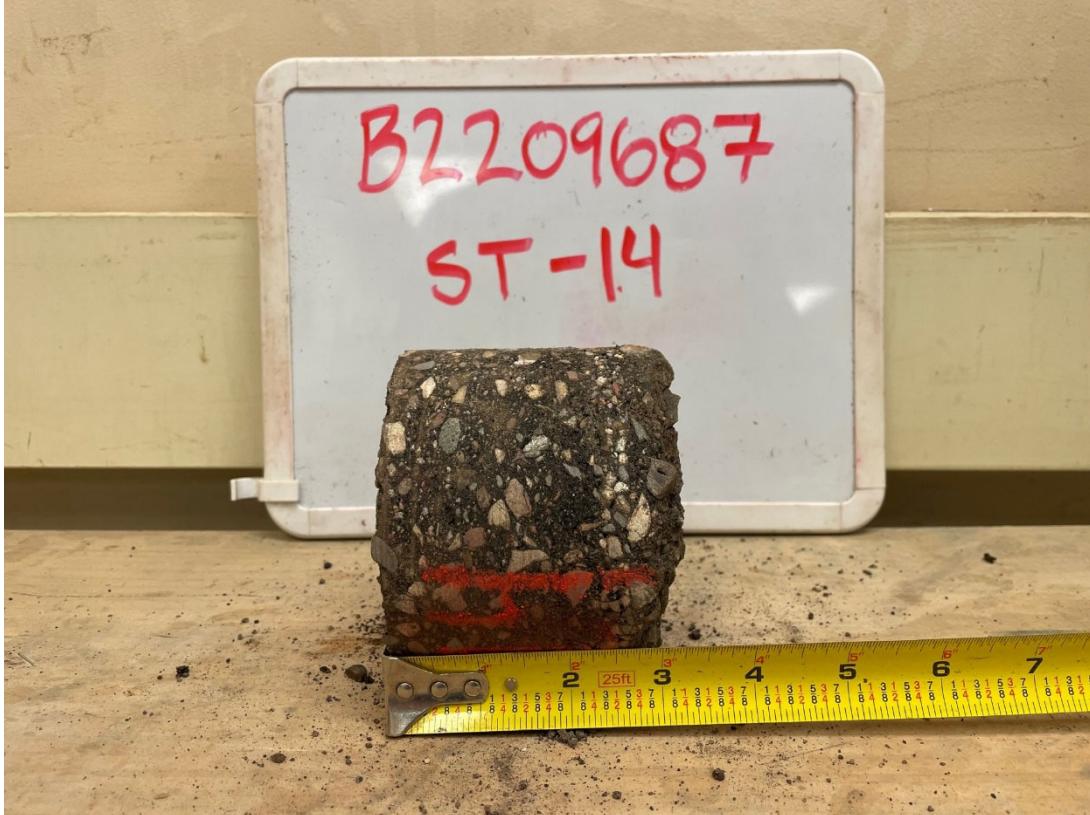
Core #:	ST-14			Project: B2209687
Pavement thickness	5 inches		Agg base thickness:	7 inches
Location:	Maple Park Drive			
Date:	November 2022			
Notes:	Overall good condition.

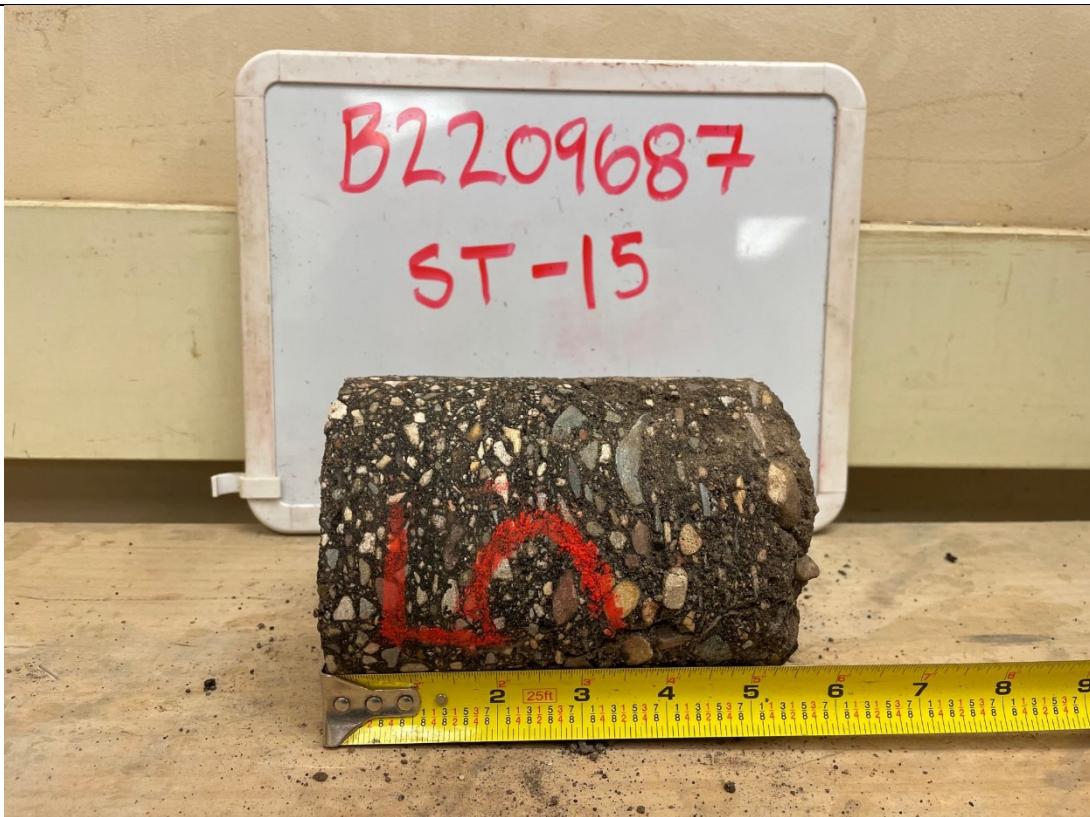
Core #:	ST-15			Project: B2209687
Pavement thickness:	5 1/2 inches		Agg base thickness:	8 inches
Location:	Maple Park Drive			
Date:	November 2022			
Notes:	Low to moderate stripping throughout.

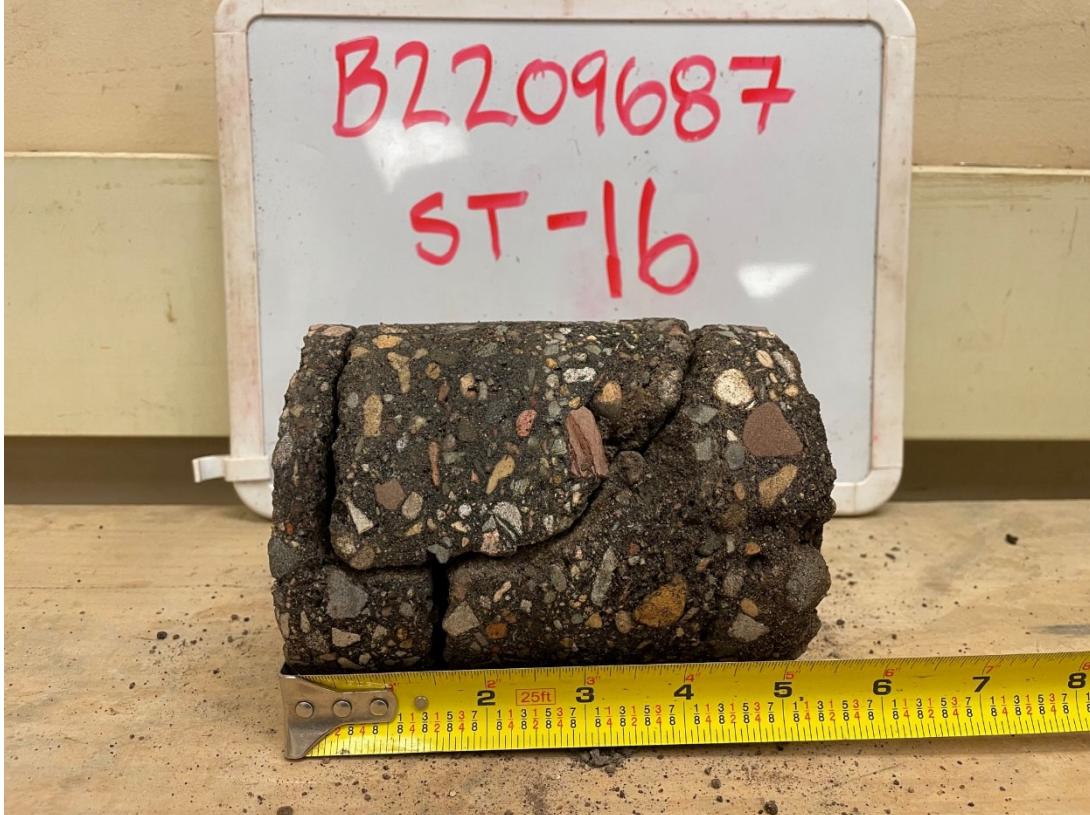
Core #:	ST-16			Project: B2209687
Pavement thickness	5 inches		Agg base thickness:	7 inches
Location:	Maple Park Drive			
Date:	November 2022			
Notes:	High deterioration, horizontal and vertical cracking throughout core.

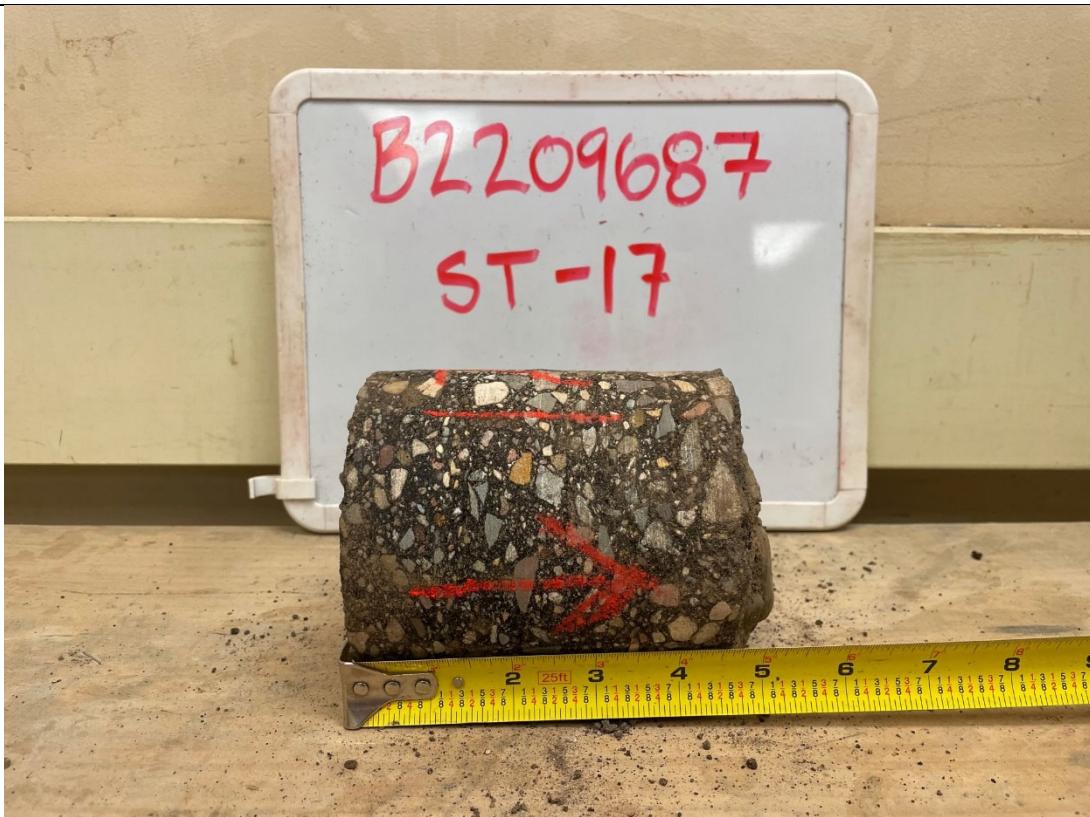
Core #:	ST-17			Project: B2209687
Pavement thickness:	4 3/4 inches		Agg base thickness:	11 1/4 inches
Location:	Ivy Hill Drive			
Date:	November 2022			
Notes:	Overall good condition

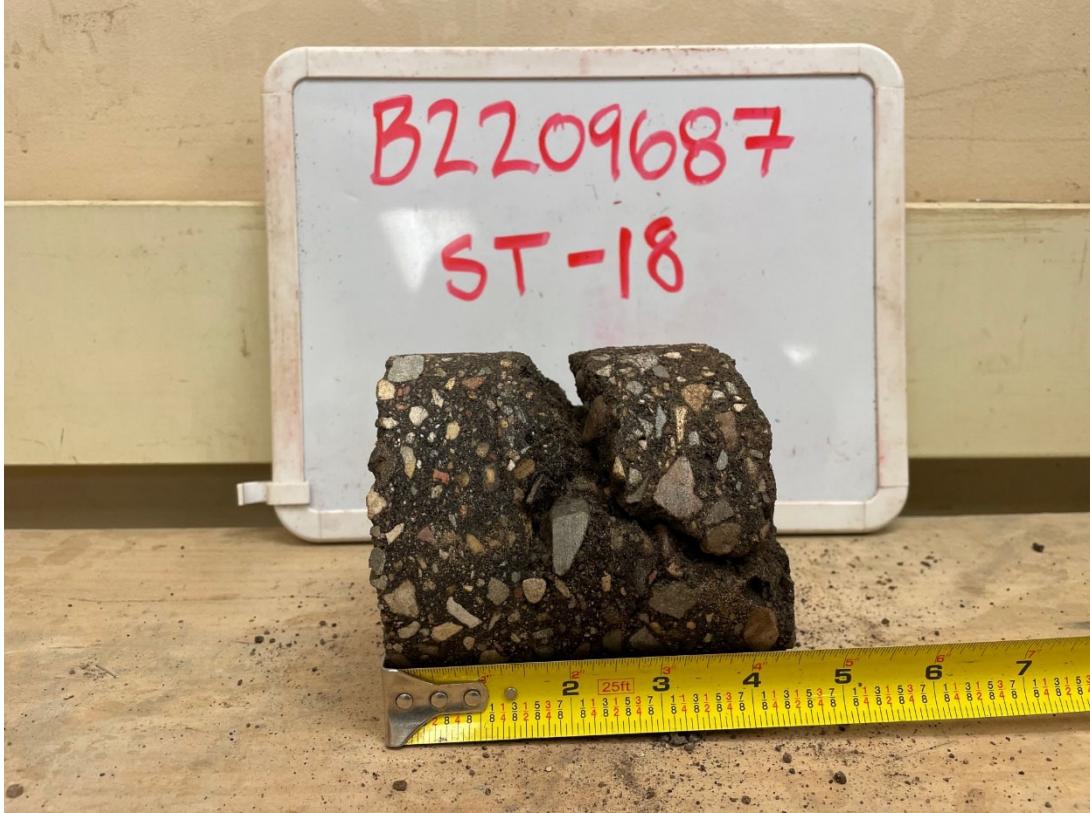
Core #:	ST-18			Project: B2209687
Pavement thickness	4 1/2 inches		Agg base thickness:	14 1/2 inches
Location:	Ivy Hill Drive			
Date:	November 2022			
Notes:	Moderate to high deterioration with cracking below 2-inches.

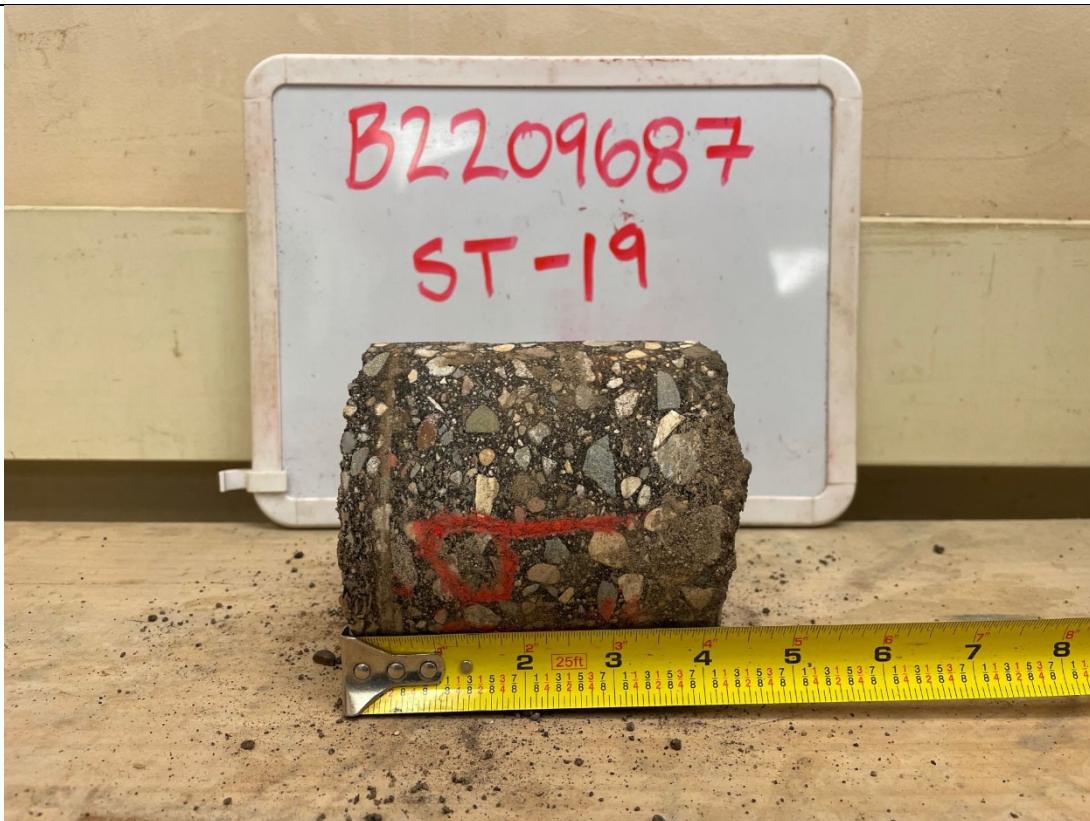
Core #:	ST-19			Project: B2209687
Pavement thickness:	4 1/2 inches	Agg base thickness:	4 inches	
Location:	Ivy Hill Drive			
Date:	November 2022			
Notes:	Overall good condition
