April 28, 2021

City of Mendota Heights

Police/City Hall Facility Space Needs Study

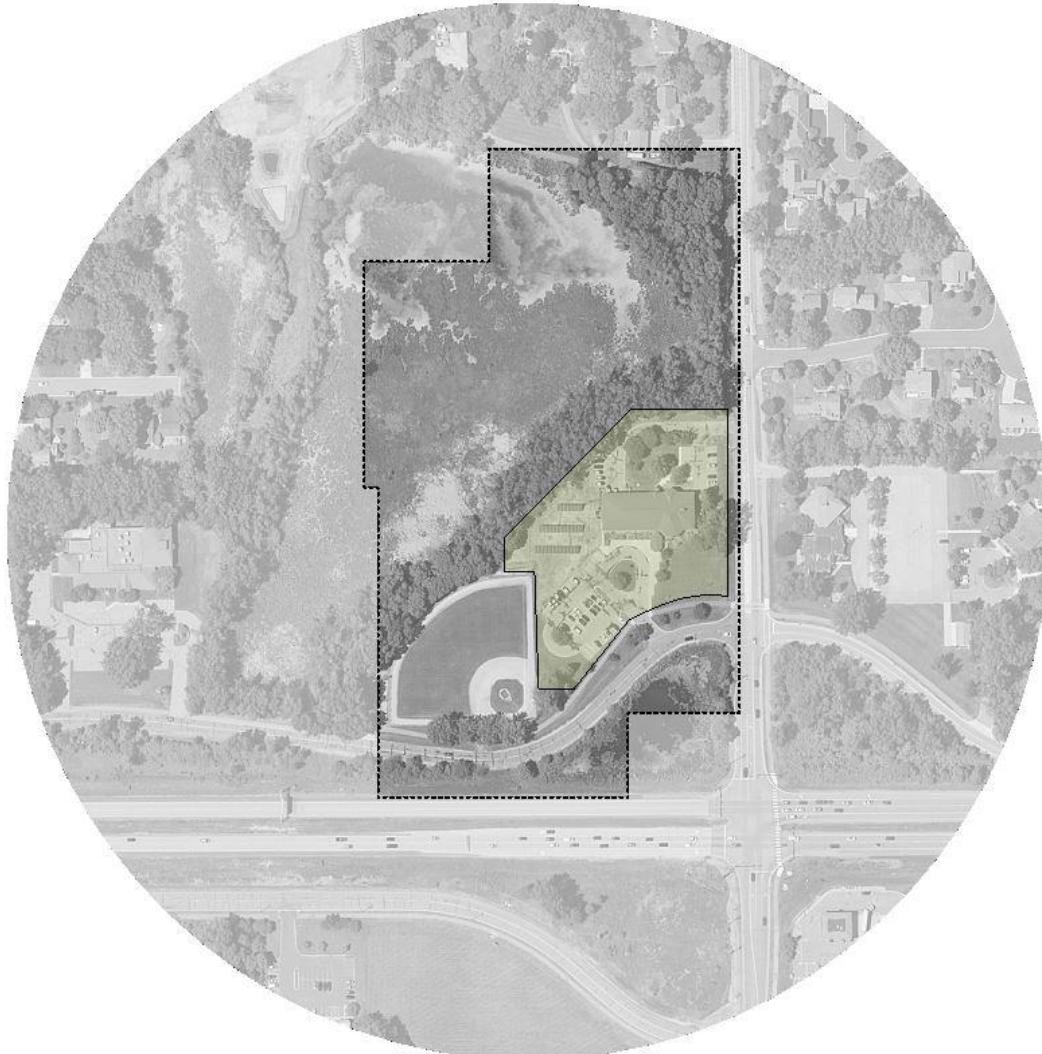
Site Statistics

- Year Built: 1988
- 17.39 acres
- 3.24 acres buildable area

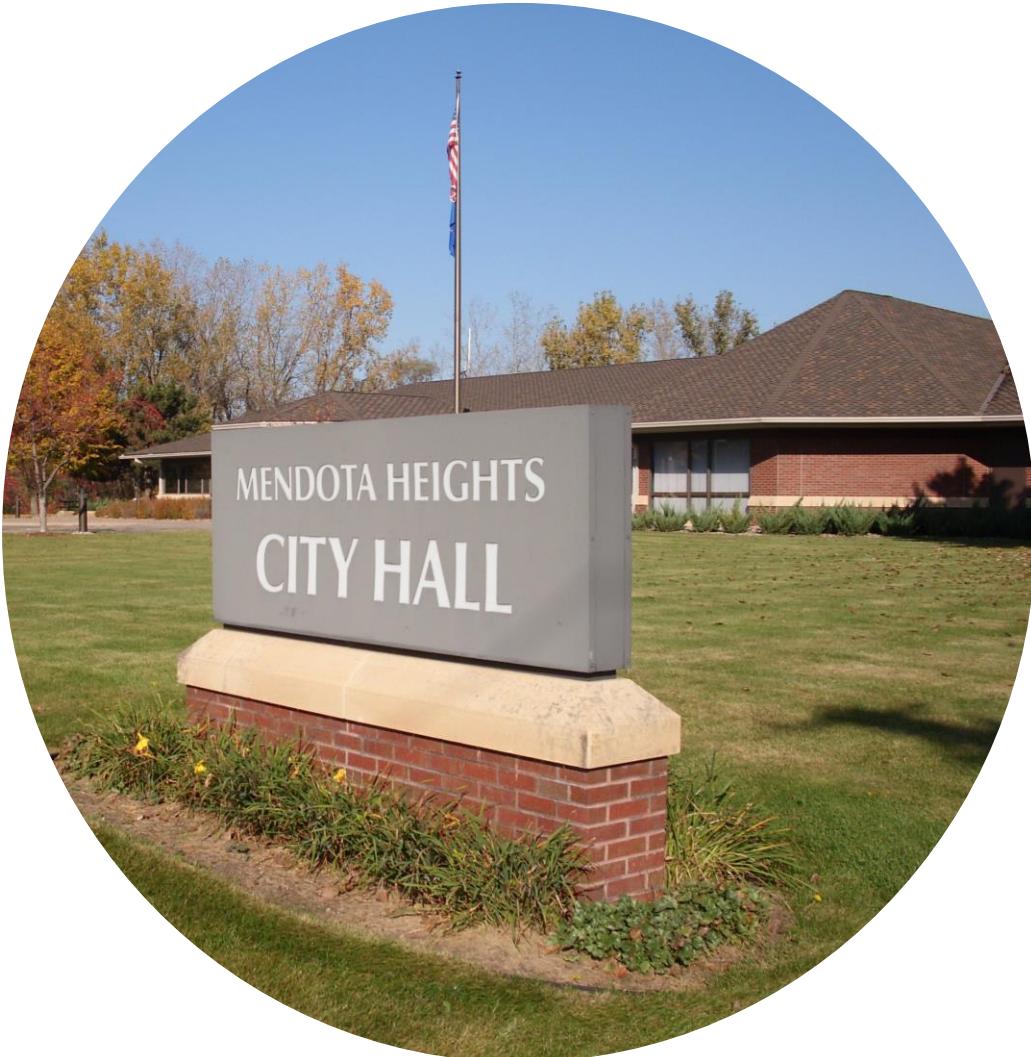
Infrastructure

- Poor circulation and flow leading to decreased functionality
- Inadequate access to utilities
- Existing building infrastructure in good shape to provide remodel/addition

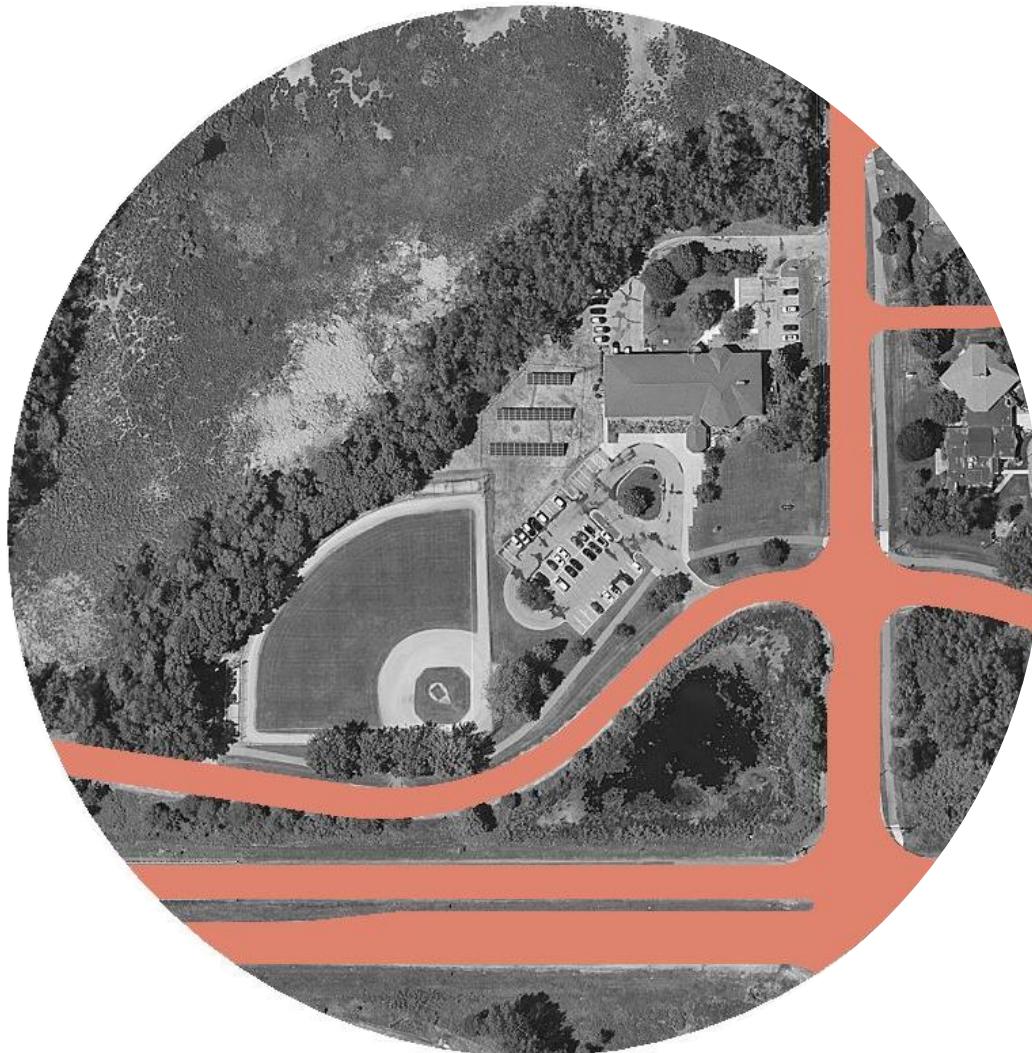
Street Access

- Located off Lexington Avenue and Victoria Curve, north of Highway 62
- Residential neighborhood
- Ample room and good visibility

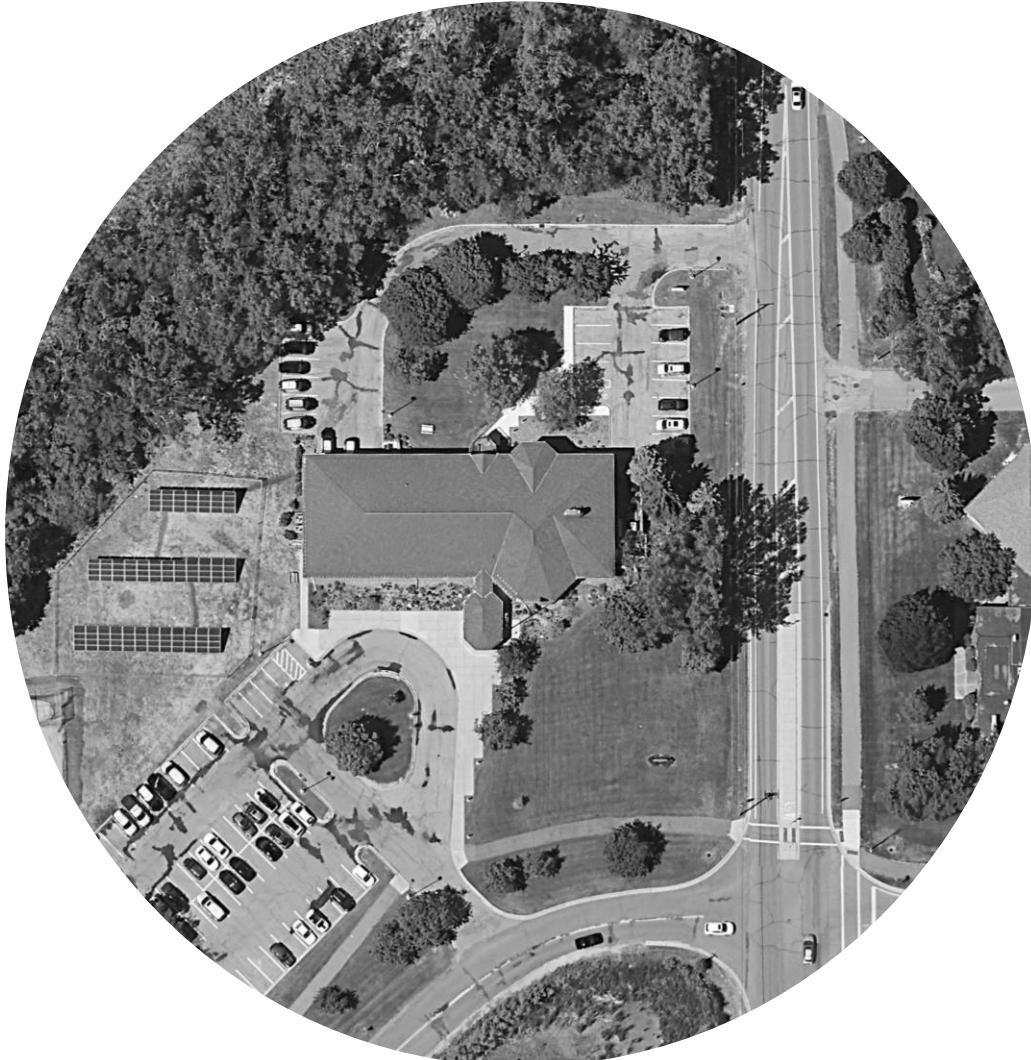
Deferred Maintenance

- West wall needs improved waterproofing
- ADA updates needed
- Elevator moisture concerns
- Outdated mechanical systems

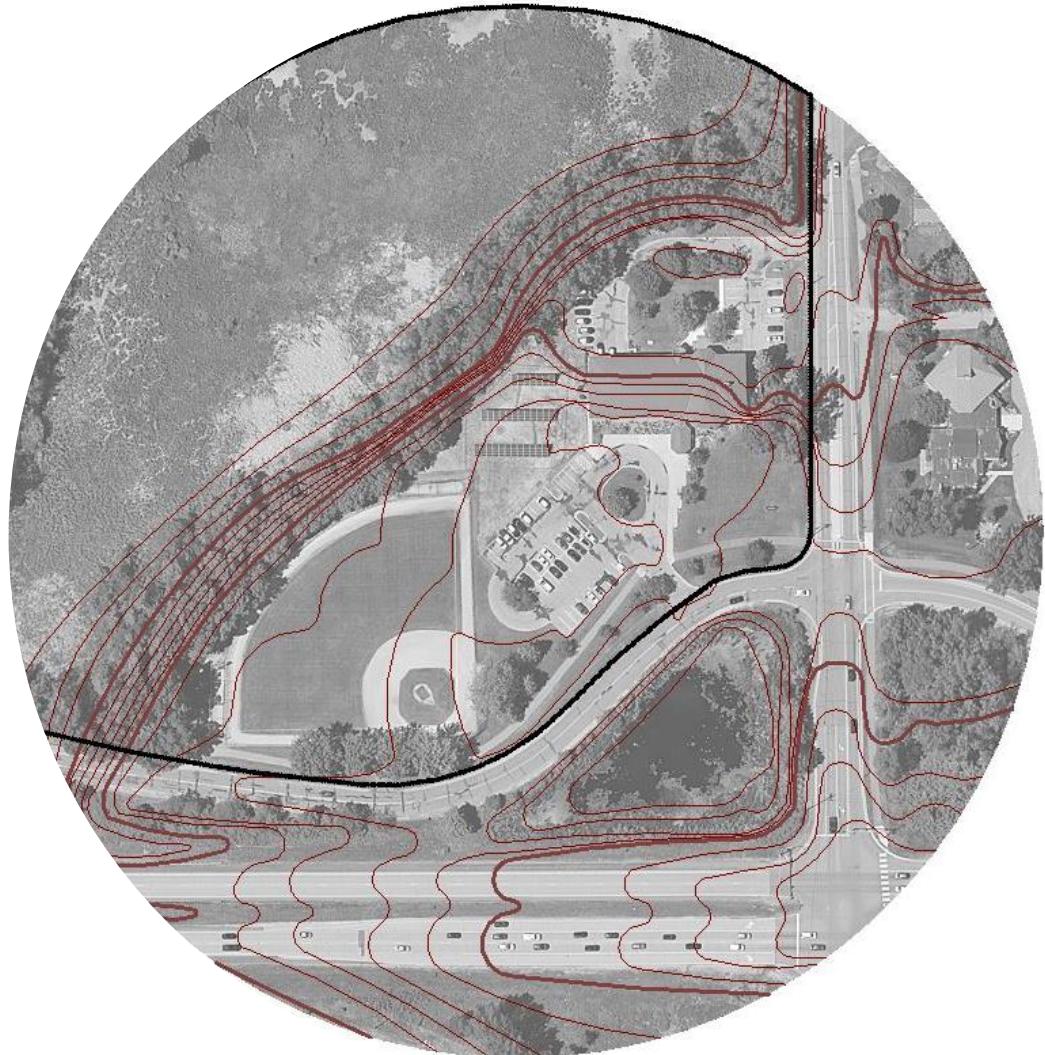
Topography

- Mostly flat across south side of site
- North and west sides have an elevation change of approximately 18 feet
- The west elevation change could have an impact on the requested road access between the two parking lots

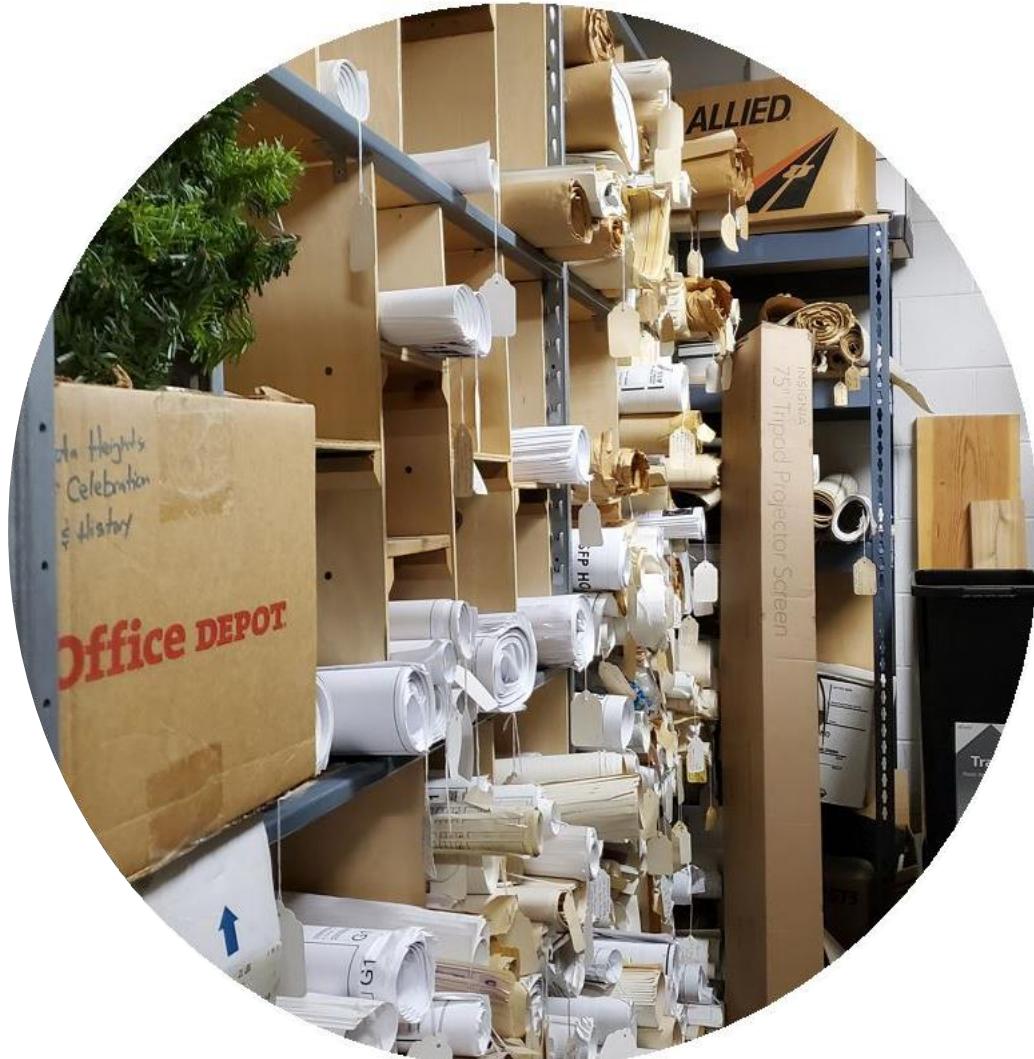
Insufficient Space

- Current spaces are too small for day-to-day operations
- No space for public use
- Lack of secure storage
- Not enough room to create additional spaces

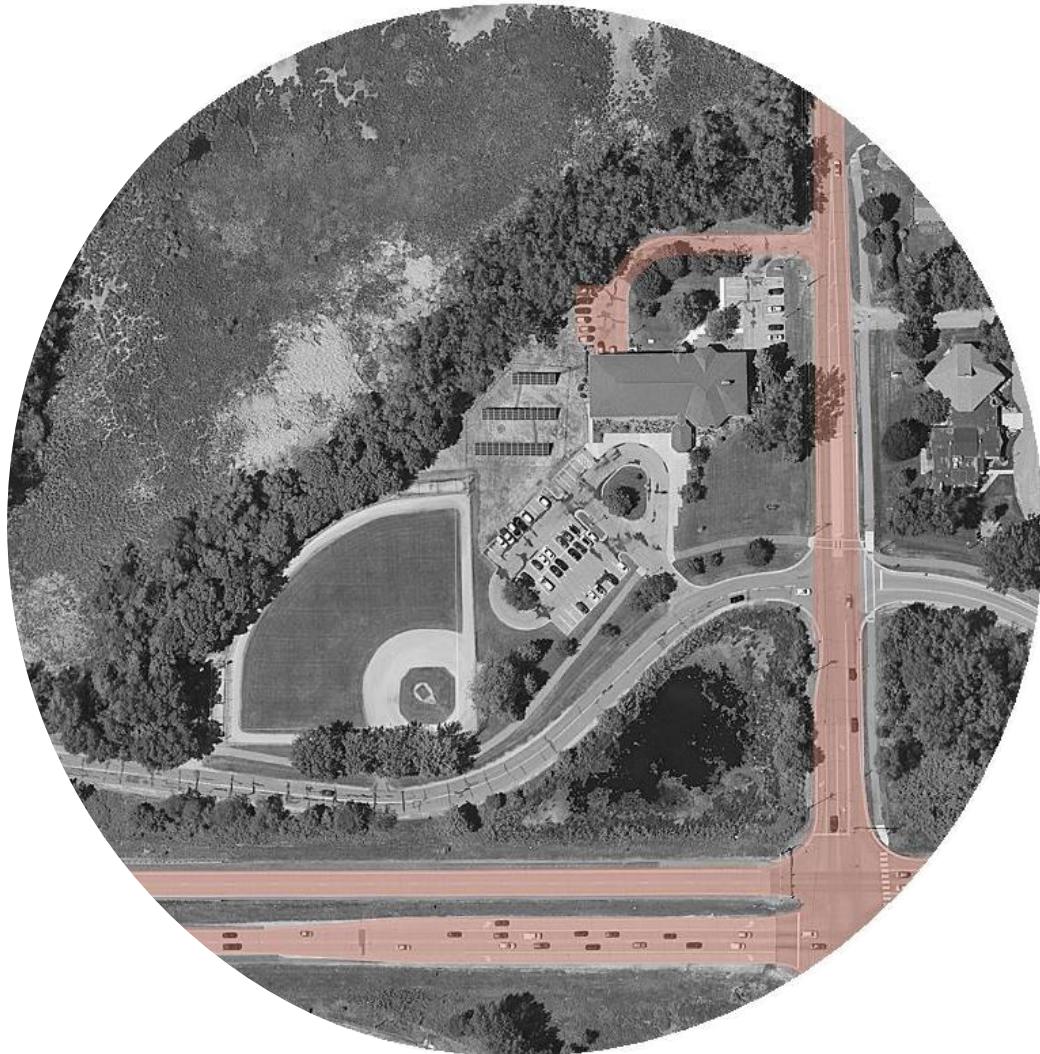
Station Access/ Response Time

- Squad cars only have one outlet to Lexington Avenue
- Single outlet can lead to increased response times or potential blockage

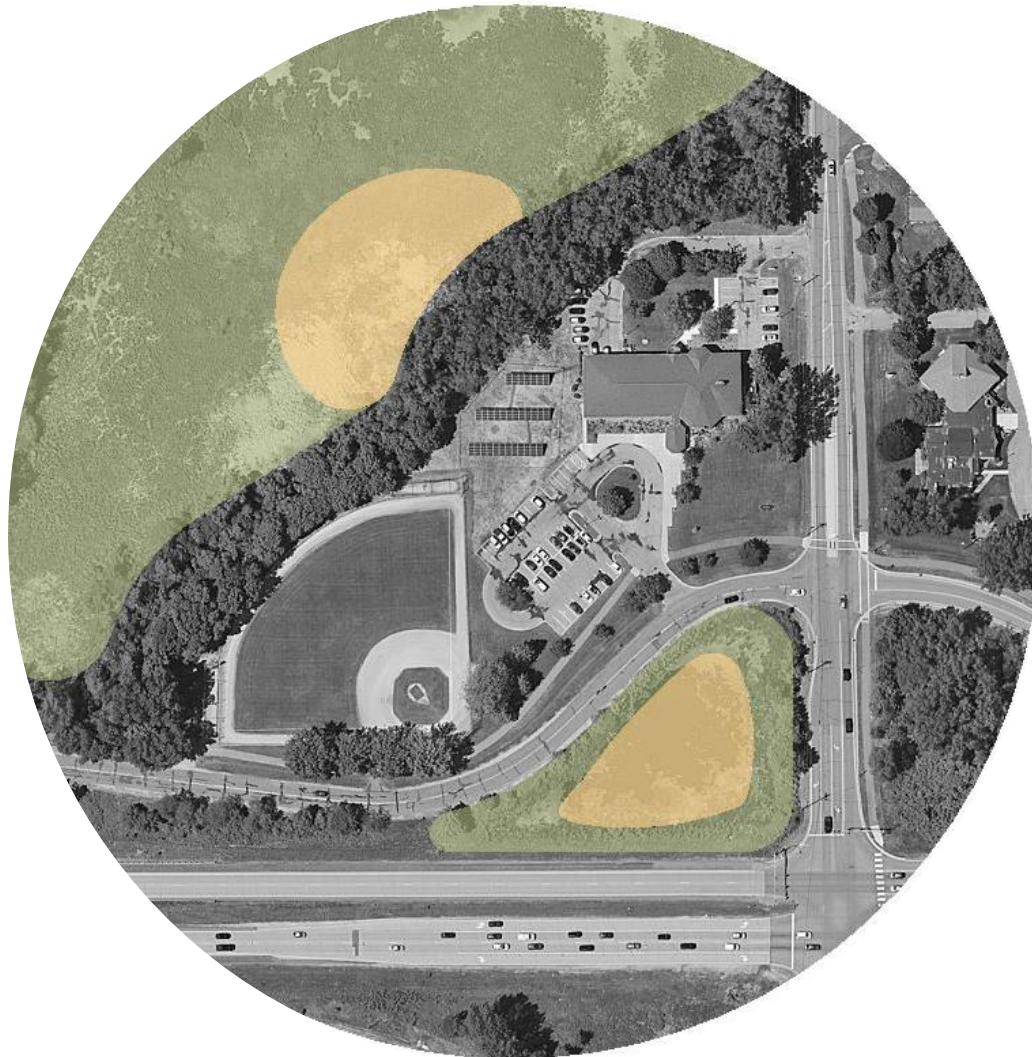
Wetlands

- DNR public water site and wetland located on northwest corner
- Smaller wetland on southeast corner of site

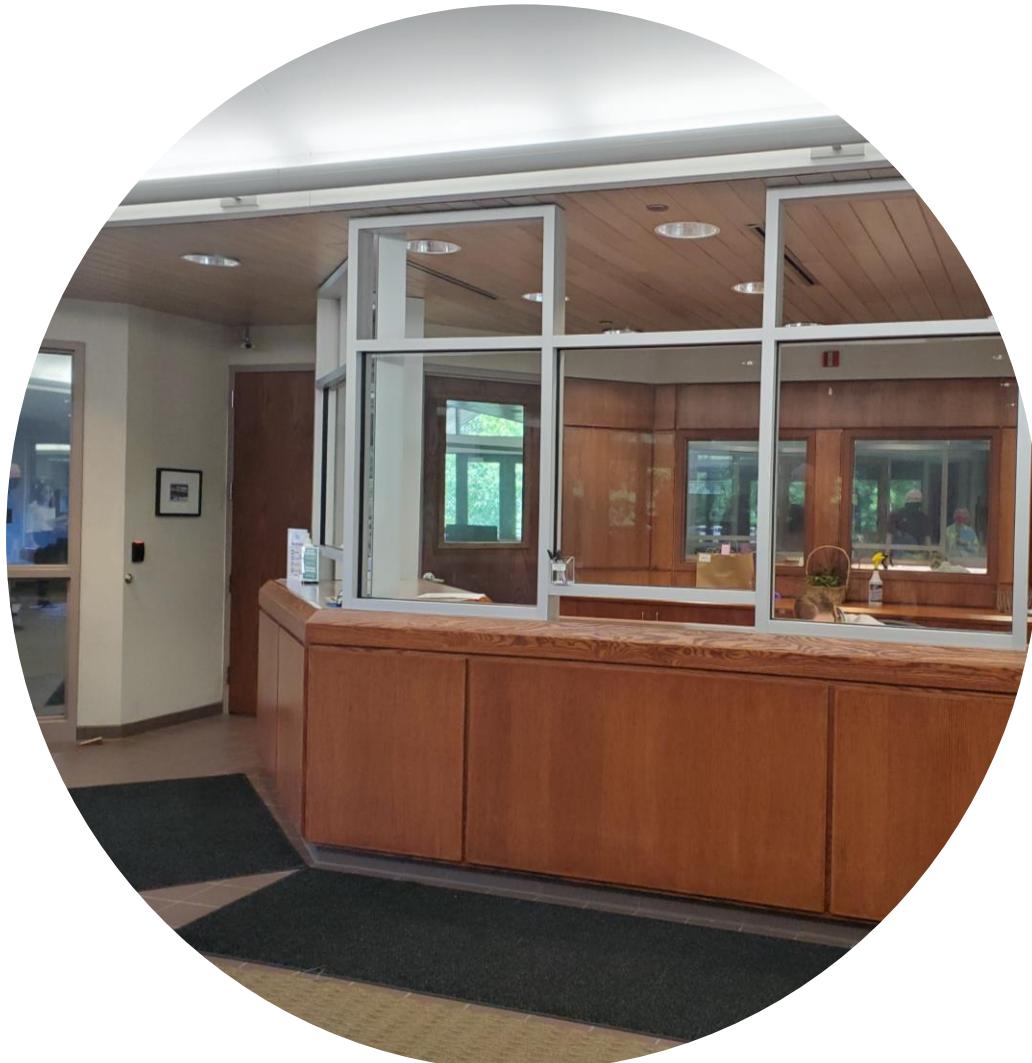
Health & Safety

- Insufficient separation between secure and public areas
- Council Chambers lacks a sufficient number of multiple exits
- Not enough garage space to securely store all squad cars and reduce vehicle idling

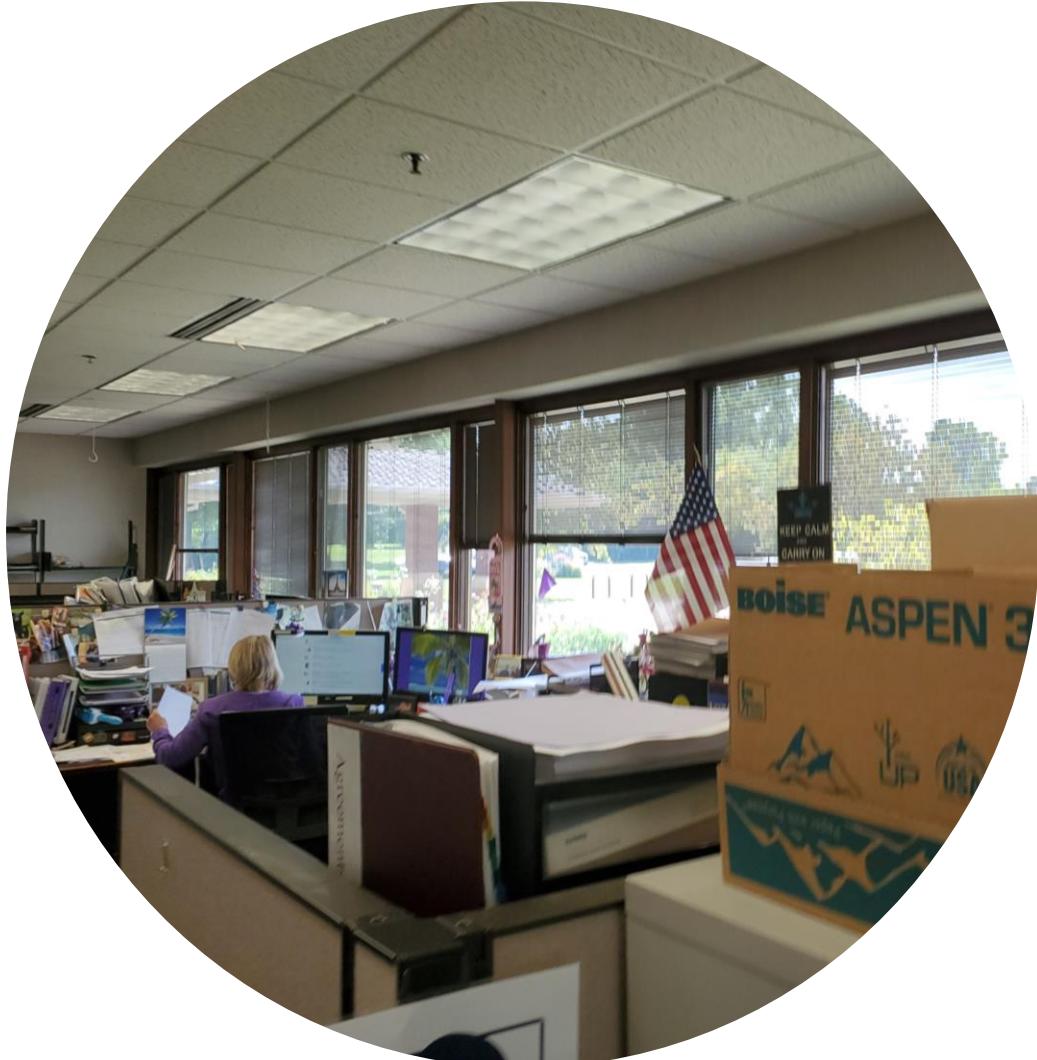
Department Operations

- No space for police training
- Council Chambers does not function well for meetings
- Not enough meeting rooms or comfortable office space

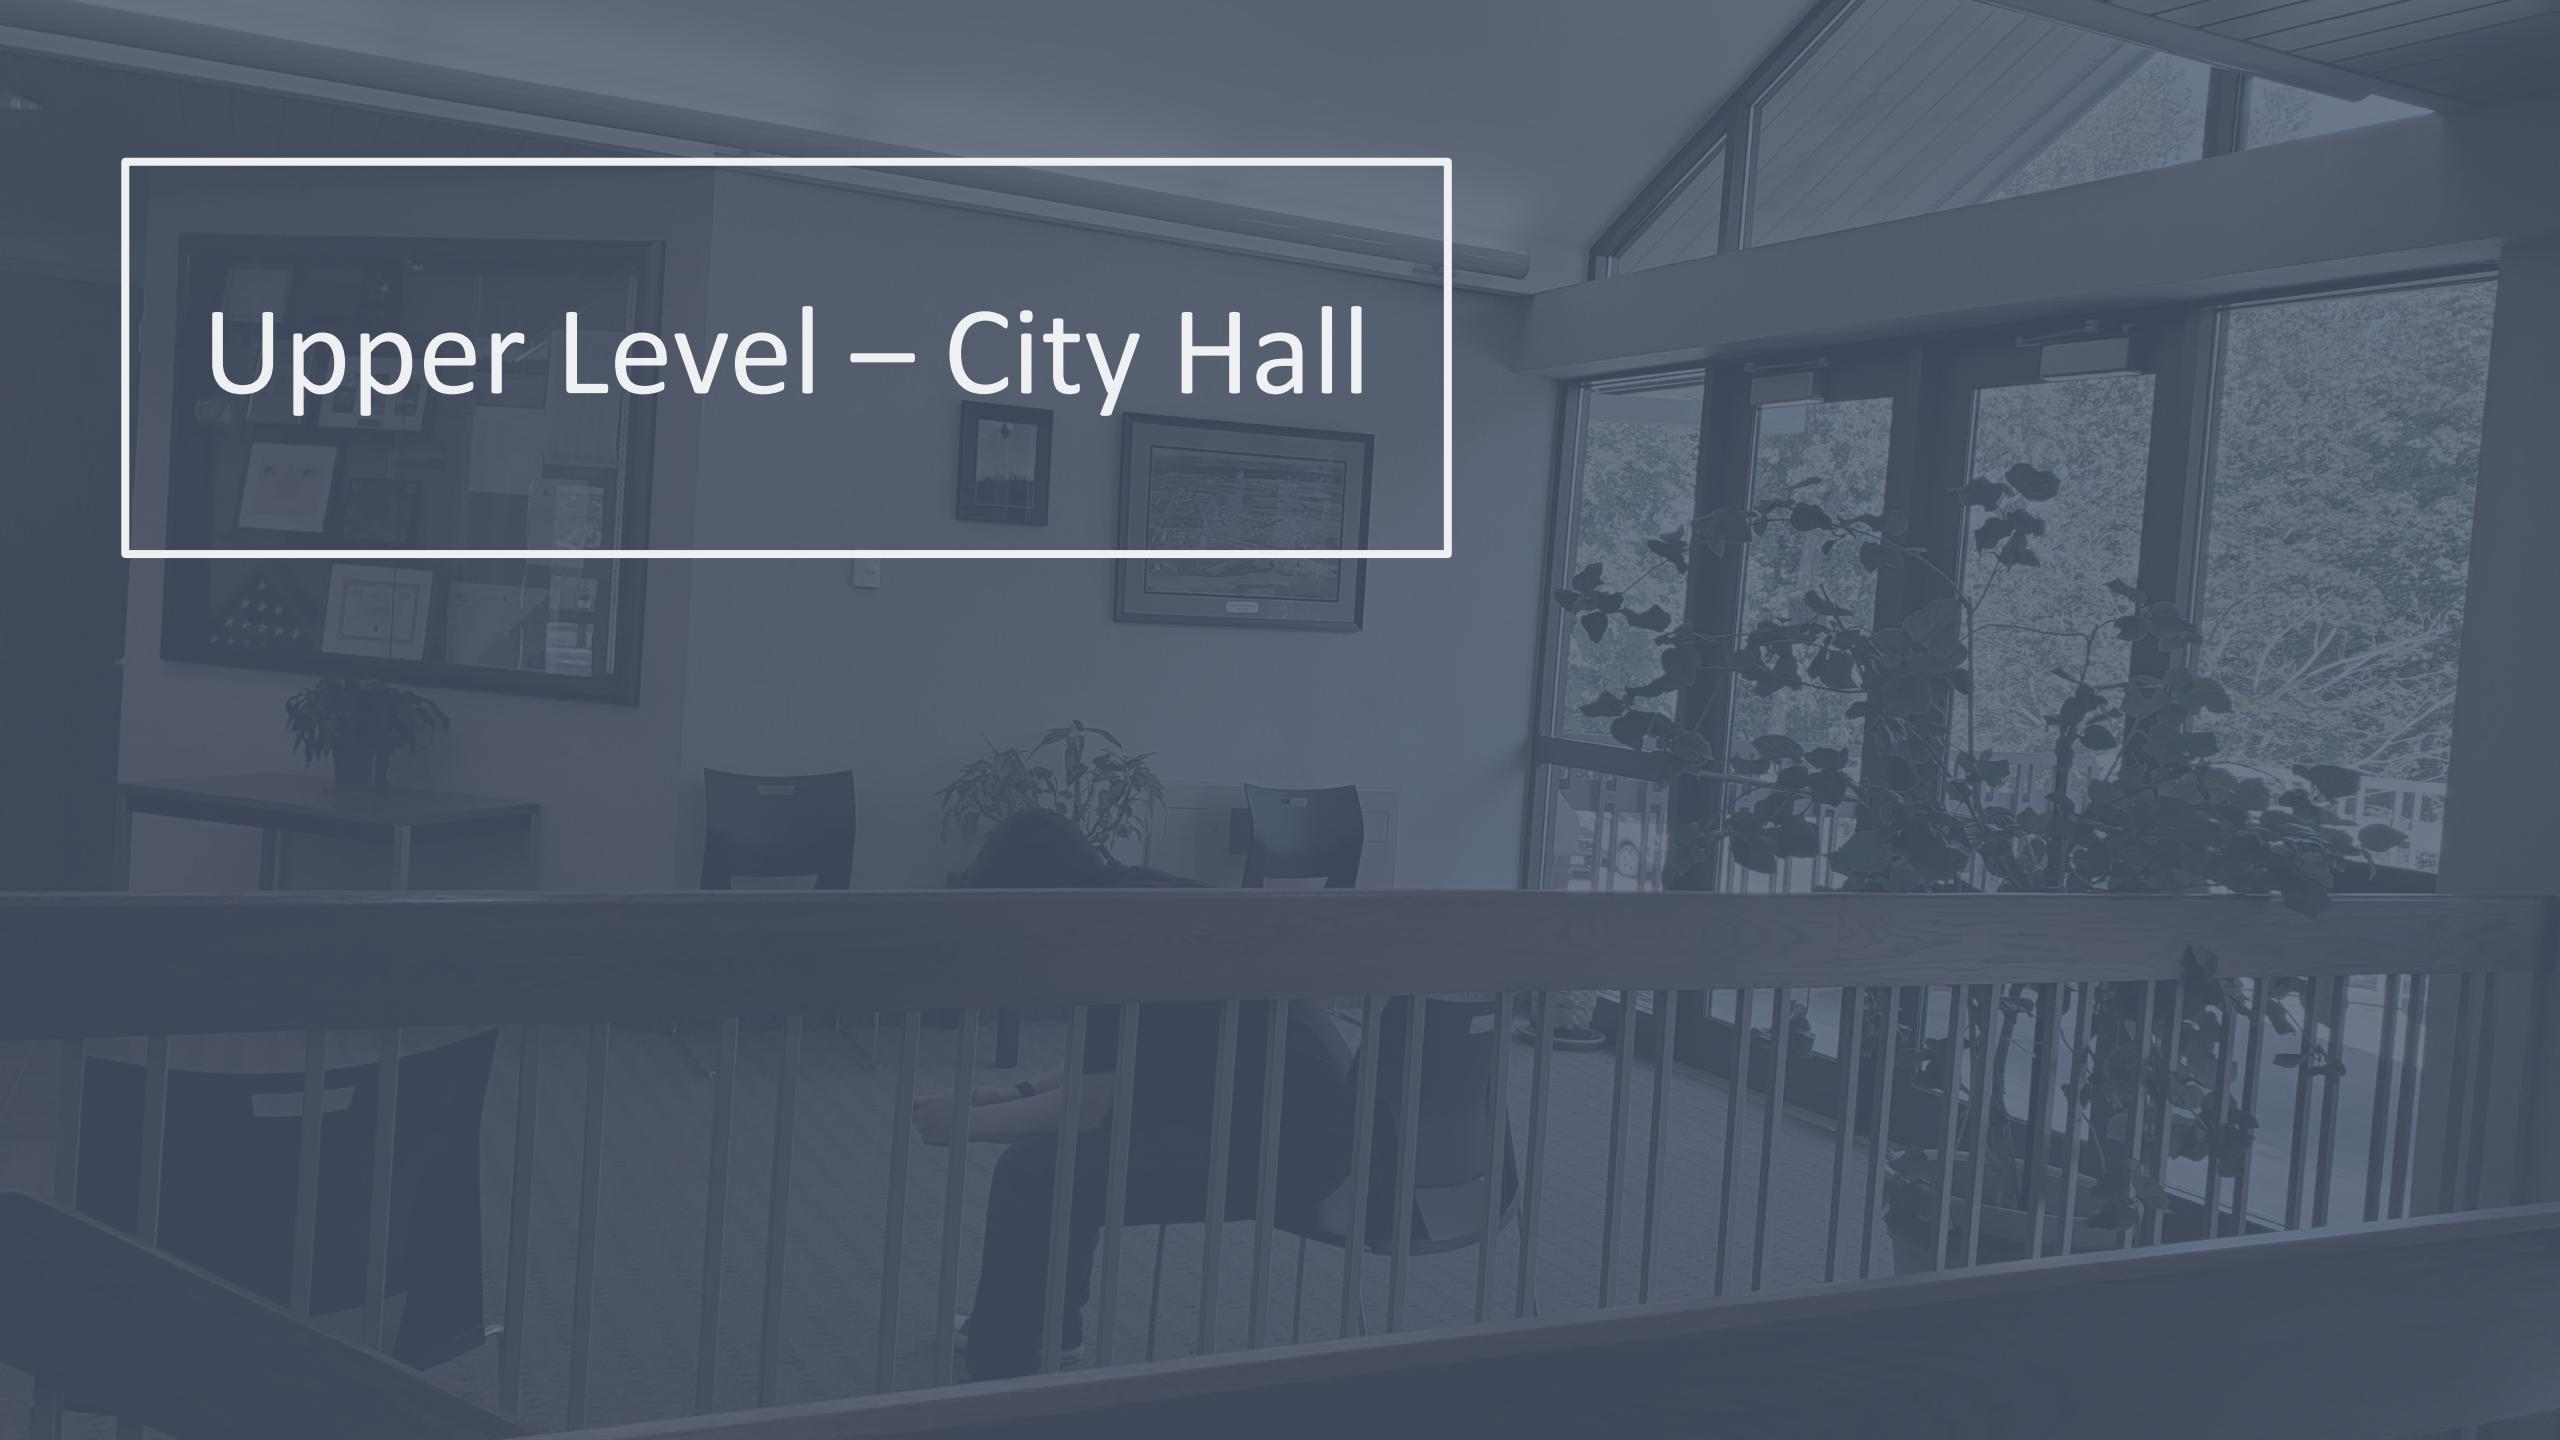
Upper Level – City Hall

Public	4,372 SF
Staff Office	3,791 SF
Support/Storage	908 SF
Circulation	1,502 SF
Exterior Walls/Building Services	1,363 SF
<hr/>	
Total Area	11,936 SF
Existing Area	9,944 SF
Shortage	1,992 SF

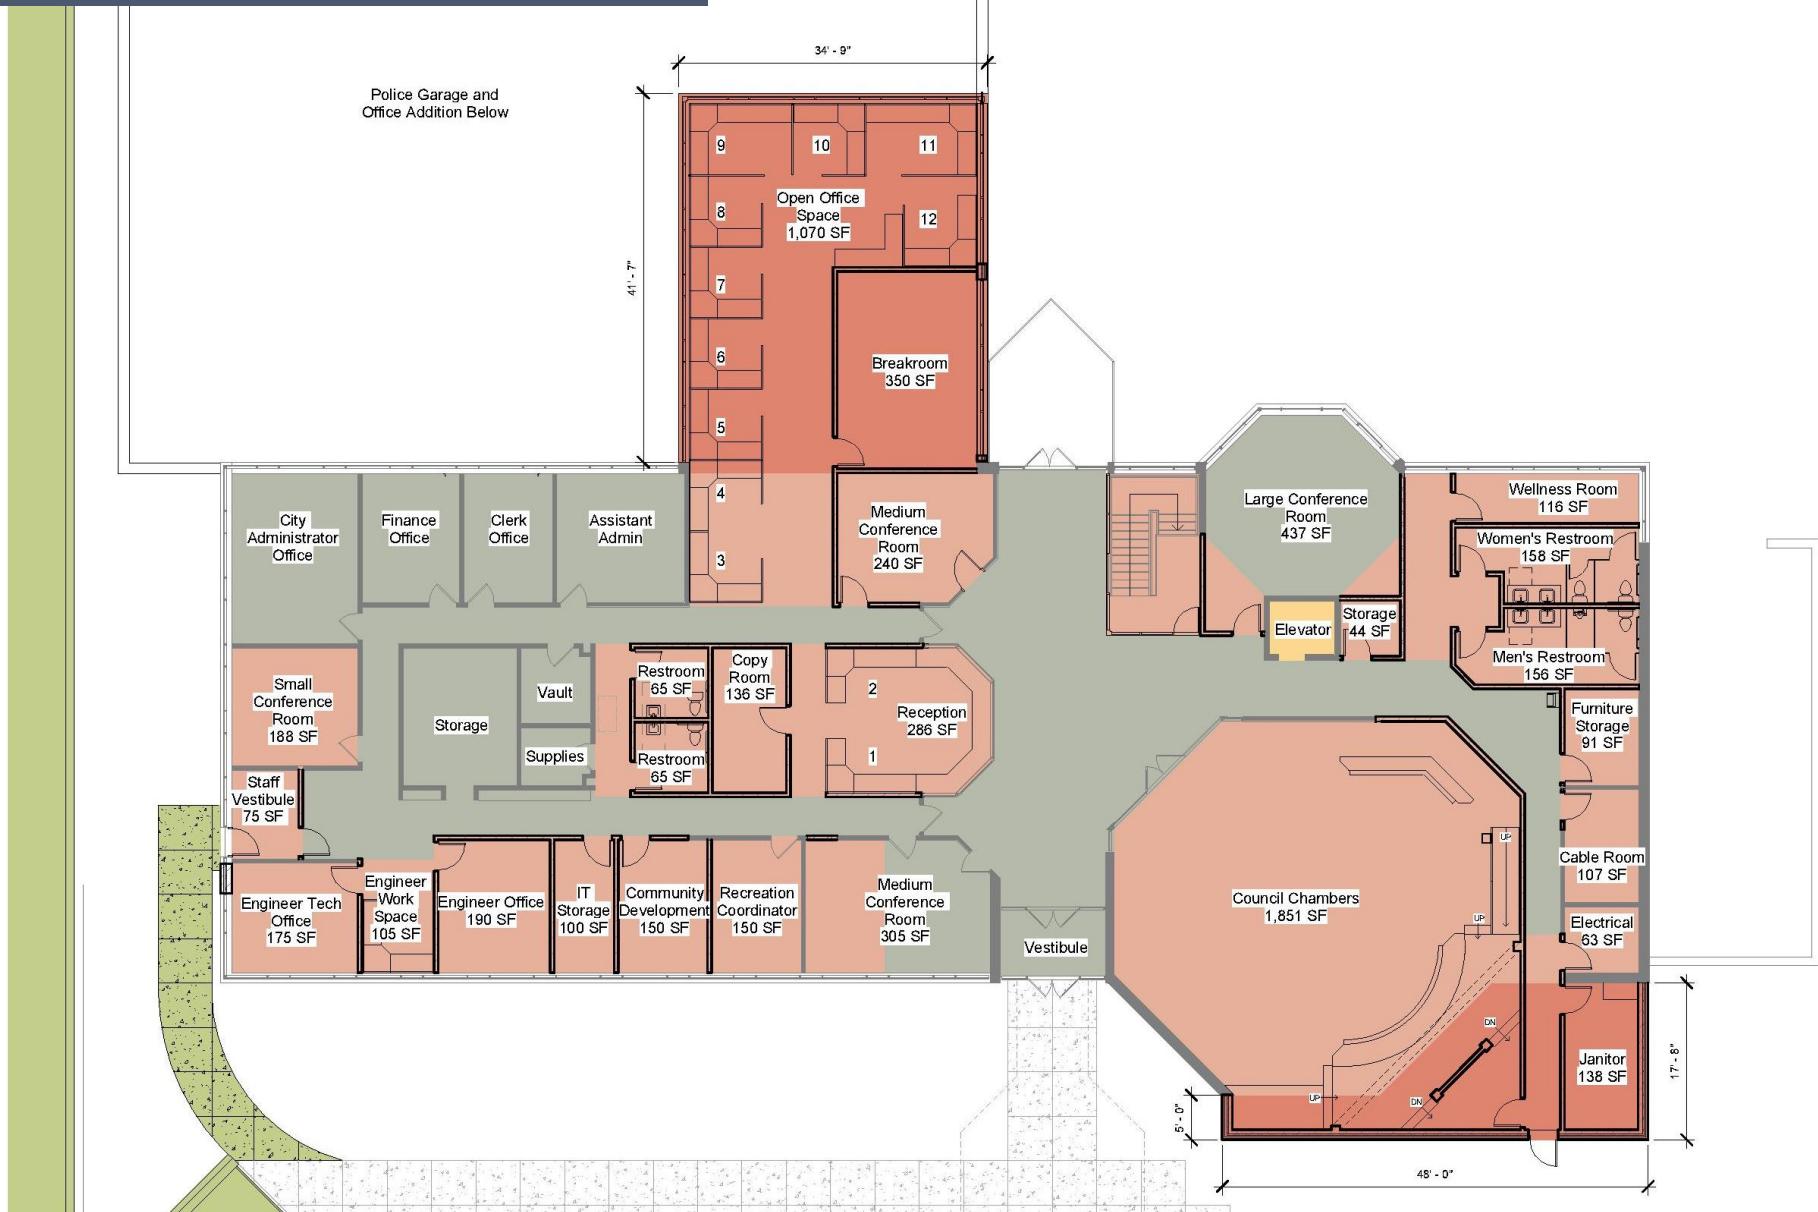
Upper Level Plan

City Hall

Upper Level Program

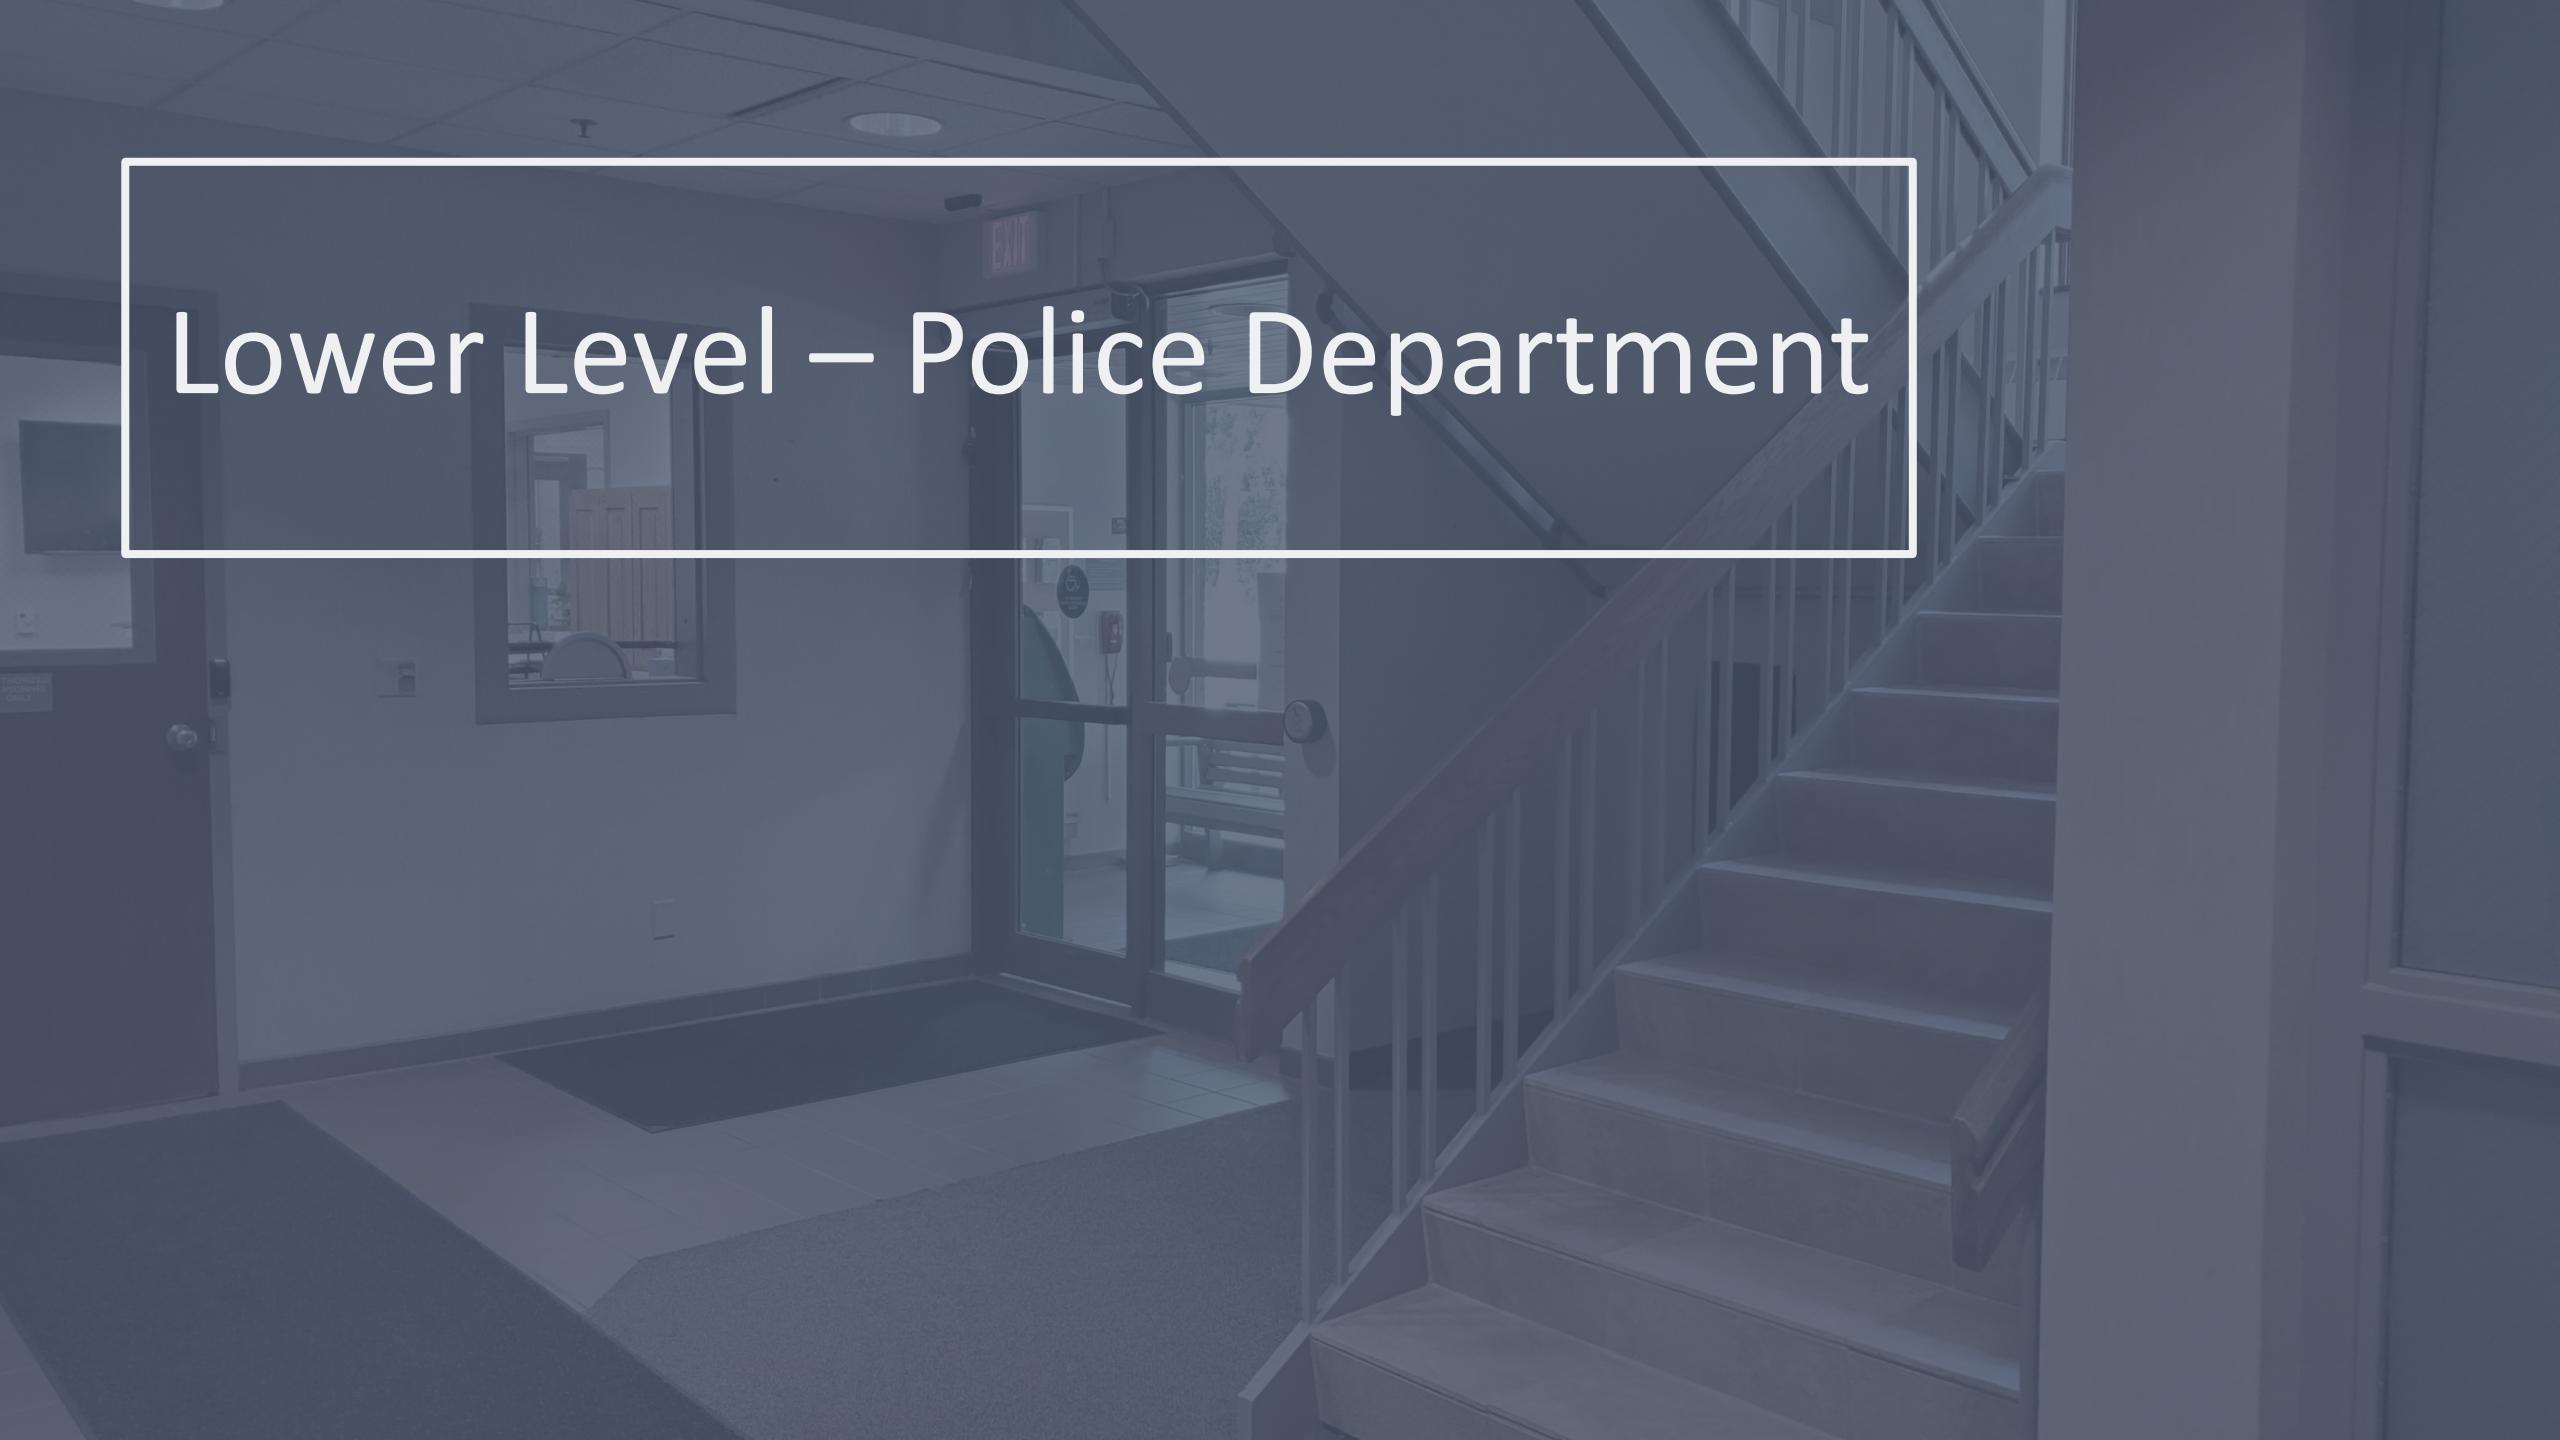
Lower Level – Police Department

Department Office	1,218 SF
Training	1,715 SF
Common	1,989 SF
Secure Operations	819 SF
Support	2,588 SF
Garage	5,429 SF
Circulation	1,933 SF
Exterior Walls & Building Services	1,632 SF
<hr/>	
Total Area	17,323 SF
Existing Area	9,944 SF
Shortage	7,379 SF
