April 28, 2021

City of Mendota Heights

Police/City Hall Facility Space Needs Study

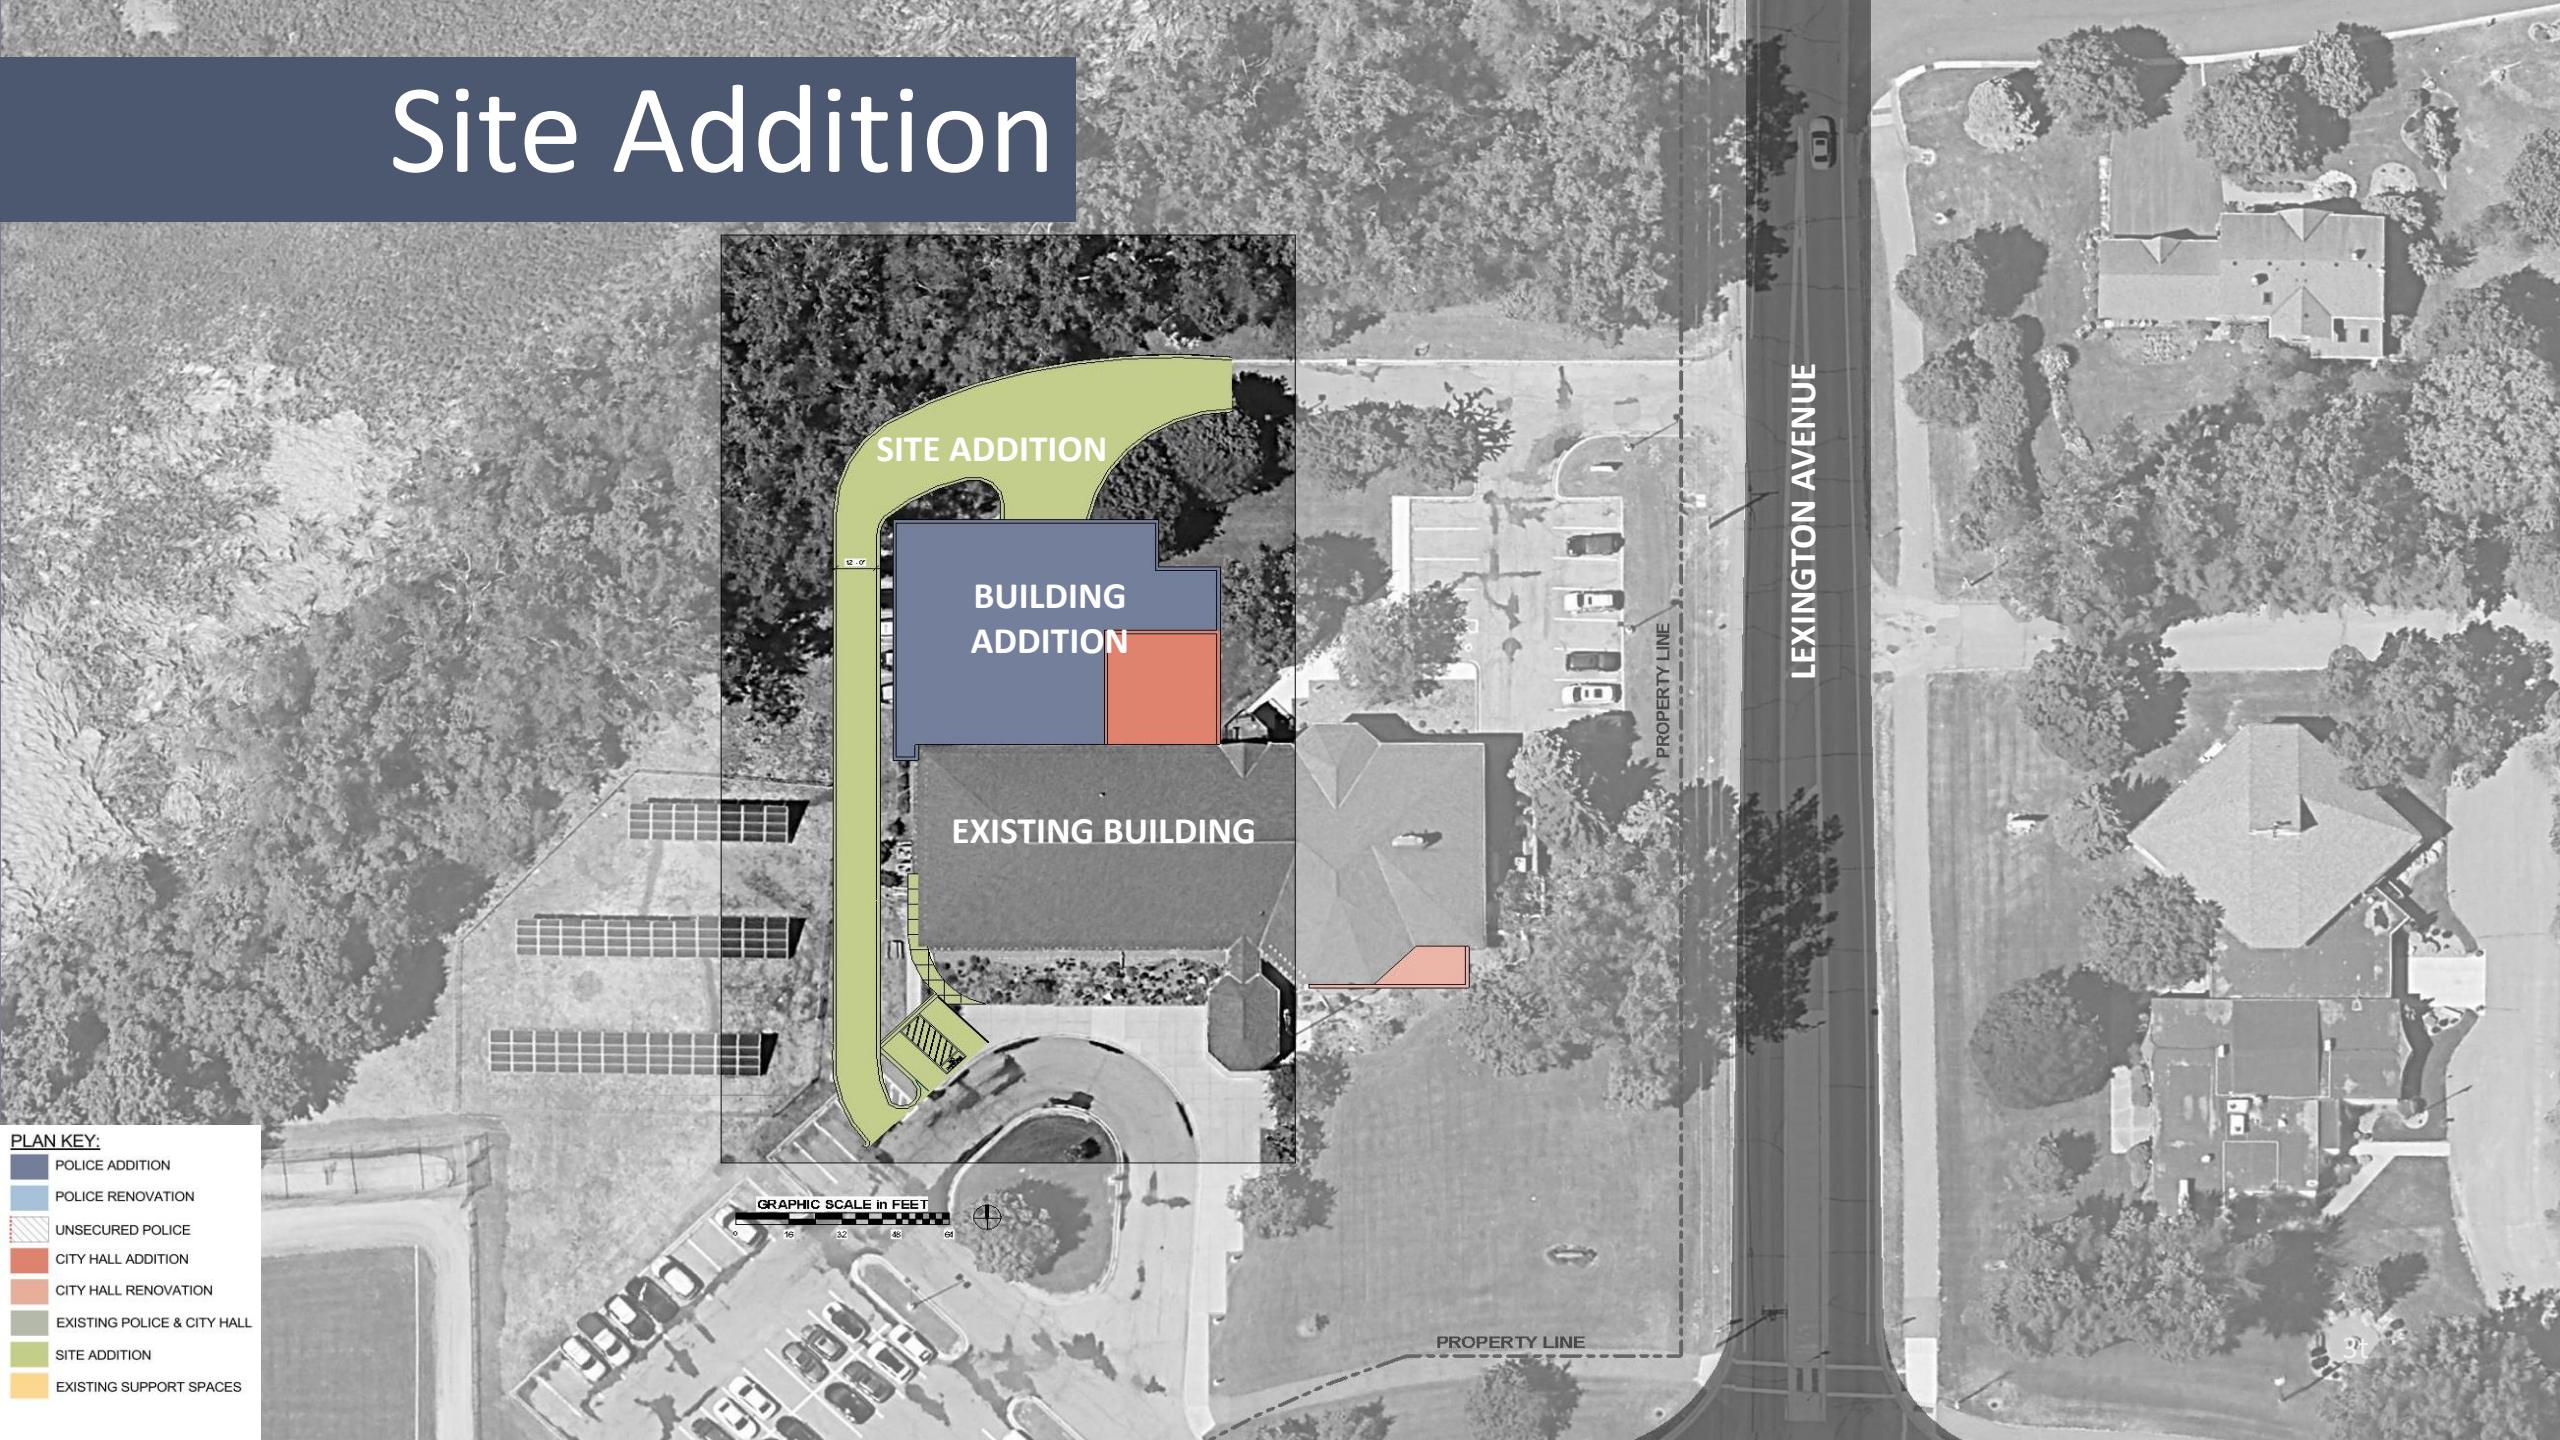
Site Addition

Site – Road Addition
