# City of Mendota Heights

Municipal Campus Space Needs Study  
1101 Victoria Curve, Mendota Heights, MN 55118

August 6, 2025

# FACILITY CONDITION SUMMARY

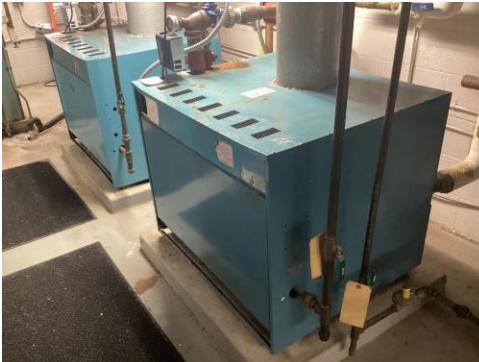
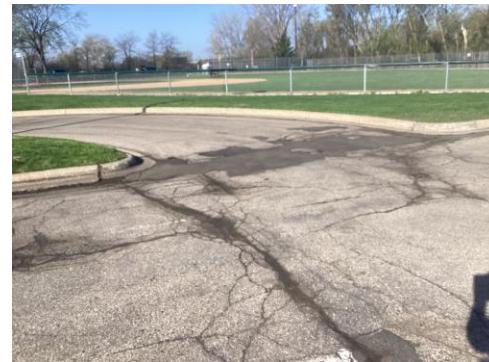
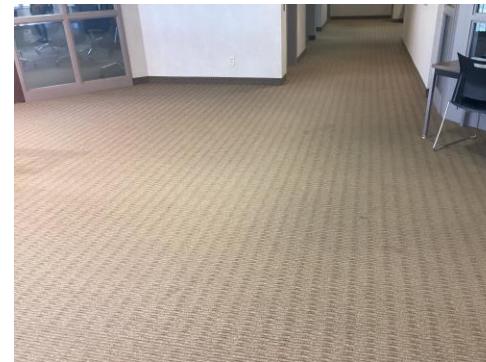
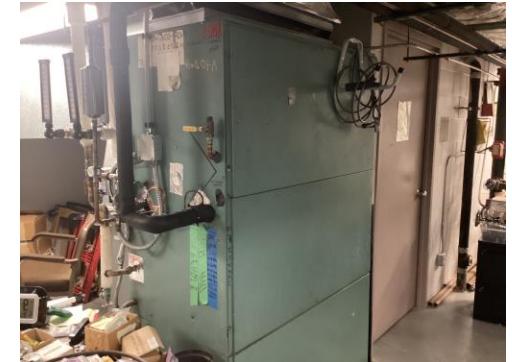
The following components and systems were reviewed during site visits and observations, assuming [like-for-like](#) replacements, **unless replacements are required to meet code requirements by the authority having jurisdiction:**

- Facility Site (including parking lots, sidewalks, etc.)
- Building Envelope (exterior walls, sealants, windows, roofs, etc.)
- Building Interior Finishes (flooring, walls & ceilings)
- Mechanical Systems (HVAC, hydronics, boilers, plumbing, automated controls, etc.)
- Electrical Systems (service, power distribution, lighting, etc.)
- Life Safety Systems (PA, fire alarm, fire protection, security, etc.)
- Accessibility Issues (site and building)

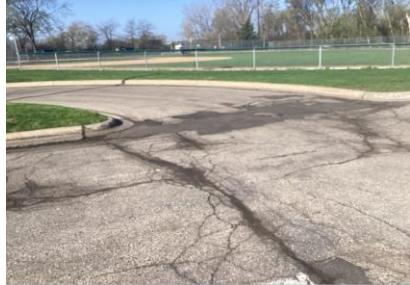
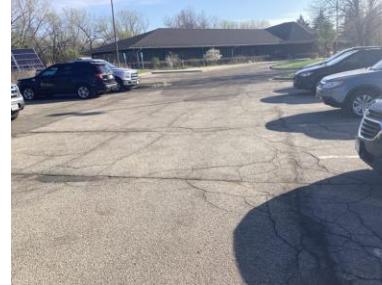
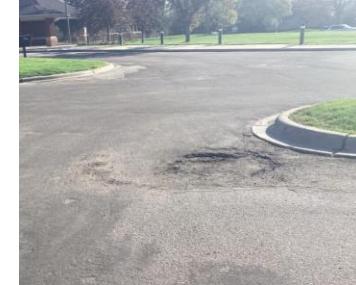
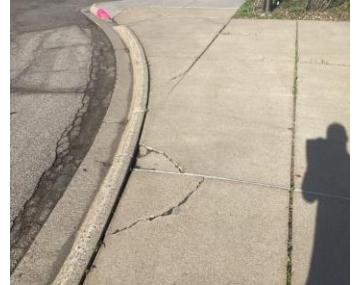
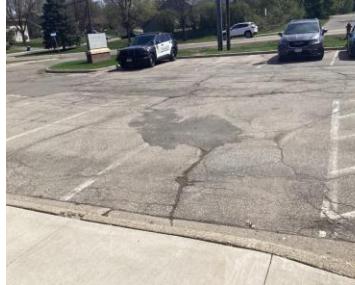
### Facility Site

- Parking lots, drives and walks are deteriorating rapidly and will require replacement soon.

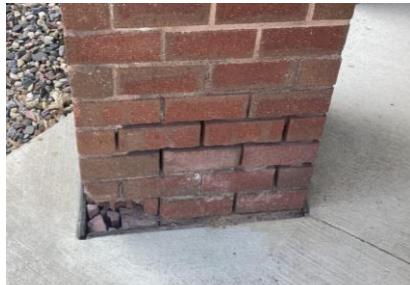
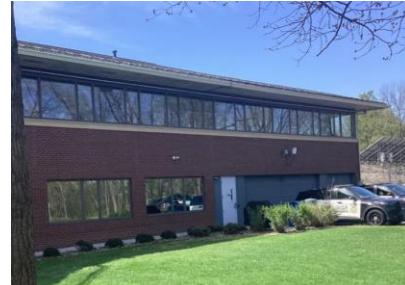
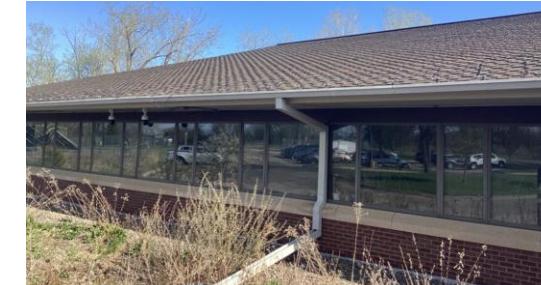
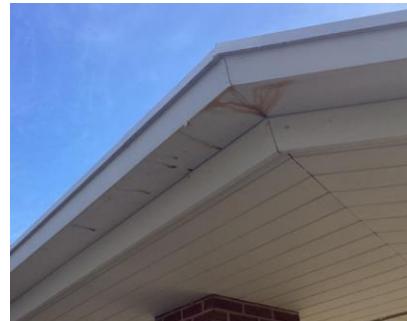
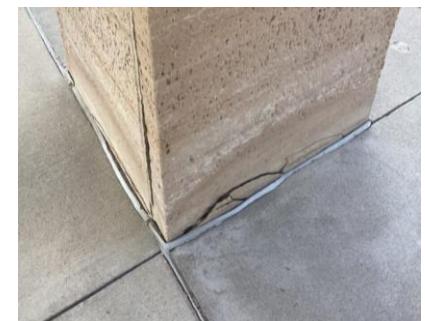
### Building Envelope

- The masonry is good shape with no areas of concern other than deteriorating columns at entries.
- Windows should be replaced for better energy efficiency, and for security reasons for PD & City Council
- The roof will need to be replaced within the next 10 years.
- Past evidence of moisture intrusion through the foundation.

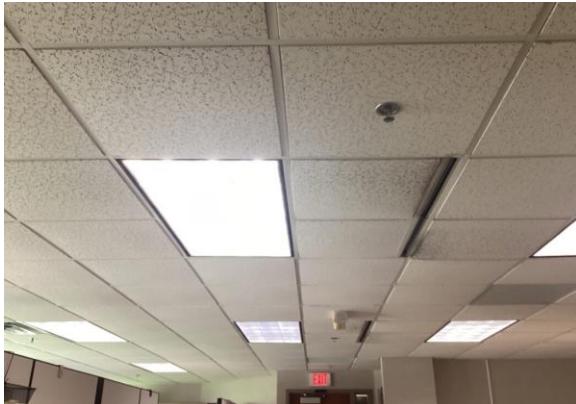
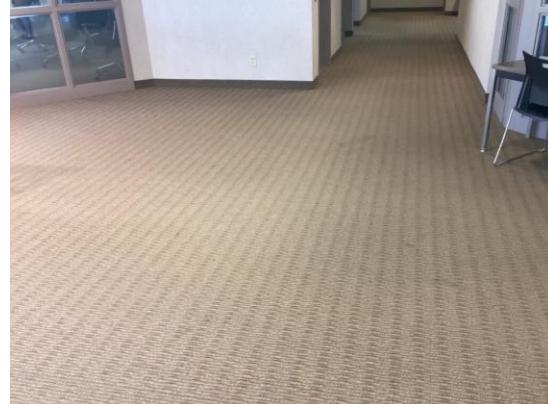
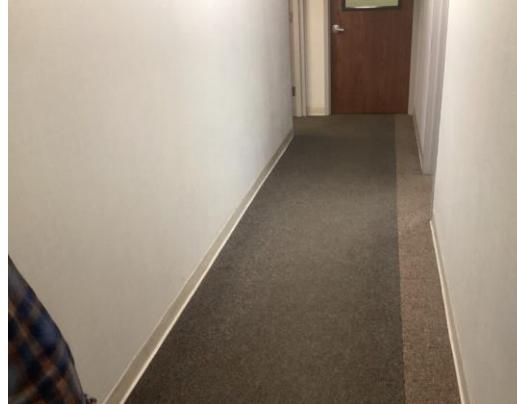
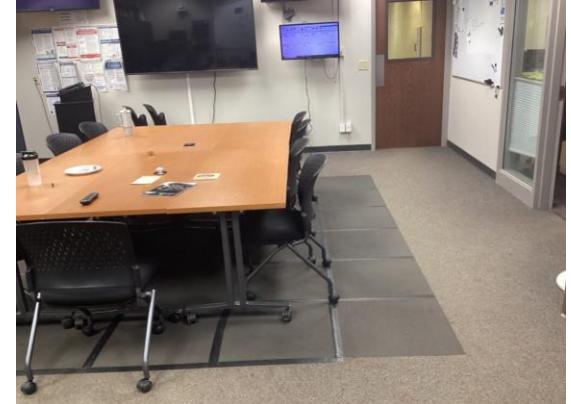
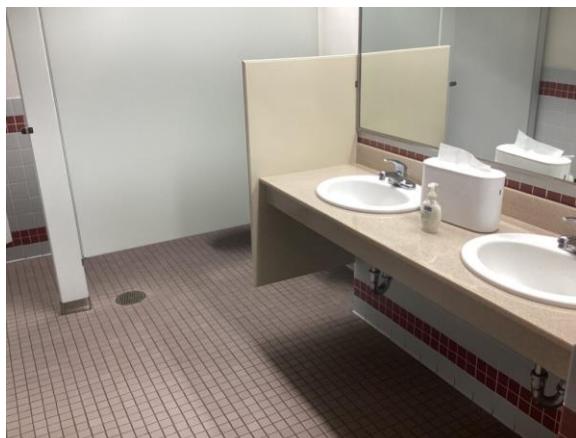
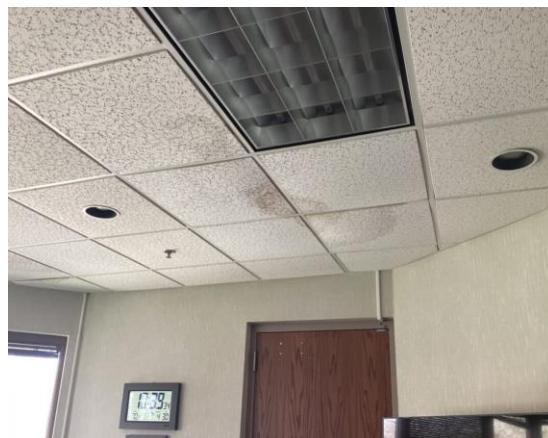
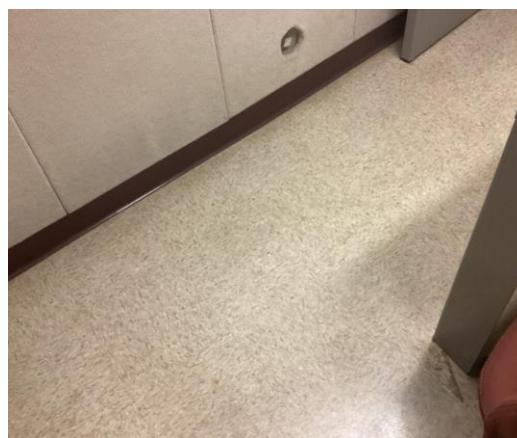
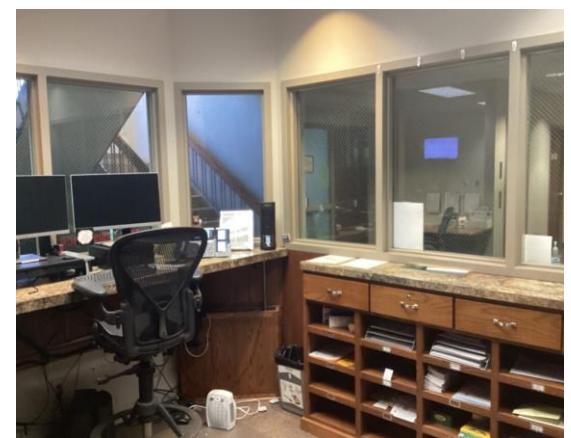
### Building Interior Finishes

- Many of the interior finishes are tired and worn. No indication performance issues, just appearances.
- Safety issue with PD glass counter installed incorrectly.

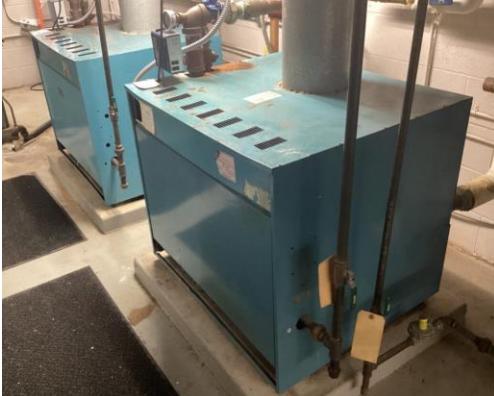
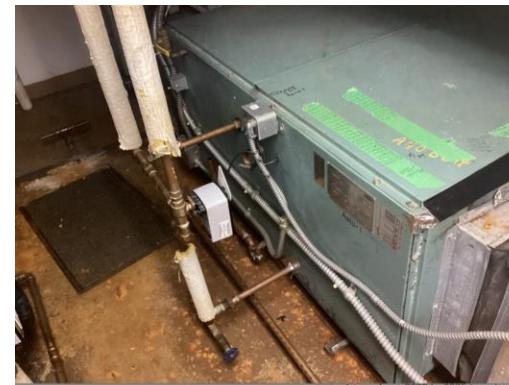
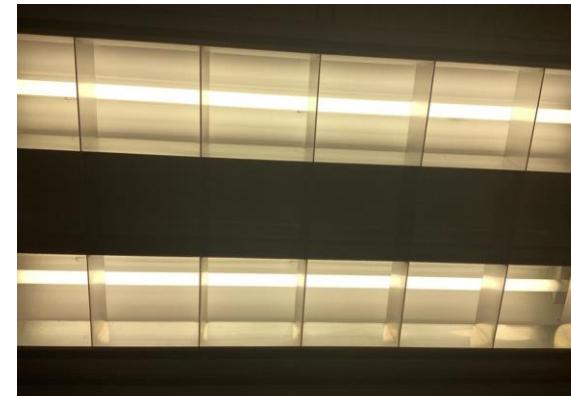
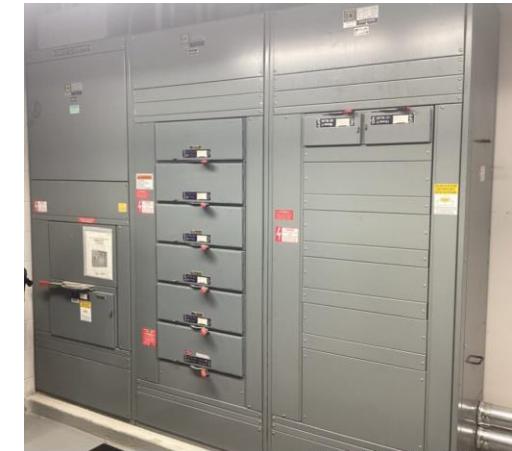
### Mechanical Systems

- Mechanical systems are mostly original to the building, except the air conditioning condensers, and are nearing end of life. Consideration for replacement should be given to mitigate potential failure, improve energy performance, and provide better indoor air quality.

- The electrical systems are original to the building and appear to be in good condition and are performing as designed.
- Legacy lighting should be upgraded to LED.

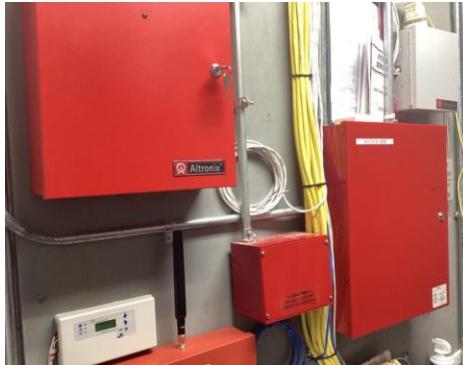
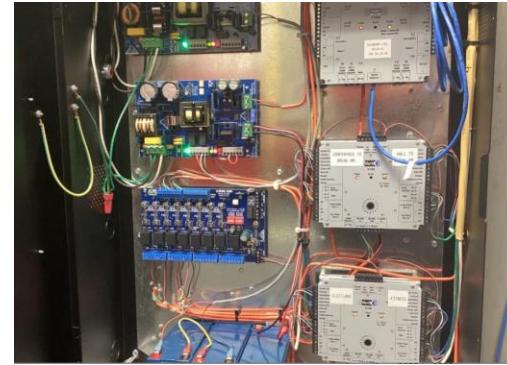
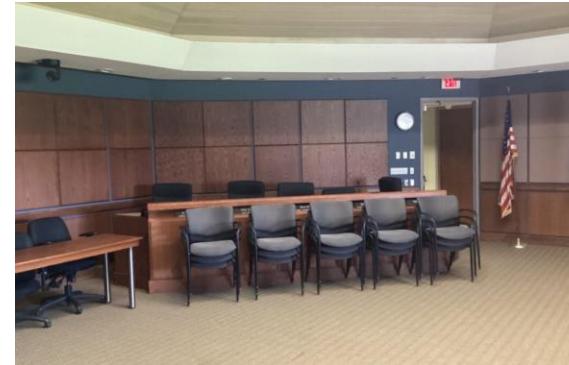
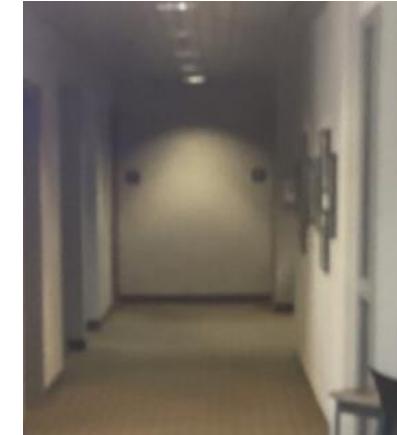
### Life Safety Systems

- Systems have been upgraded and appear to be functioning well. Continue proactive maintenance and inspection.

- Size and location of public restrooms, assigned stalls in parking lot, and longer walk to the building from parking lot are challenging accessibility issues, dias limitations

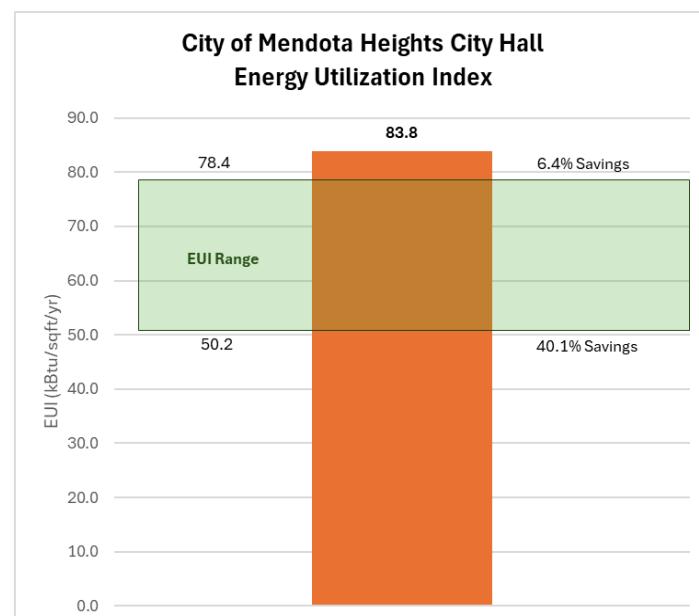
### City of Mendota Heights City Hall Energy Utilization Index

Energy baseline calculations were determined from utility bills and energy data from Xcel Energy.

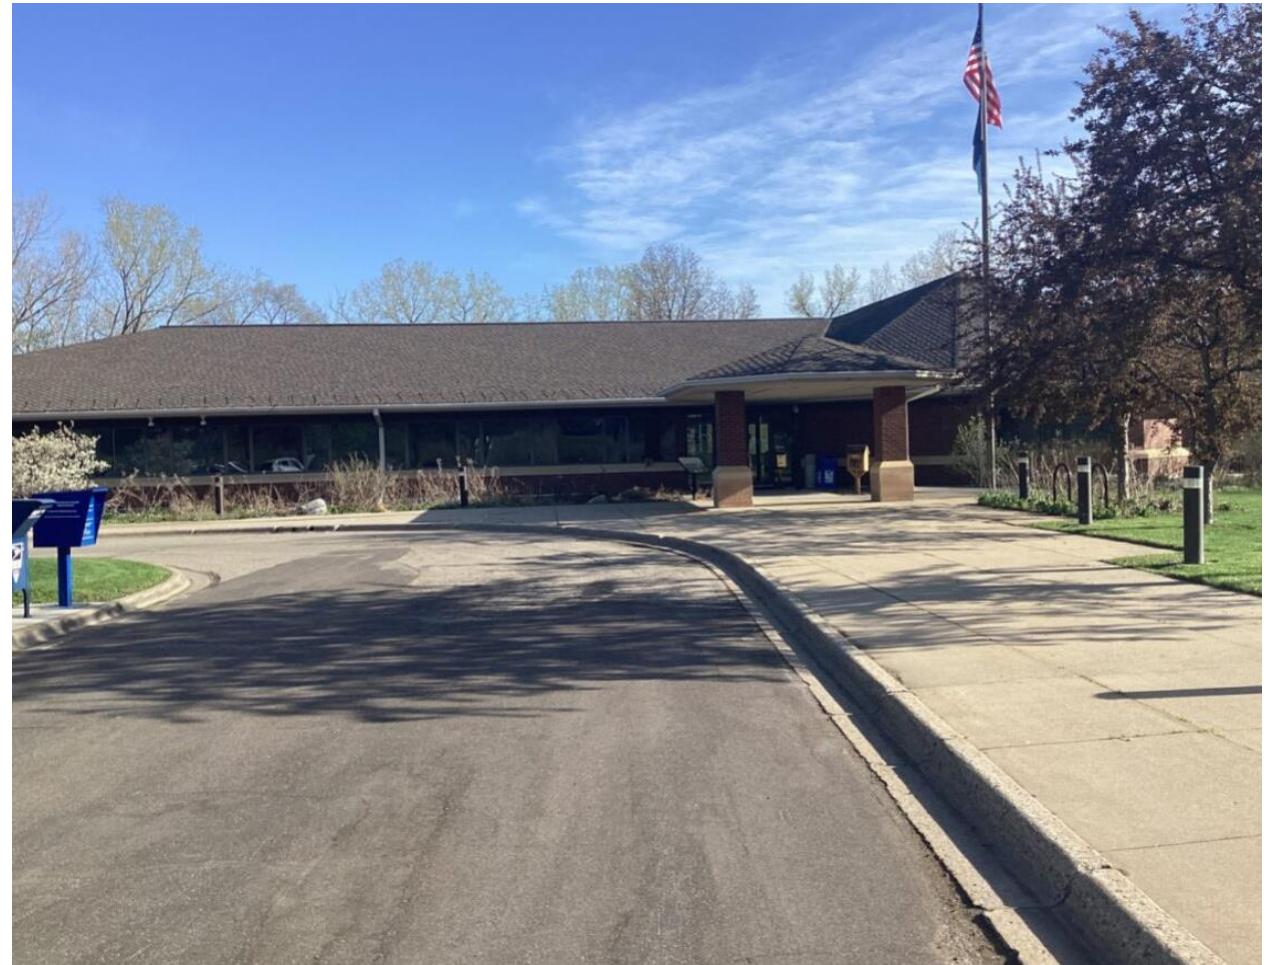
# CITY HALL – UPPER LEVEL

- Reception Desk / Counter
- Offices & Workstations
- Small conference room
- Shared public/staff restroom (1)
- Breakroom
- Small conference room in office area
- Conference room open to public
- Mother's room (old closet)
- Council Chambers
- Public/Staff balcony – no longer used
- Mechanical room in lower level
- Elections storage lower level

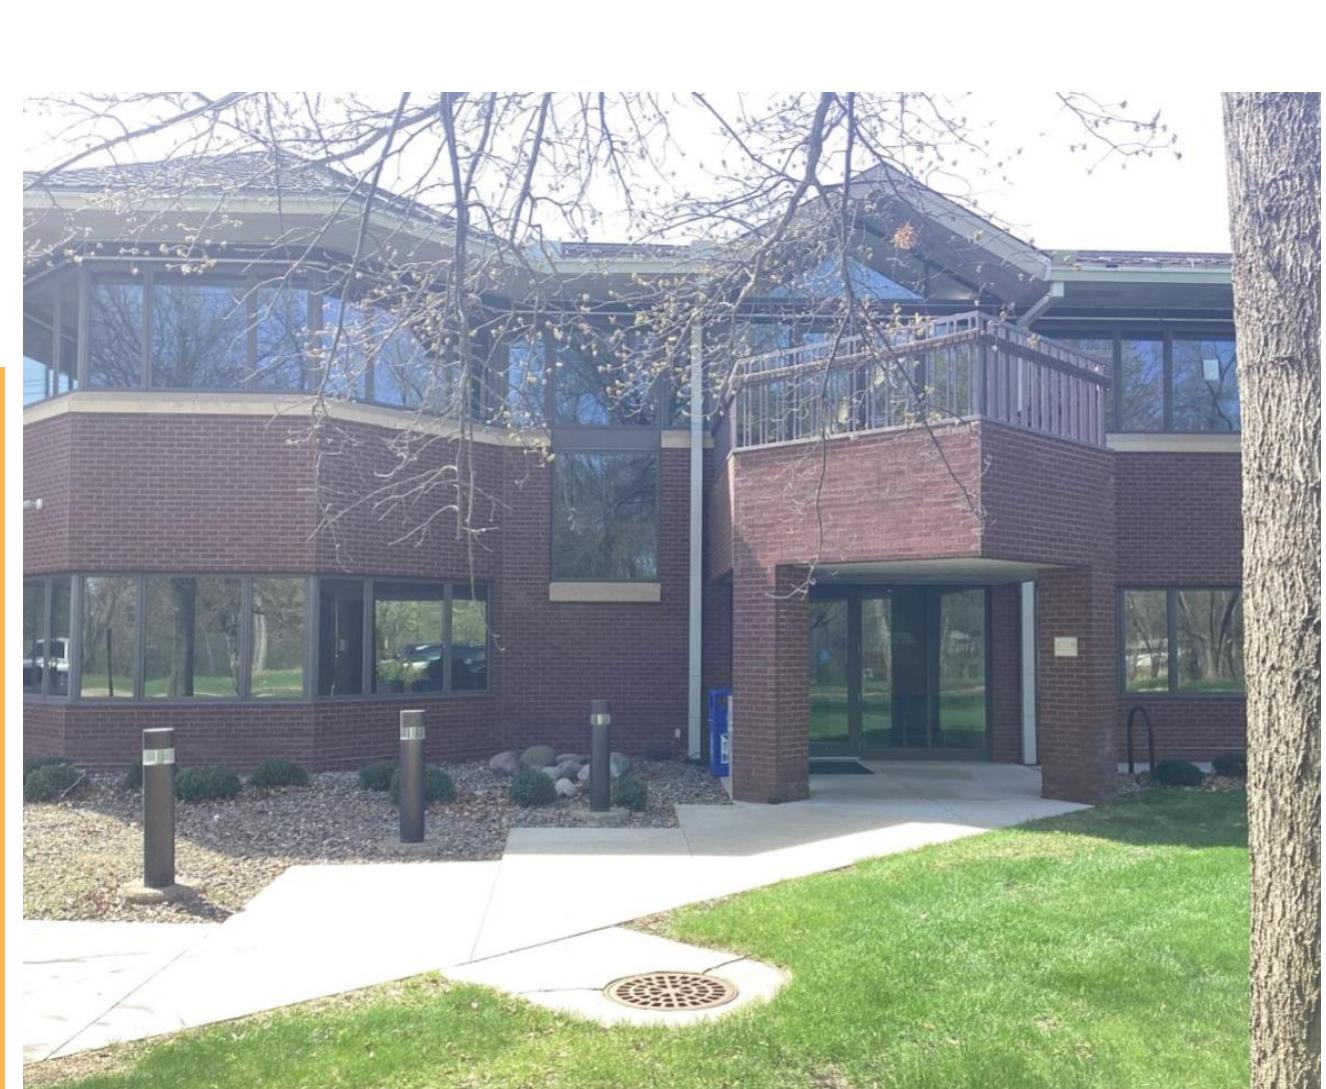
# POLICE DEPARTMENT – LOWER LEVEL

- Witness testimony cubicle – public area
- Work out room, separate from offices
- Offices
- Reception/Report Area
- Breakroom / conference/meeting room /court video / equipment/lockers
- Locker rooms
- Interview rooms; (1) used as an office
- Garage (2 stalls)
- Evidence storage
- In-custody holding area

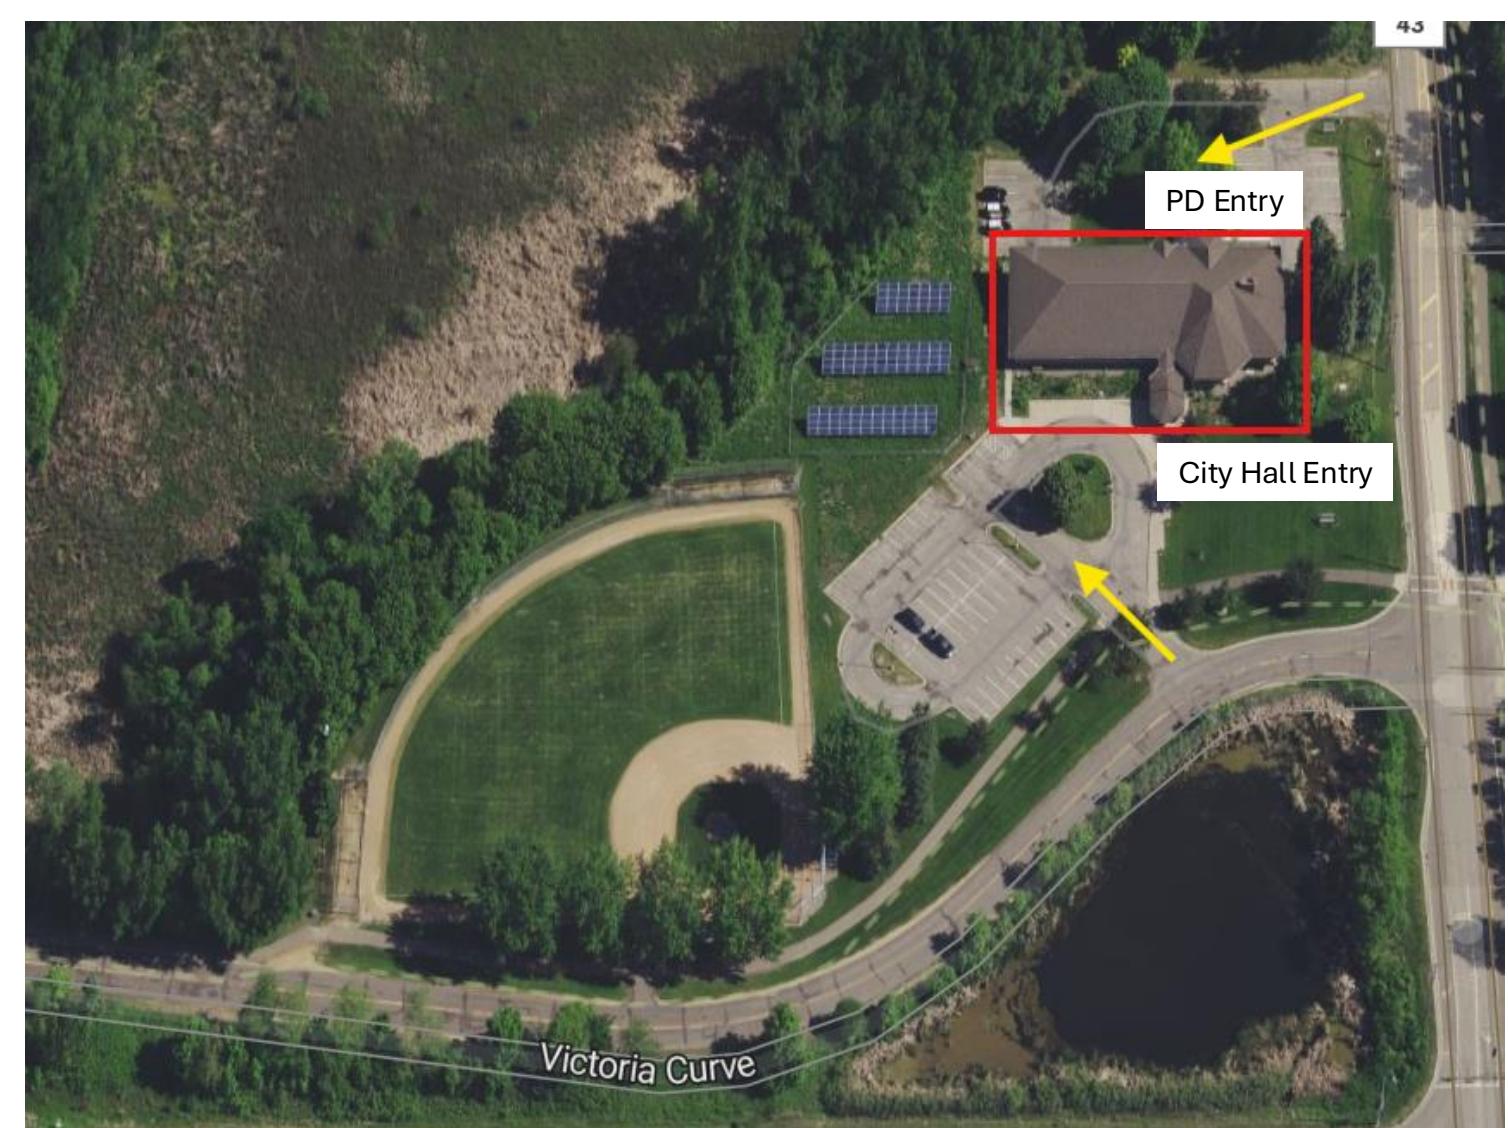
# MUNICIPAL CAMPUS PARKING

- Community & City Hall Staff
- Baseball Field Parking (after hours)

- Police Department (West lot)
- Community & Staff (East lot)

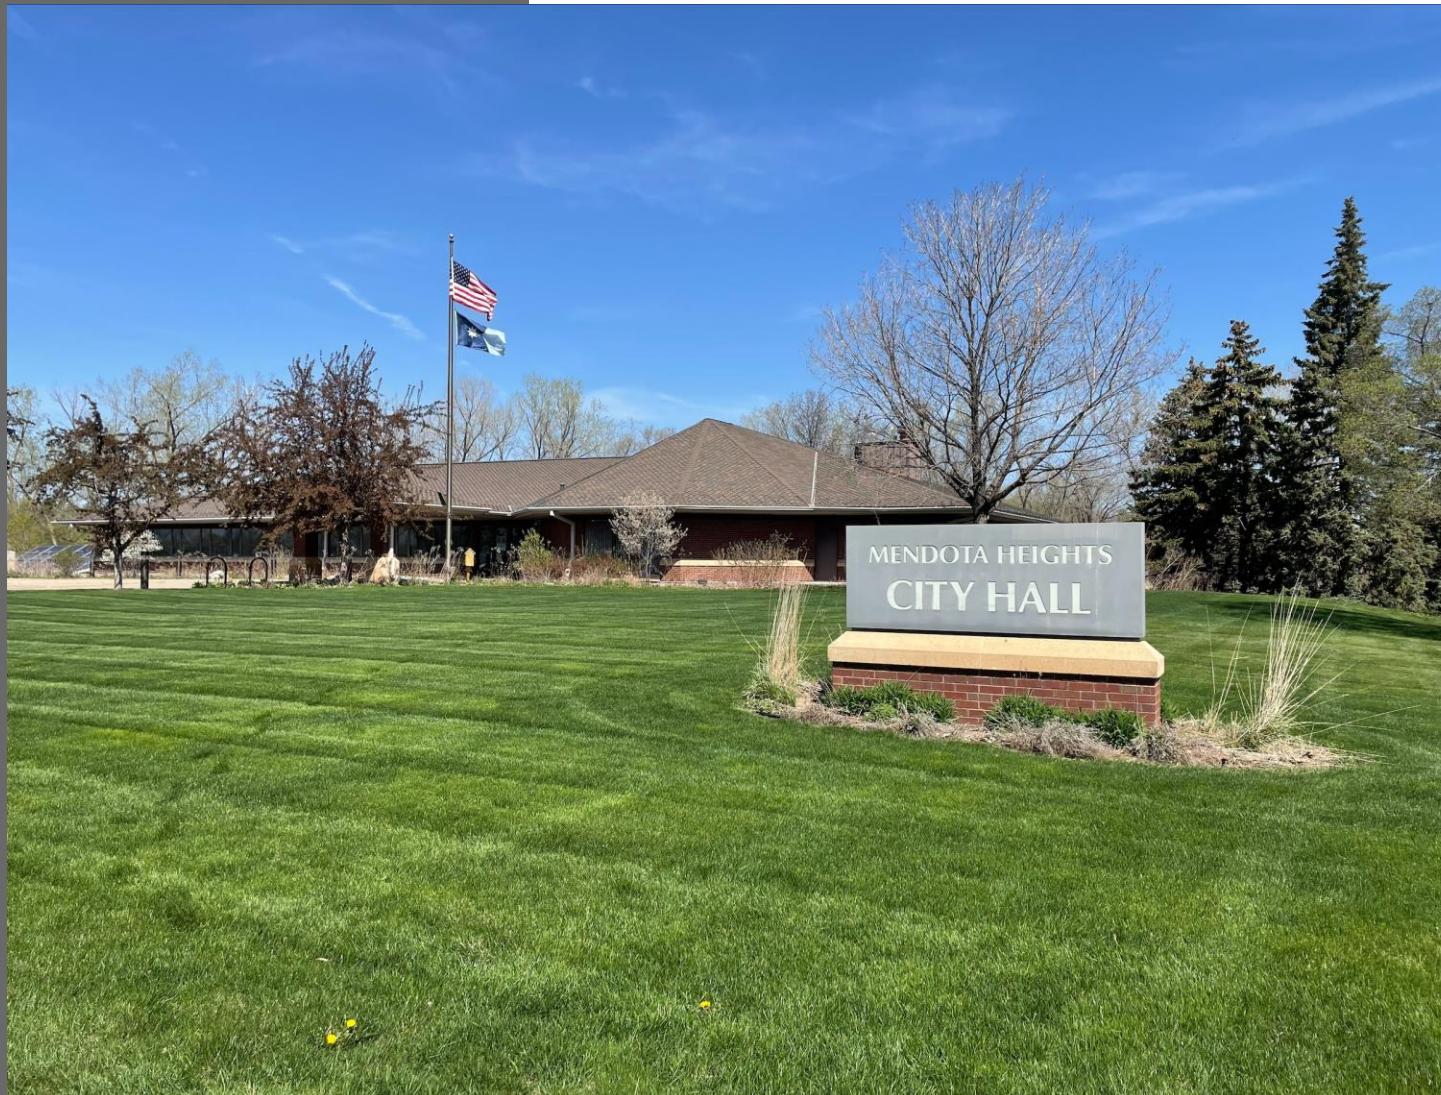
# STAFF ENGAGEMENT SURVEY RESULTS

- 1) Strong consensus for building a new facility to address space constraints.
- 2) Safety concerns (both exterior and interior)
- 3) Inadequate facilities for PD, City Staff, and Community interactions and uses
- 4) Limited functionality, storage needs, meeting space availability
- 5) Heavily affecting morale, operations, & recruitment

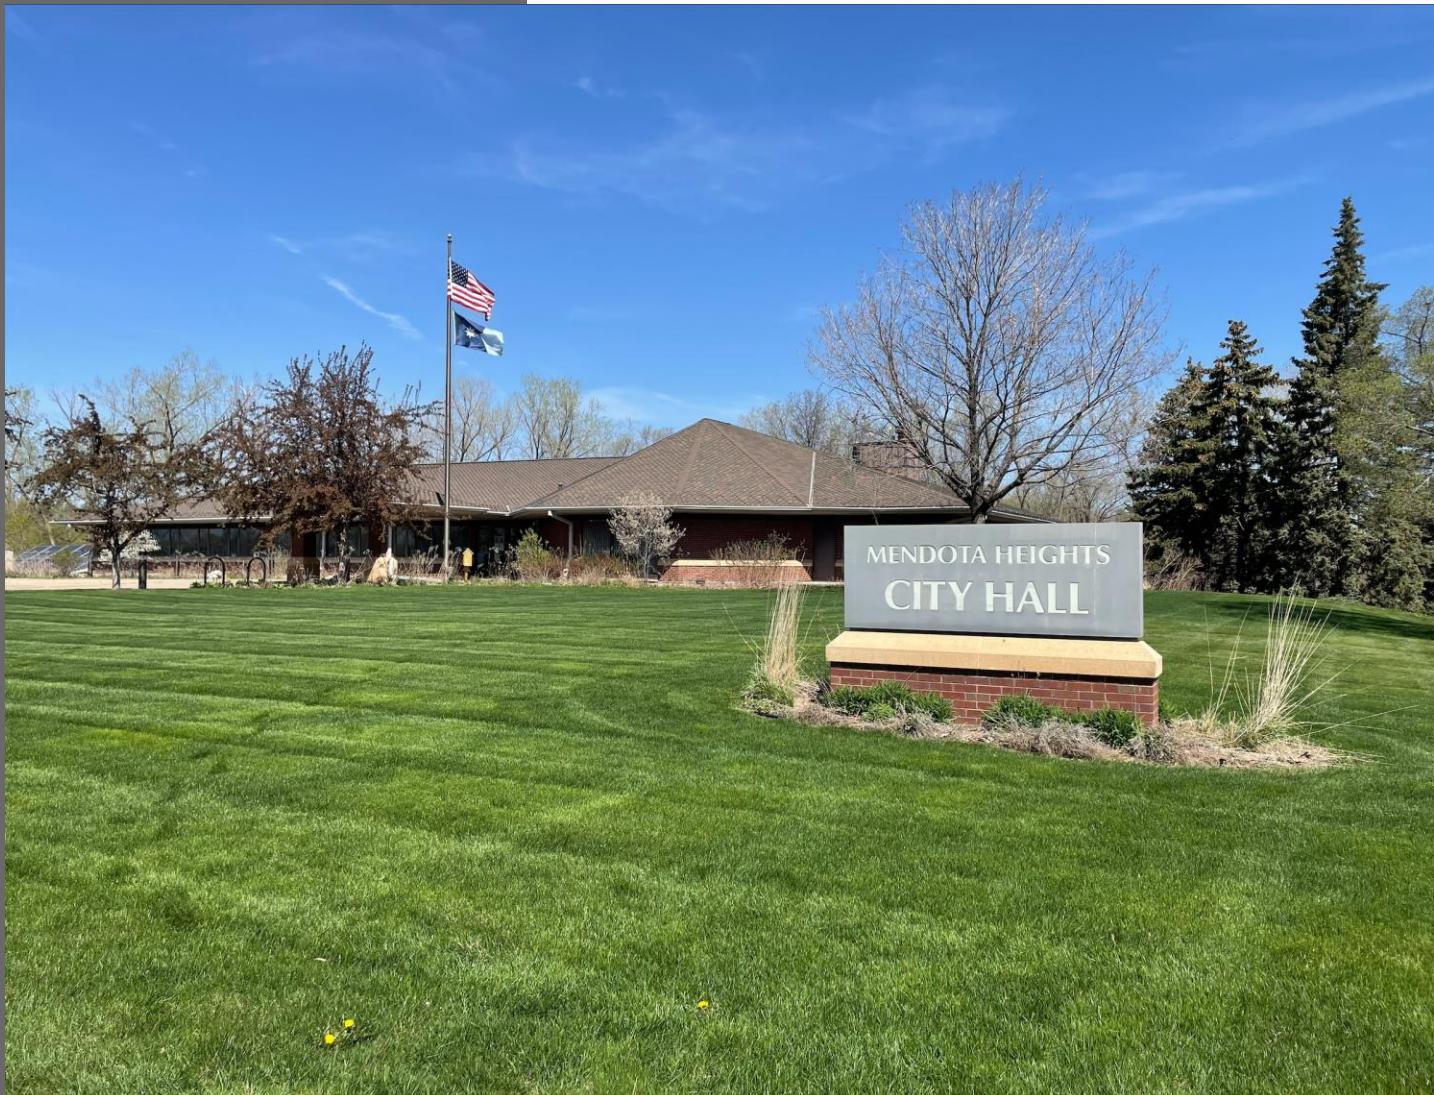
# CITY COUNCIL ENGAGEMENT SURVEY RESULTS

- 1) Responses highlight the pressing need for improvements at the Municipal Campus
- 2) Key Concerns: safety, efficiency, technology, ADA compliance, storage and space needs, and community meeting spaces.
- 3) Inadequate facilities impacting officer recruitment, retention, and morale.
- 4) Looking for options to either significantly remodel or constructing a new building: looking for professional evaluation, emphasizing cost-benefit analysis to ensure long-term efficacy.
- 5) Building demands significant upgrades to reflect prudent use of taxpayer funds to address MHPD, Staff and broader community service needs.

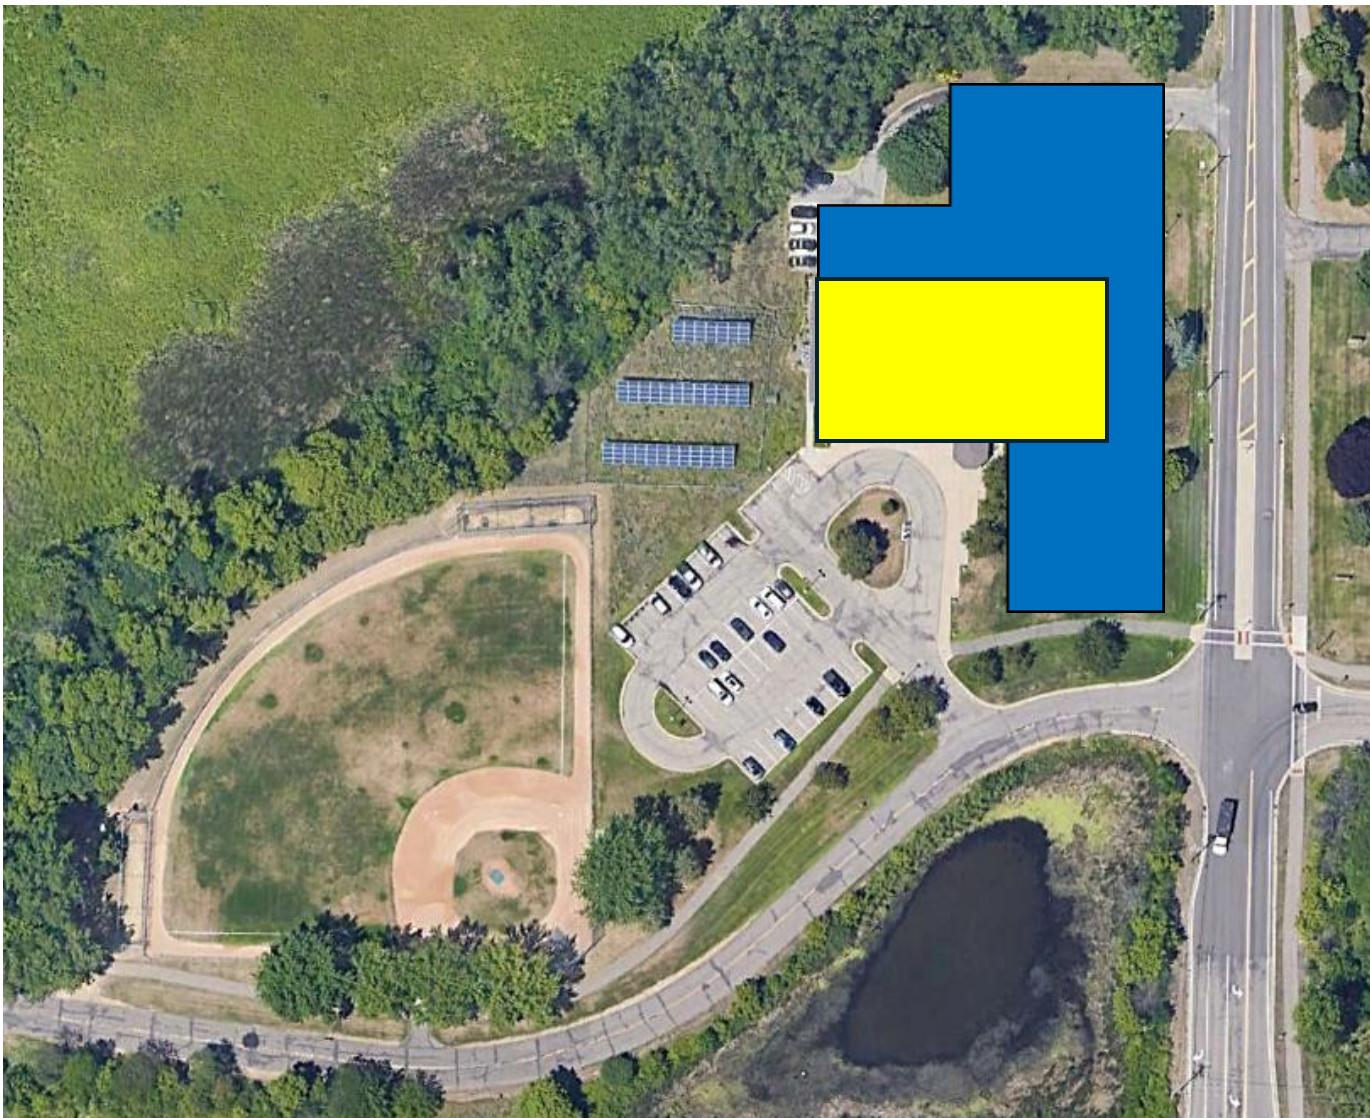
# SCENARIO #1 – RENOVATE EXISTING w/ ADDITIONS

Existing Building Renovations	\$ 3,980,000
Additions to City Hall	\$ 1,977,500
Additions to Police	\$ 11,189,200
Facility Hardening Features (Bldg./Site)	\$ 250,000
Furniture, Fixtures & Equipment (FFE)	\$ 1,075,000
Technology (Screens, etc.)	\$ 225,000
Security (Card Reader/Camera/Other)	\$ 150,000
Site Costs	\$ 1,425,000
Modifications to Solar Array (if needed)	\$ 0

**Total Estimated Project Costs: \$ 26,513,975**

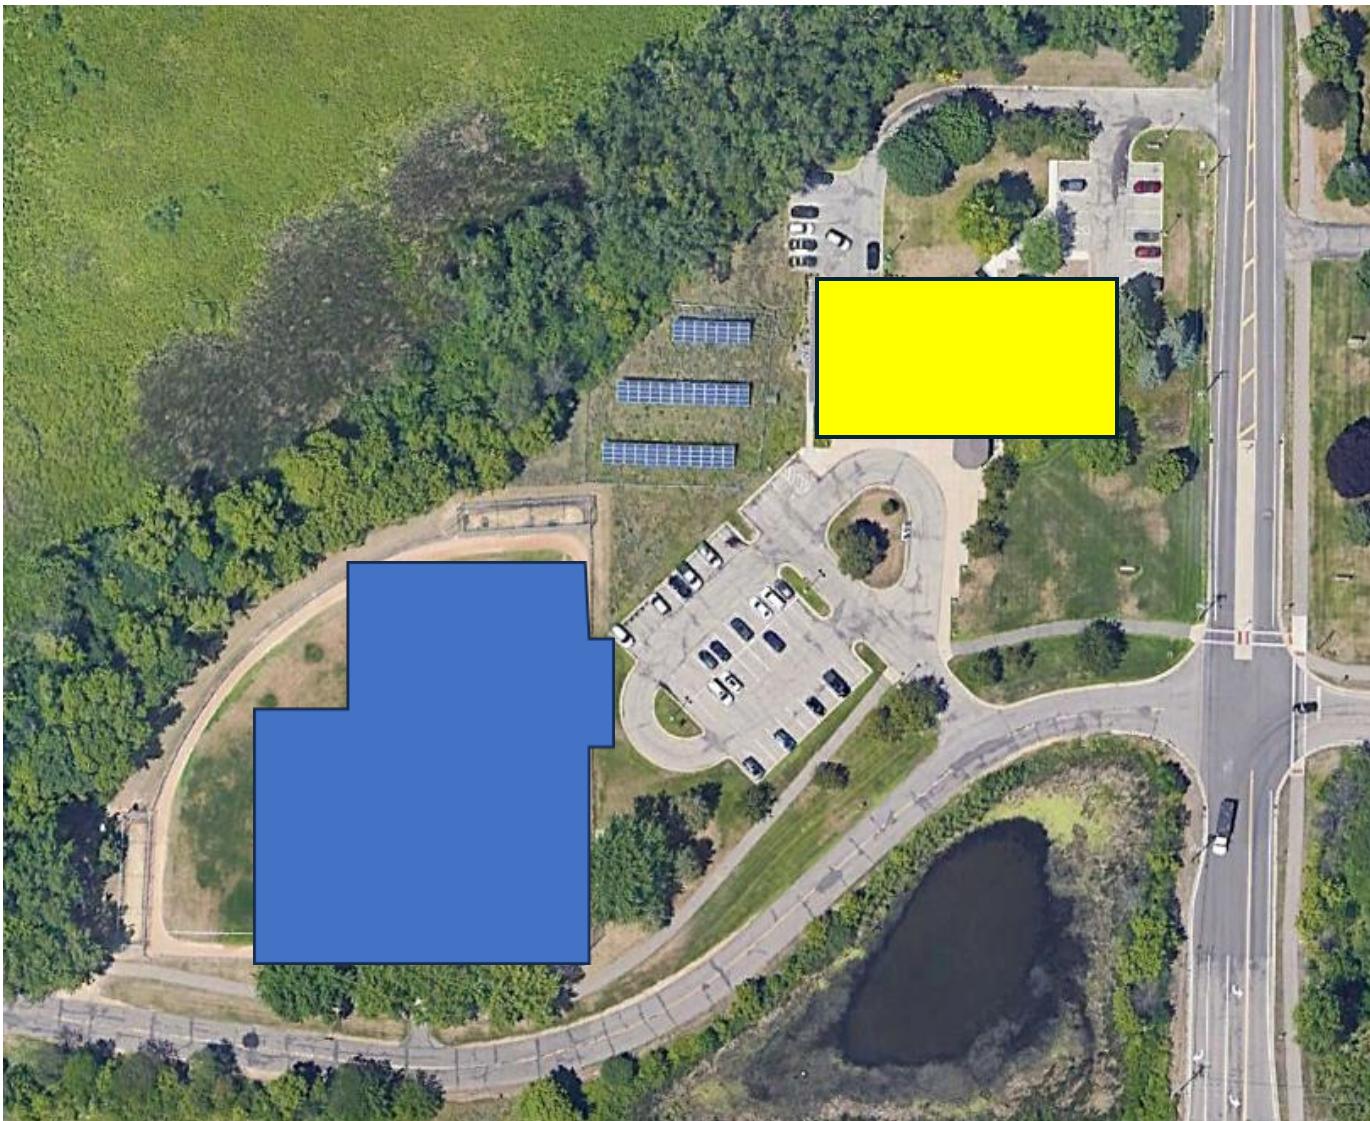
# SCENARIO #2 – NEW POLICE & RENOVATE CITY HALL

Existing Building Renovation	\$	3,980,000
New Police Station Construction	\$	14,589,150
Facility Hardening Features (Bldg./Site)	\$	250,000
Furniture, Fixtures & Equipment (FFE)	\$	1,075,000
Technology (Screens, etc.)	\$	225,000
Security (Card Reader/Camera/Other)	\$	150,000
Site Costs	\$	1,775,000
Modifications to Solar Array (if needed)	\$	0

**Total Estimated Project Costs: \$ 30,578,715**

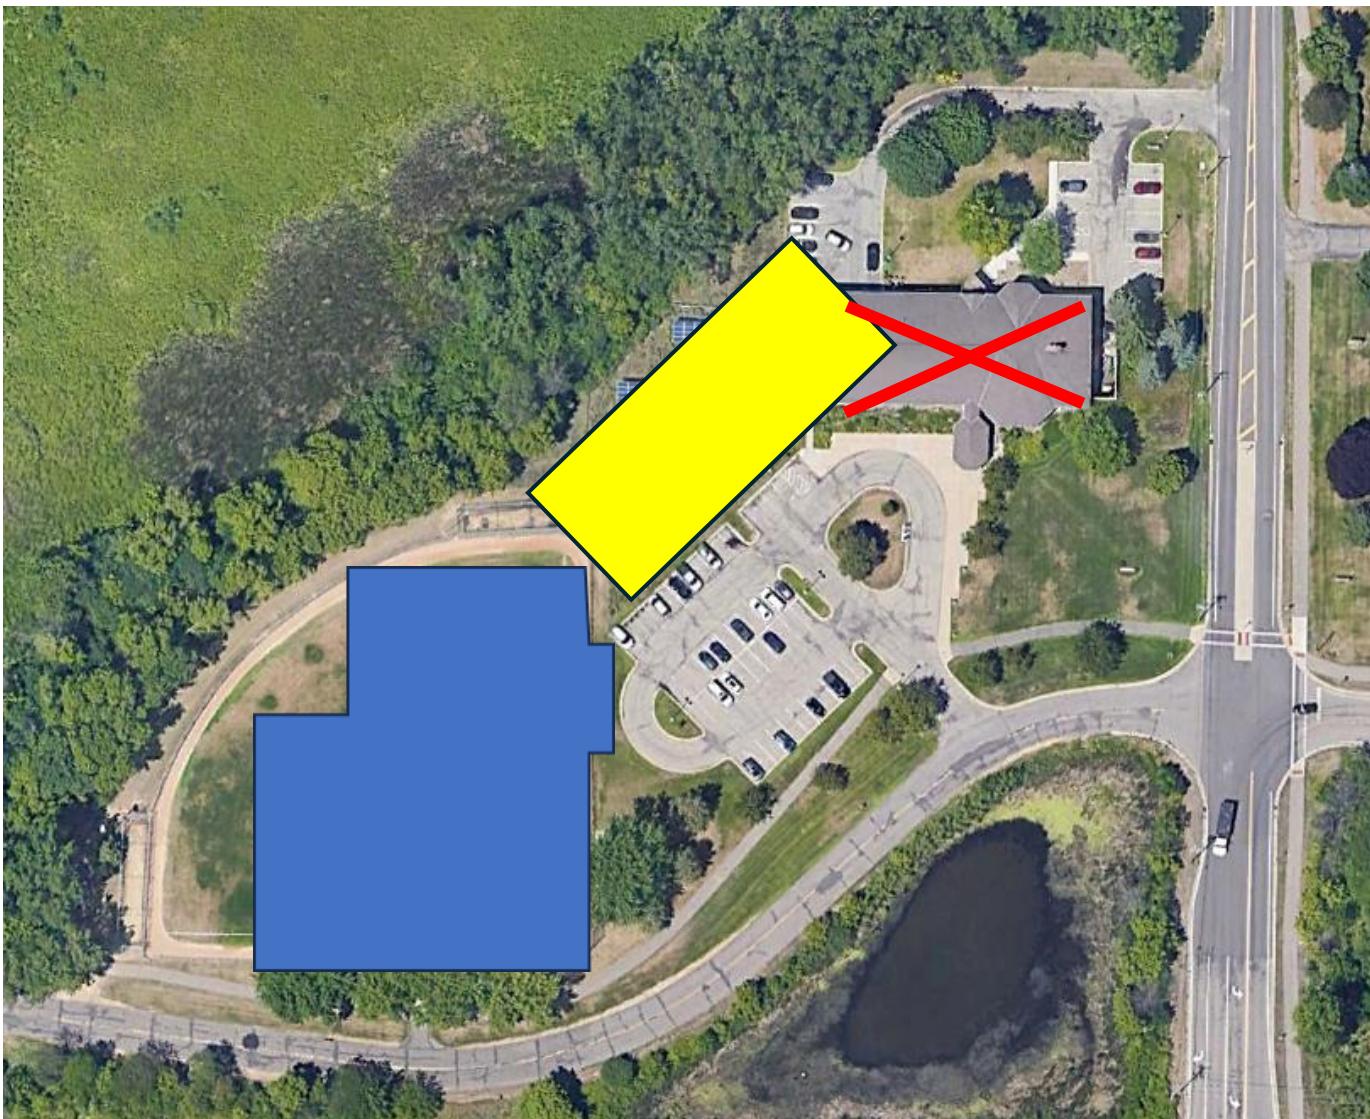
# SCENARIO #3 – CONSTRUCTING NEW FACILITY – SAME SITE

New City Hall Construction	\$ 5,965,250
New Police Station Construction	\$ 14,589,150
Facility Hardening Features (Bldg./Site)	\$ 250,000
Furniture, Fixtures & Equipment (FFE)	\$ 1,075,000
Technology (Screens, etc.)	\$ 225,000
Security (Card Reader/Camera/Other)	\$ 150,000
Site Costs	\$ 2,250,000
Demolish Existing Facility	\$ 296,500
Modifications to Solar Array (if needed)	\$ 100,000
