NOVEMBER 2025

ADA Transition Plan

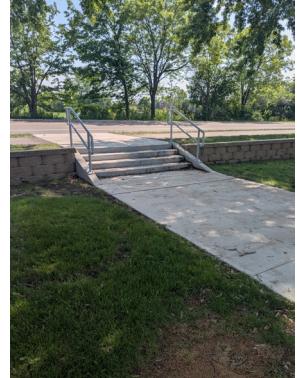
Figure 1 Route requiring stairs
at Civic Center Park

A sewer cap near the ADA-accessible restroom runs parallel to the traffic direction, and the cap gaps are too large. The pathway to the restroom from the trail requires stairs.

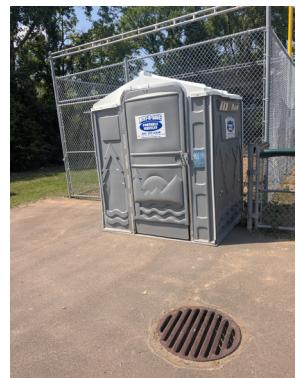
Figure 2 Accessible Restroom
at Civic Center Park. Sewer Cap
with large spacing.

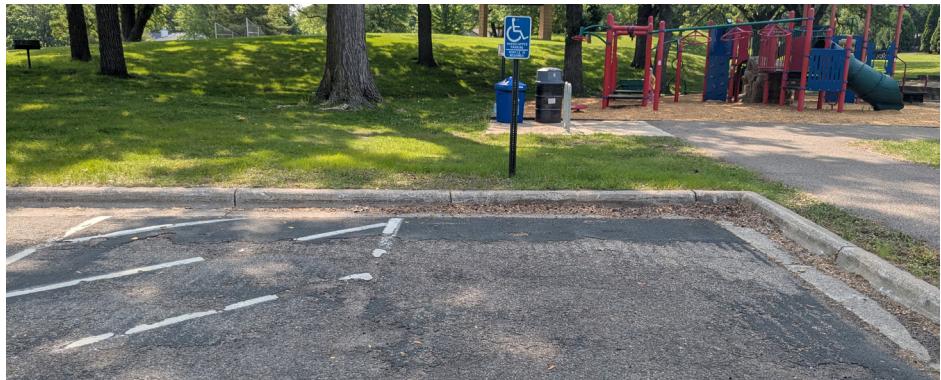
Figure 1 Southern Parking Lot at Friendly Hills

- Restripe the central lot access aisle section for an 8-foot access aisle. Provide compliant signage. See **MN Accessibility Codes 502.2 and 502.4** for requirements. Ensure that the access aisle has a “No Parking” sign at the head.

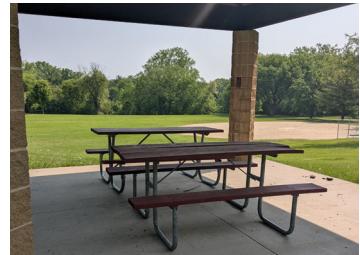
Figure 2 Picnic Tables at Friendly Hills Park

Tree roots create uneven surfaces in some places. The picnic pavilions have no accessible route and a steep grass path.

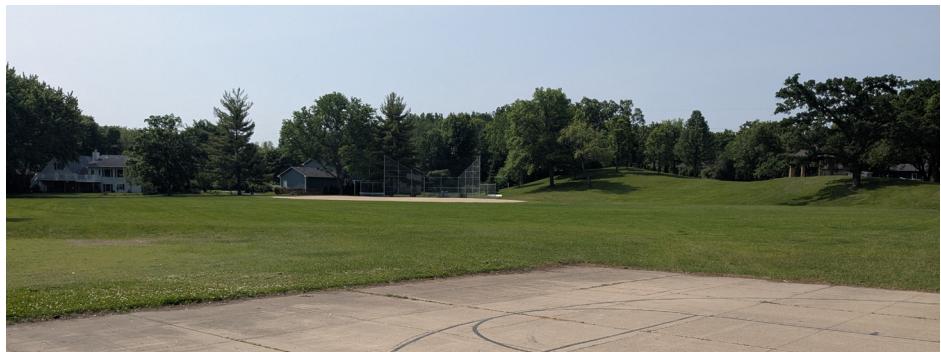
Figure 3 Access Route to Baseball Field from the Basketball Court at Friendly Hills Park

Although there is no concrete path to the field or court, pathways to the ball field are through grass and are generally flat. At the time of the evaluation, the weather was good. Grass pathways can become unstable and slippery in adverse weather.

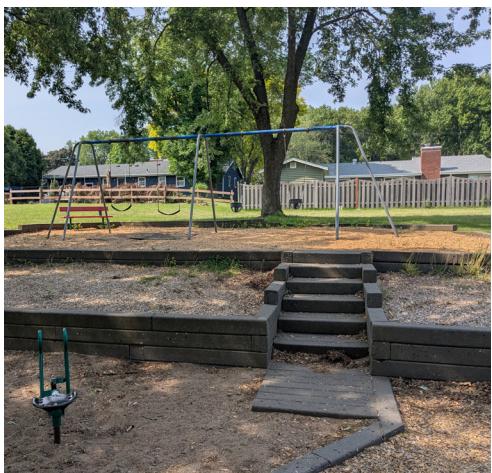
Figure 5 Tiered Swing Area at Friendly Hills Park

- Add an accessible route to the swings that does not involve stairs and follows accessible route requirements. **ADA 1008.2.1**
- Although Engineered Wood Fiber is an accessible play surface, it does require the most maintenance as the wood shifts when used. Ensure this playground is inspected regularly, raked out, and maintained to meet accessible requirements. See **ADA 401**.

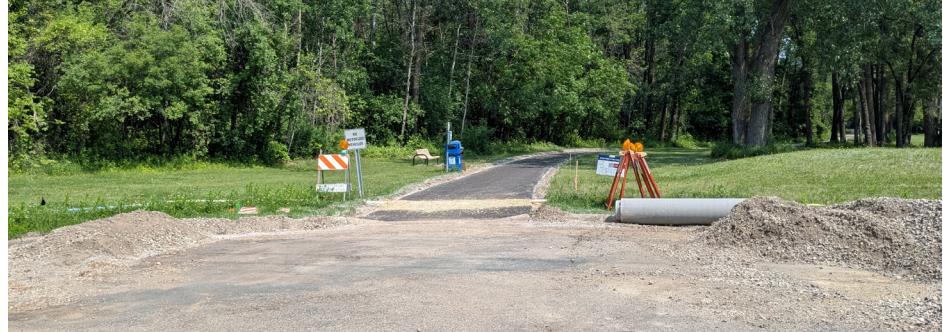
Figure 1 Cul-de-sac at Friendly Marsh Park

- Consider adding an accessible parking sign at the cul-de-sac so that there is a designated parking space. **ADA 502**

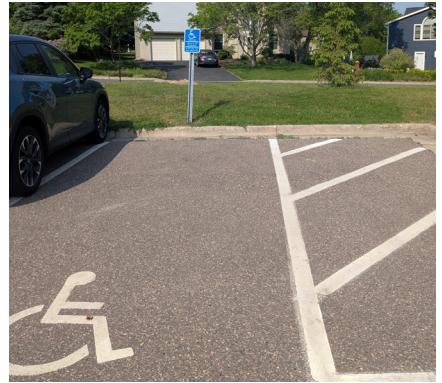
The parking lot has a designated parking space, is flat, and accommodates accessible needs. Parking spaces and aisles are marked. However, the ball field has no paved path, so the best parking would be on the street. There is no designated ADA parking on the street.

Figure 1 Compliant Parking Lot at Hagstrom-King Park

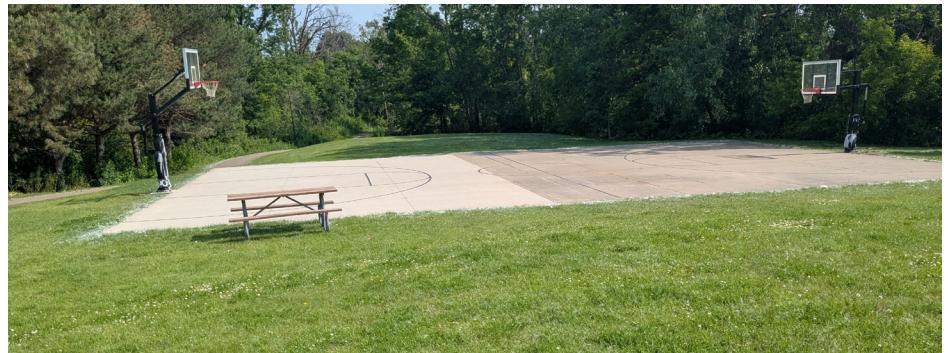
Figure 3 Basketball Court at Hagstrom-King

Although there is no concrete path to the basketball court or ball field, pathways are through grass and are generally flat. At the time of the evaluation, the weather was good. Grass pathways can become unstable and slippery in adverse weather.

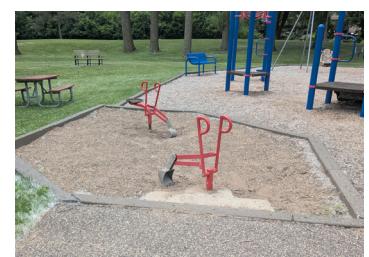
Figure 3 Accessible Diggers at Ivy Hills

The playground has the correct number of accessible elements, many accessible components, and a great variety of types of play.

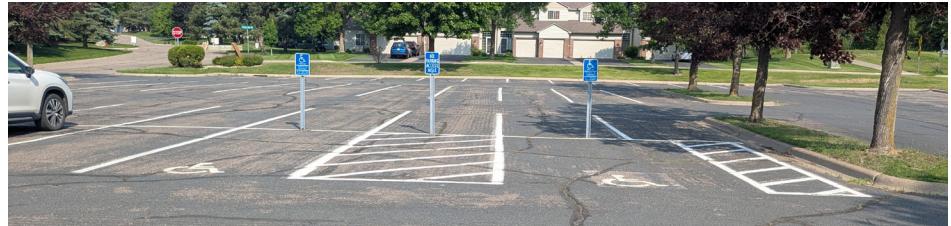
Figure 1 Compliant Parking Lot at Kensington Park

- Restripe the soccer field access aisle section for an 8-foot access aisle. Provide compliant signage. See **MN Accessibility Codes 502.2 and 502.4** for requirements. Ensure that the access aisle has a “No Parking” sign at the head.

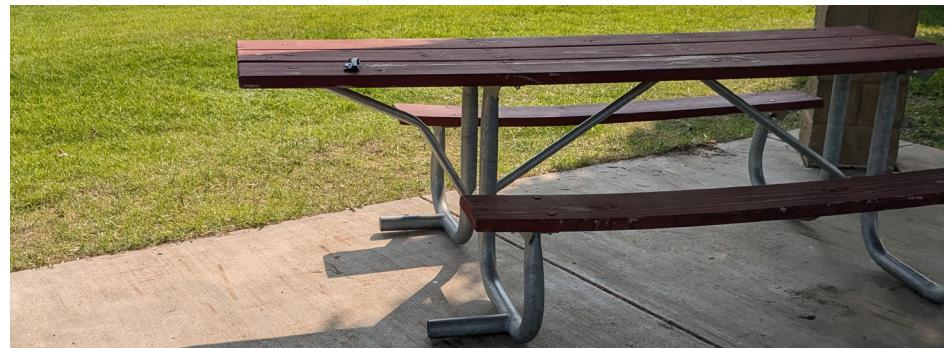
Figure 3 Picnic Table at Kensington Park

Although there is no concrete path to the fields, pathways to sports fields are through grass and generally flat. At the time of the evaluation, weather was good. Grass pathways can become unstable and slippery in adverse weather.

- Regularly sweep the sidewalk surface during the pinecone shedding season to stabilize the route. Consider adding a stable, slip-resistant pathway to the soccer fields. **MN Accessibility Code 302**
- Add an accessible picnic table to the other picnic shelter. Ensure a clear path to the accessible portion. **ADA 4.32.2**
- Add a temporary concession surface that is 36 inches from the floor. Consider an accessible window when it is reconstructed. **ADA 904.3.2**
- If possible, recess the drinking fountain or provide bollards so a cane can detect the drinking fountain. Ensure that bollards comply with accessible route requirements. **ADA 307.2**

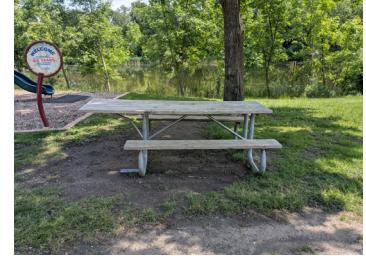
Figure 1 Accessible seating at Marie Park

Accessible picnic tables are provided.

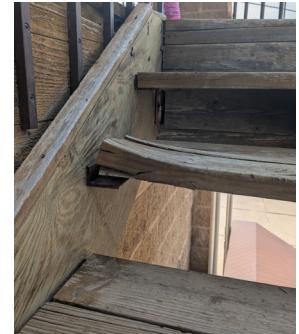
Figure 1 Step in Raised Picnic Area

- Replace the wooden step at the raised picnic area to avoid a trip hazard. **MN Accessibility Code 302**
- Ensure there are accessible seating spaces dispersed throughout the park. **ADA 902**
- Replace the drinking fountain with a maximum height of 36 inches from the ground. **ADA 602.4**

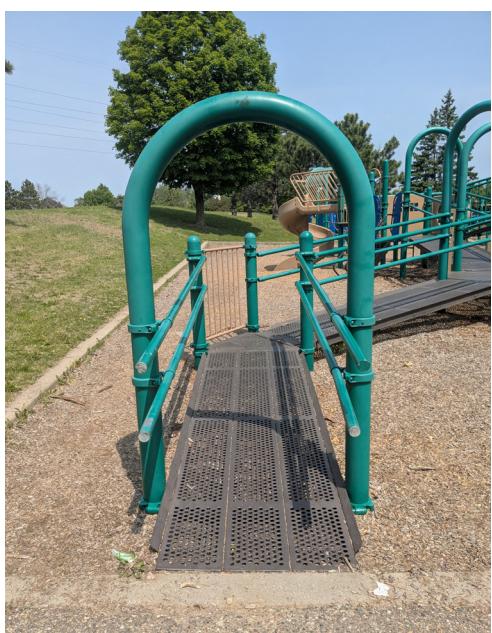
Figure 4 Accessible Play Ramp at Mendakota

- Add a stable, slip-resistant pathway to the sand table. **ADA 1008.2.1**.
- Although Engineered Wood Fiber is an accessible play surface, it does require the most maintenance as the wood shifts when used. Ensure this playground is inspected regularly, raked out, and maintained to meet accessible requirements. See **ADA 401**.

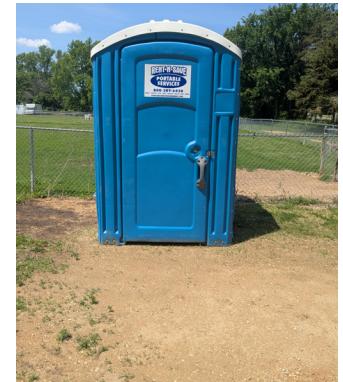
Figure 2 Accessible Restroom at Dog Park

There is an accessible portable toilet.

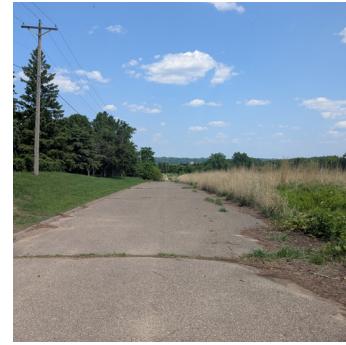
Several points along the walking trail have non-compliant running slopes, though they would not be considered severe.

- Consider adding a compliant handrail to put the sidewalk into compliance without leveling the ground. **ADA 405.8**.

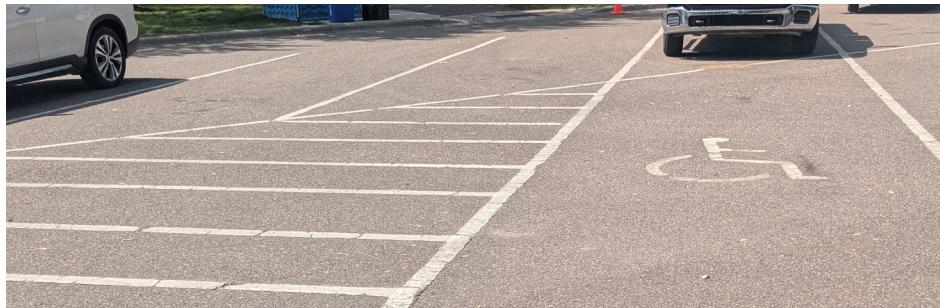
Figure 1 Playground Parking Lot at Rogers Lake Park

- Provide compliant signage and spaces. For requirements, see **MN Accessibility Codes 502.2 and 502.4**. Ensure that the access aisle has a "No Parking" sign at the head.

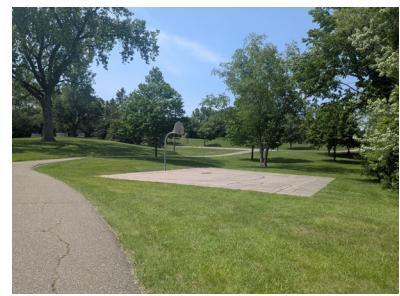
Figure 2 Basketball Court at Rogers Lake

Although there is no concrete path to the basketball or volleyball court, pathways are through grass and are generally flat. At the time of the evaluation, the weather was good. Grass pathways can become unstable and slippery in adverse weather.

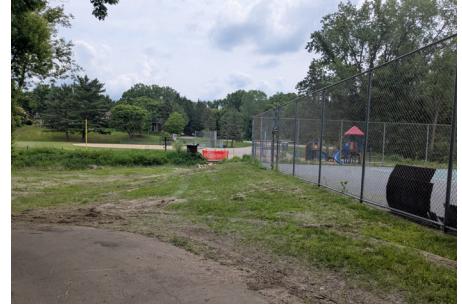
Figure 1 Unpaved route to the tennis court

A majority of the walking trail is too steep.

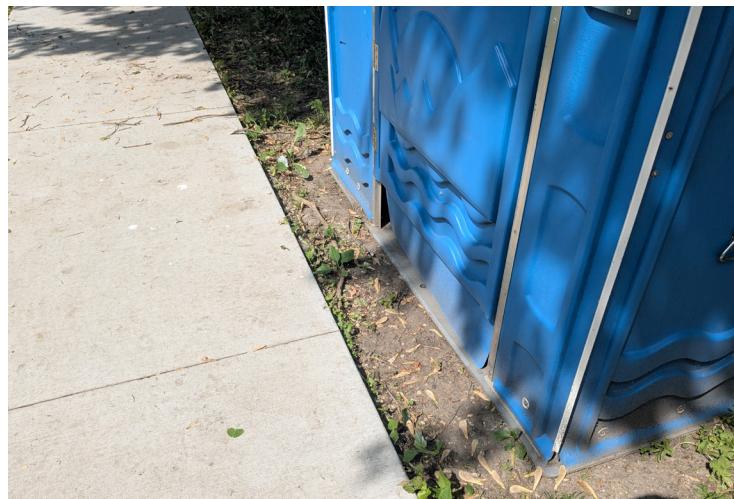
Figure 1 Raised Lip at Accessible Restroom

- Level the threshold by moving the restroom or providing a flat surface to span the gap. **ADA 404.2.5**

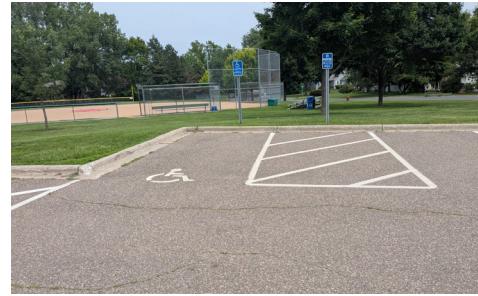
Figure 1 Accessible parking at Victoria Highlands

There is one parking lot with the correct number of accessible spaces.

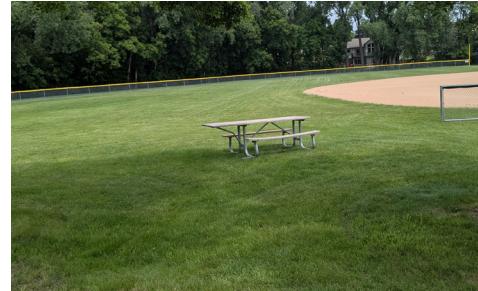
Figure 2 Accessible table at Victoria Highlands

Accessible picnic tables are provided; however, there are not enough ADA seats, and they are only available at the ball field.

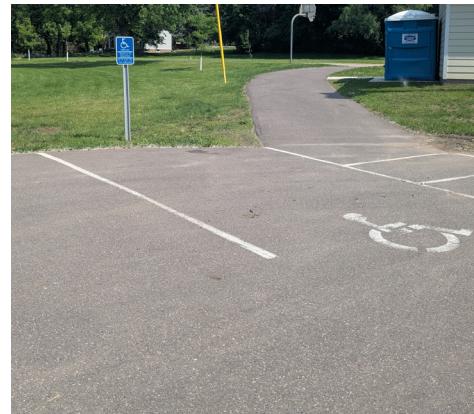
There is one parking lot with the correct number of accessible spaces; however, there is no sign to discourage parking in the access aisle.

Figure 1 Accessible parking at Wentworth

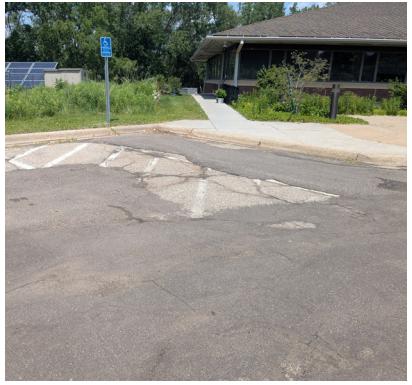
One parking lot is available, shared with the Civic Center Ball Field. Recent patchwork makes the parking spaces slope over five percent in some spots. There is no sign to discourage parking on the access aisle (which should be restriped with the patch job), and the parking space sign is too high.

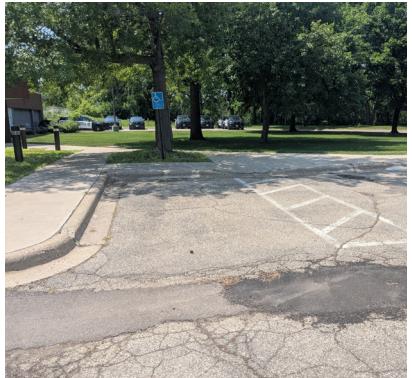
Figure 2 Parking space at Police Entrance

There is no sign to discourage parking on the access aisle (which is too narrow).

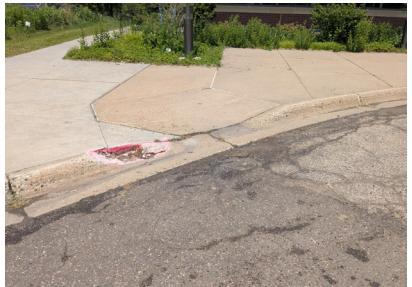
City Hall's curb ramp from the access aisle has a too-short cross-slope and running slope. One of the flares is broken. The Police entrance curb ramp has a too-short running slope. Both entrance doors are fully compliant.

Figure 3 Broken flare at City Hall

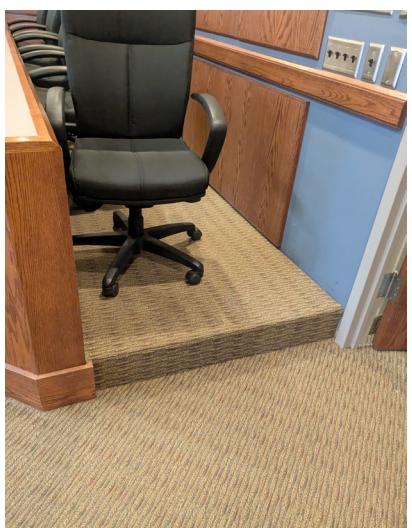
Figure 4 Council Chambers at City Hall

In City Hall, most conference rooms' doorknobs were not operable without grabbing and twisting. The City Council Chambers did not have a way for wheelchair users to access the councilmember or staff seats. Seats in conference rooms are movable for a variety of seating options.

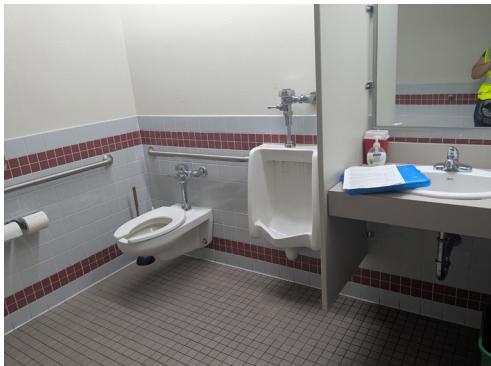
The Police Station provides both men's and women's restrooms. Both have tactile signs, but they are not mounted on the latch side of the door. The doors are heavy to operate, requiring ten pounds of force to open. The coat hooks in the women's room are mounted too high at 65 inches. The sink in the men's room is not insulated. The toilet flush (men's room) is not on the open side of the toilet.

Figure 8 Men's restroom at Police Station

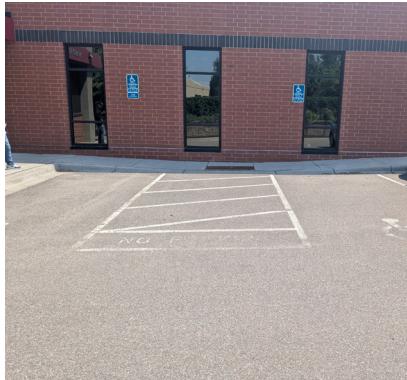
There is one parking lot available. It does have the correct number of accessible spaces. The spaces are compliant; however, there is no sign indicating not to park in the access aisle.

Figure 1 Parking space at the Fire Station

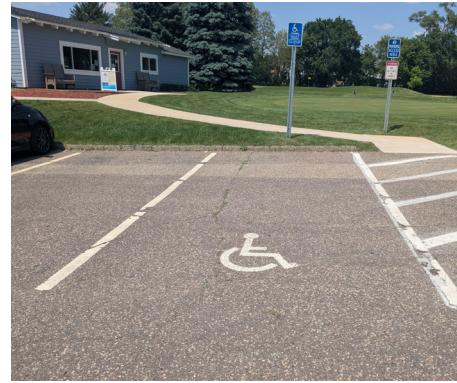
There is one parking lot available. It does have the correct number of accessible spaces. However, the slopes at the spaces and access aisles peaked at five percent, outside the required two percent level surface. The “no parking” signs are mounted too high at 80 inches.

- Consider regrading the parking stalls and access aisles to have a maximum slope of two percent. **ADA 502.4**
- Lower signs to 60-66" from the parking surface and centered on the parking stall. **MN Accessibility Code 502.4.4**

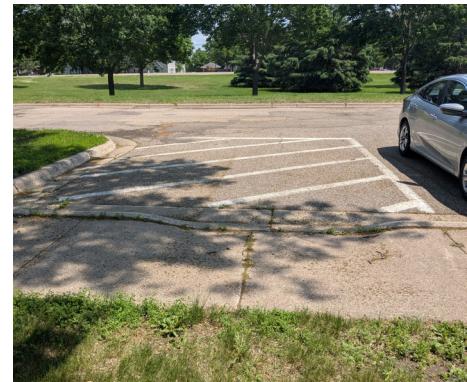
There is one parking lot available. Although there is a striped access aisle, there are no designated accessible parking spaces.

Figure 1 Parking space at Public Works

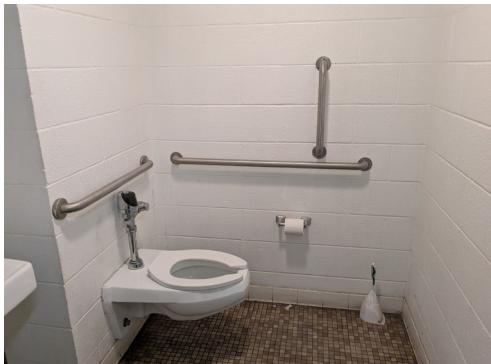
Figure 3 Restroom at Public Works

- Alter the door closer so the maximum pounds required to open the door is no more than five pounds. **ADA 404.2.8**
- Provide signage mounted at a compliant height on the door's wall (latch side). **ADA 703.1**
- Insulate the sink pipes. **ADA 606.6**
- Lower the mirror to a maximum height of 40 inches. **ADA 603.3**
- Lower the paper towels to be 15 to 48 inches from the ground
