# **LOWER MISSISSIPPI RIVER WMO—INTERSTATE VALLEY CREEK STABILIZATION AND VOLUME REDUCTION STUDY**

## **FEASIBILITY REPORT**

January 30, 2023

WSB PROJECT NO. 020683-000

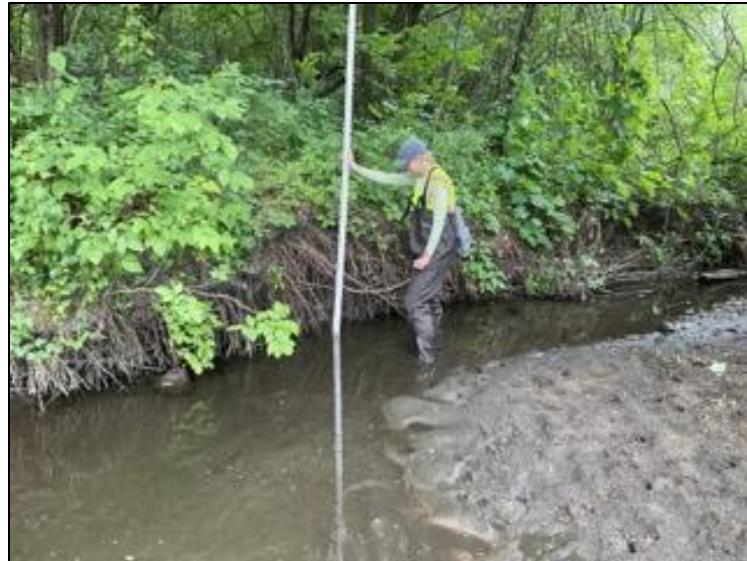
- Minor erosion issues are characterized as steep banks that are less than 3 feet high. Usually, these areas have some vegetation present which contributes to stability.

**Photo 1: Minor Erosion**

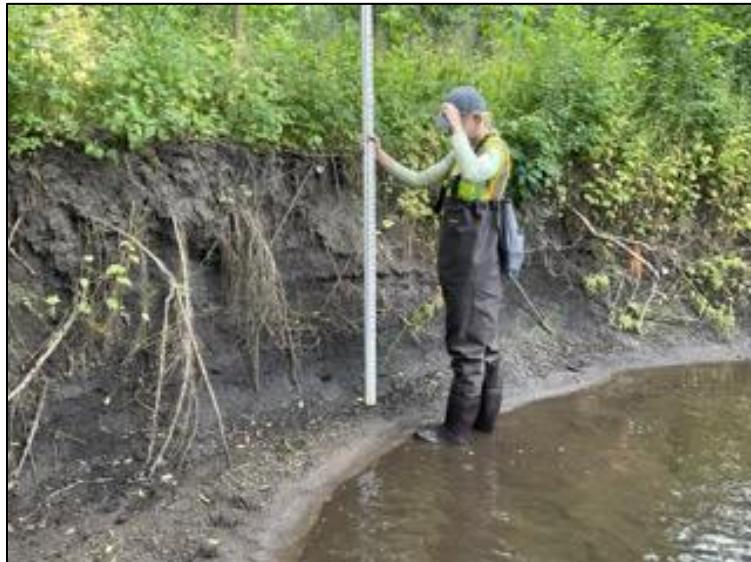
- Moderate erosion issues are characterized as steep banks approximately 3 to 6 feet high with generally minimal vegetation.

**Photo 2: Moderate Erosion**

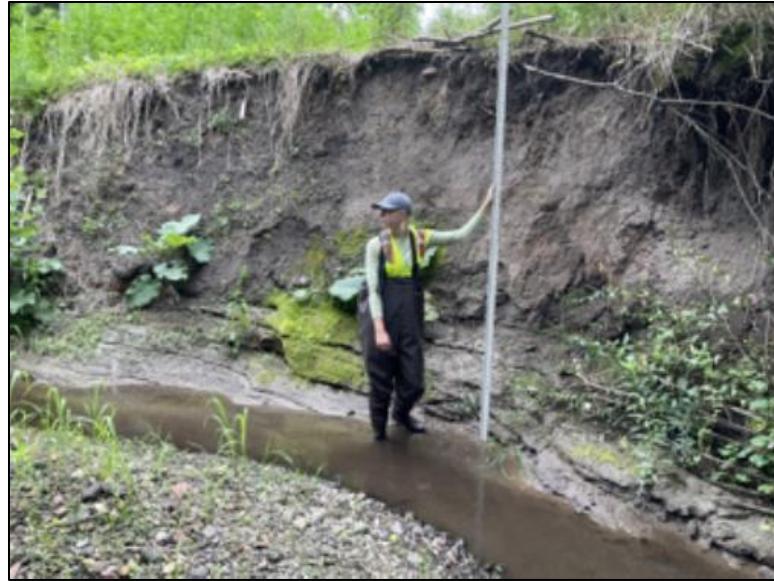
- Severe erosion issues are banks greater than 6 feet high which are generally either vertical or undercut at the bottom. Banks which were 4 to 6 feet high and had a risk to existing infrastructure and/or public safety were also classified as having severe erosion issues.

**Photo 3: Severe Erosion**

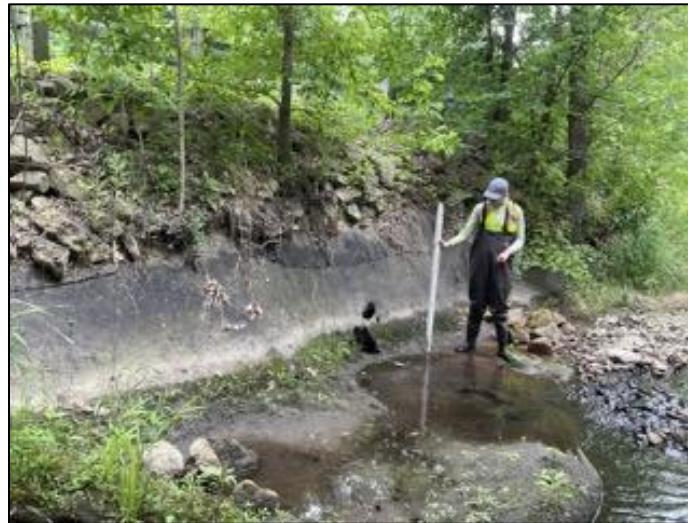
The field erosion study documented moderate erosion around the Lilydale Trailhead Parking Lot as shown in **Figure A.1**. Existing banks are steep and show evidence of prior stabilization efforts, including remnants of plastic-based geotextiles and riprap. The parking lot is built on top of a retaining wall protected by riprap, most of which has remained in place, though a significant amount of riprap has been lost from the north side below the retaining wall. WSB recommends that Dakota County replace this riprap.

**Photo 4: Retaining Wall Below Lilydale Trailhead Parking Lot**

There has been no lateral erosion observed at the Lilydale Trailhead Parking Lot site, likely due to the presence of the existing retaining wall. Replacing the riprap which has been lost will not address the vertical erosion because it will not pause downcutting. Options for addressing vertical erosion in this area include using rock riffles as grade control or by constructing a plunge pool or other type of energy dissipating structure at the downstream end of the culvert below the Lilydale Road crossing.

Access to the riprap replacement area would be from the existing trailhead parking lot and part of the parking lot would likely need to be closed during the repair work. Placement of riprap on existing banks without grading would have minimal impacts to existing vegetation or existing infrastructure.

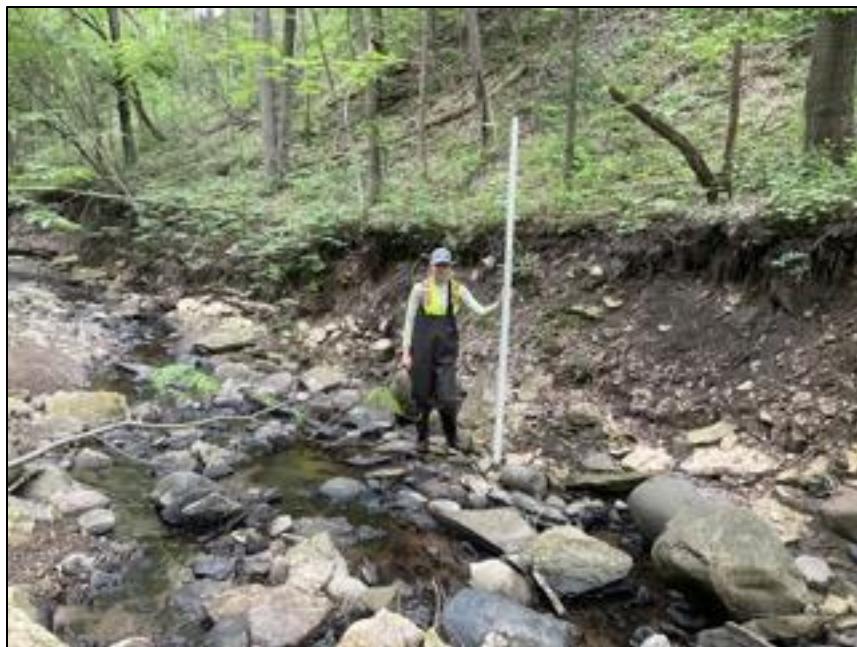
The field assessment documented moderate erosion in the IVC channel within the Park Place neighborhood. The channel in this area is in a very confined valley with steep valley walls on either side, some have noticeable sloughing while others have nearly vertical banks. There are large rocks present in the existing channel bottom which suggest a past stabilization attempt. The 2D modeling results show an area of localized high velocity flow in the area of documented moderate erosion ([see Appendix E](#)).

**Photo 5: Bank Erosion at Park Place Site**

The proposed stabilization design for Park Place is shown in [Figure A.2](#). WSB recommends addressing the vertical erosion with two rock riffles placed to deflect flow during major storm events away from the valley walls. Given the amount of large rock present in the channel already, these riffles may be able to be mostly constructed with material already on site.

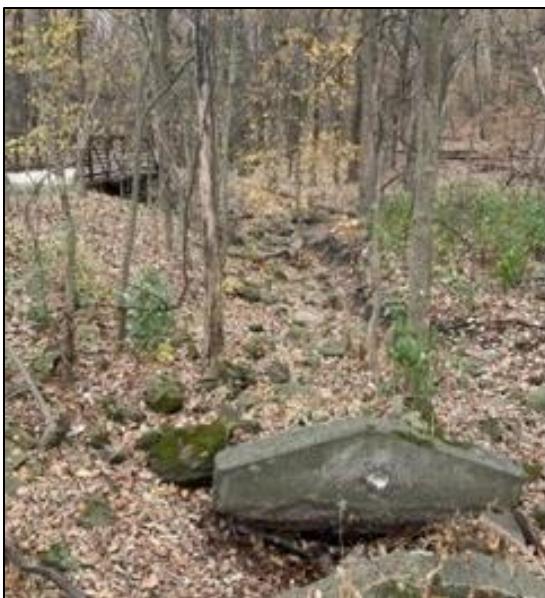
The proposed Park Place Filtration Basin, shown in **Figure A.3**, would provide rate and pollutant reductions for approximately 14.2 acres of single-family residential area that currently outlets directly to the IVC main stem from a 24-inch reinforced concrete (RC) pipe. The proposed filtration basin is in an area with soils that are primarily hydrologic soil group (HSG) B, which are conducive to infiltration. However, due to the presence of surface karsts in the area, infiltration is prohibited and filtration is proposed. The existing RC pipe outlets to a channel approximately 50 feet upstream of the IVC main stem. This channel exhibits minor erosion, with steep banks approximate 2-3 feet high, as shown in **Photos 6 and 7**.

**Photo 6: Park Place Storm Sewer Outlet**

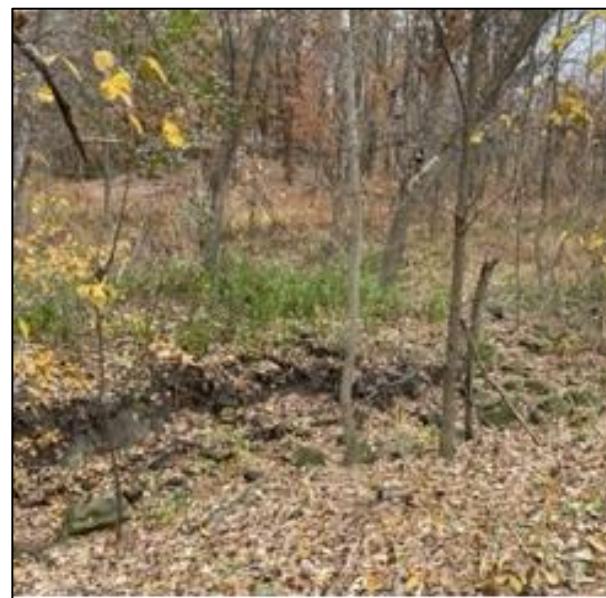
**Photo 7: Eroded Channel**

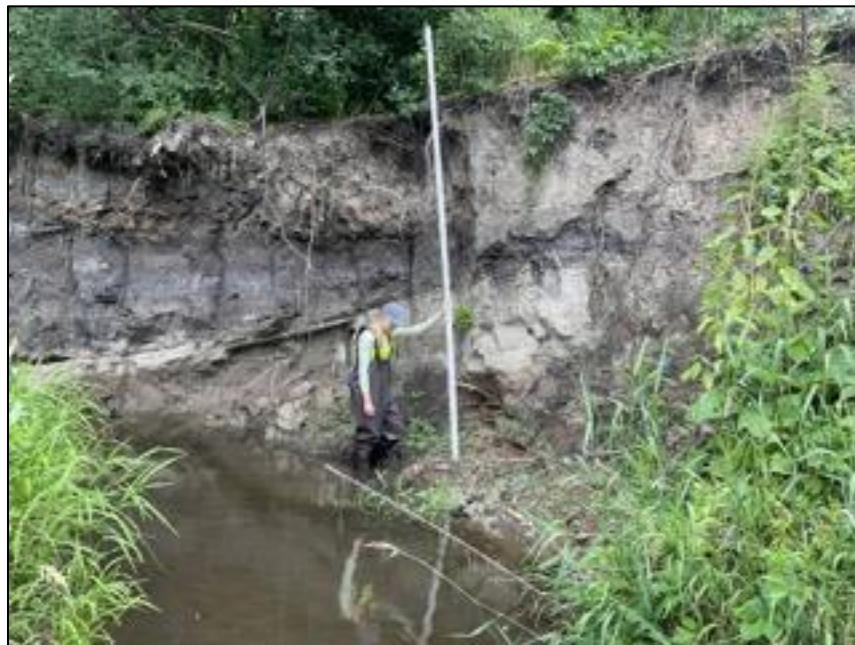
**Photo 8: Severe Erosion at Valley Park RTR to Wentworth Site**

WSB recommends regrading the existing vertical banks and installing toe wood on the most severely eroded banks to create a stable bank that will not continue to laterally migrate toward the power line corridor. Regrading the vertical banks will reduce the likelihood of occasional large sediment inputs into IVC due to bank sloughing, and it will also create space for native plant installation in accordance with the vegetation management recommendations in the MH NRMP.

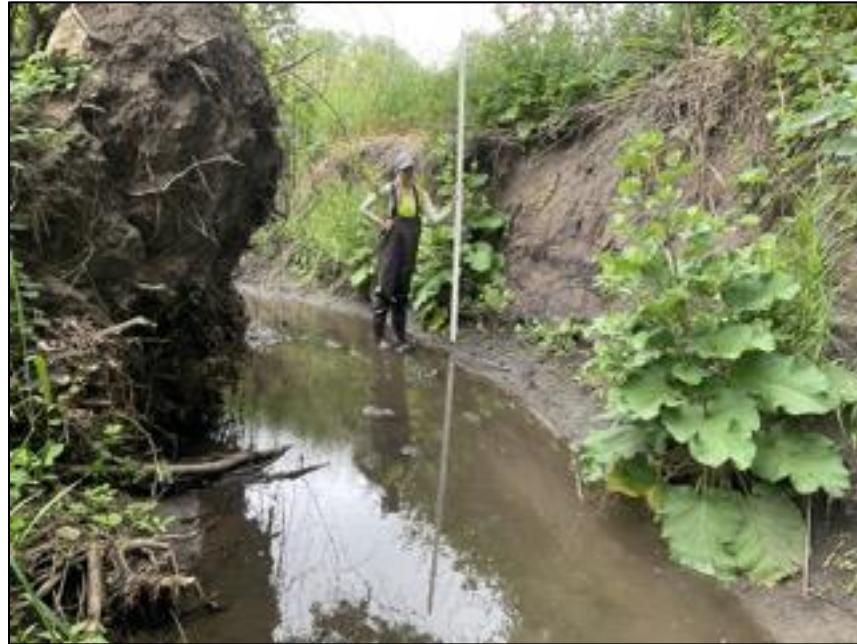
**Photo 9: Severe Erosion at Valley Park Wetland Site**

The field study documented nearly 300 feet of severely eroded channel banks within the Valley Park Wetland Stabilization site, and approximately 150 feet of moderate erosion. The maximum bank height in the severely eroded section was 8 feet, and the maximum in the moderate erosion section was 5 feet. This corresponds to the 2D model results which indicate channel velocities above 10 feet per second in the 10-year storm event in the reach labeled as having severe erosion.

The recommended stabilization measures for this site include toe wood and bank grading, as well as planting the regraded banks with native vegetation in accordance with the MH NRMP.

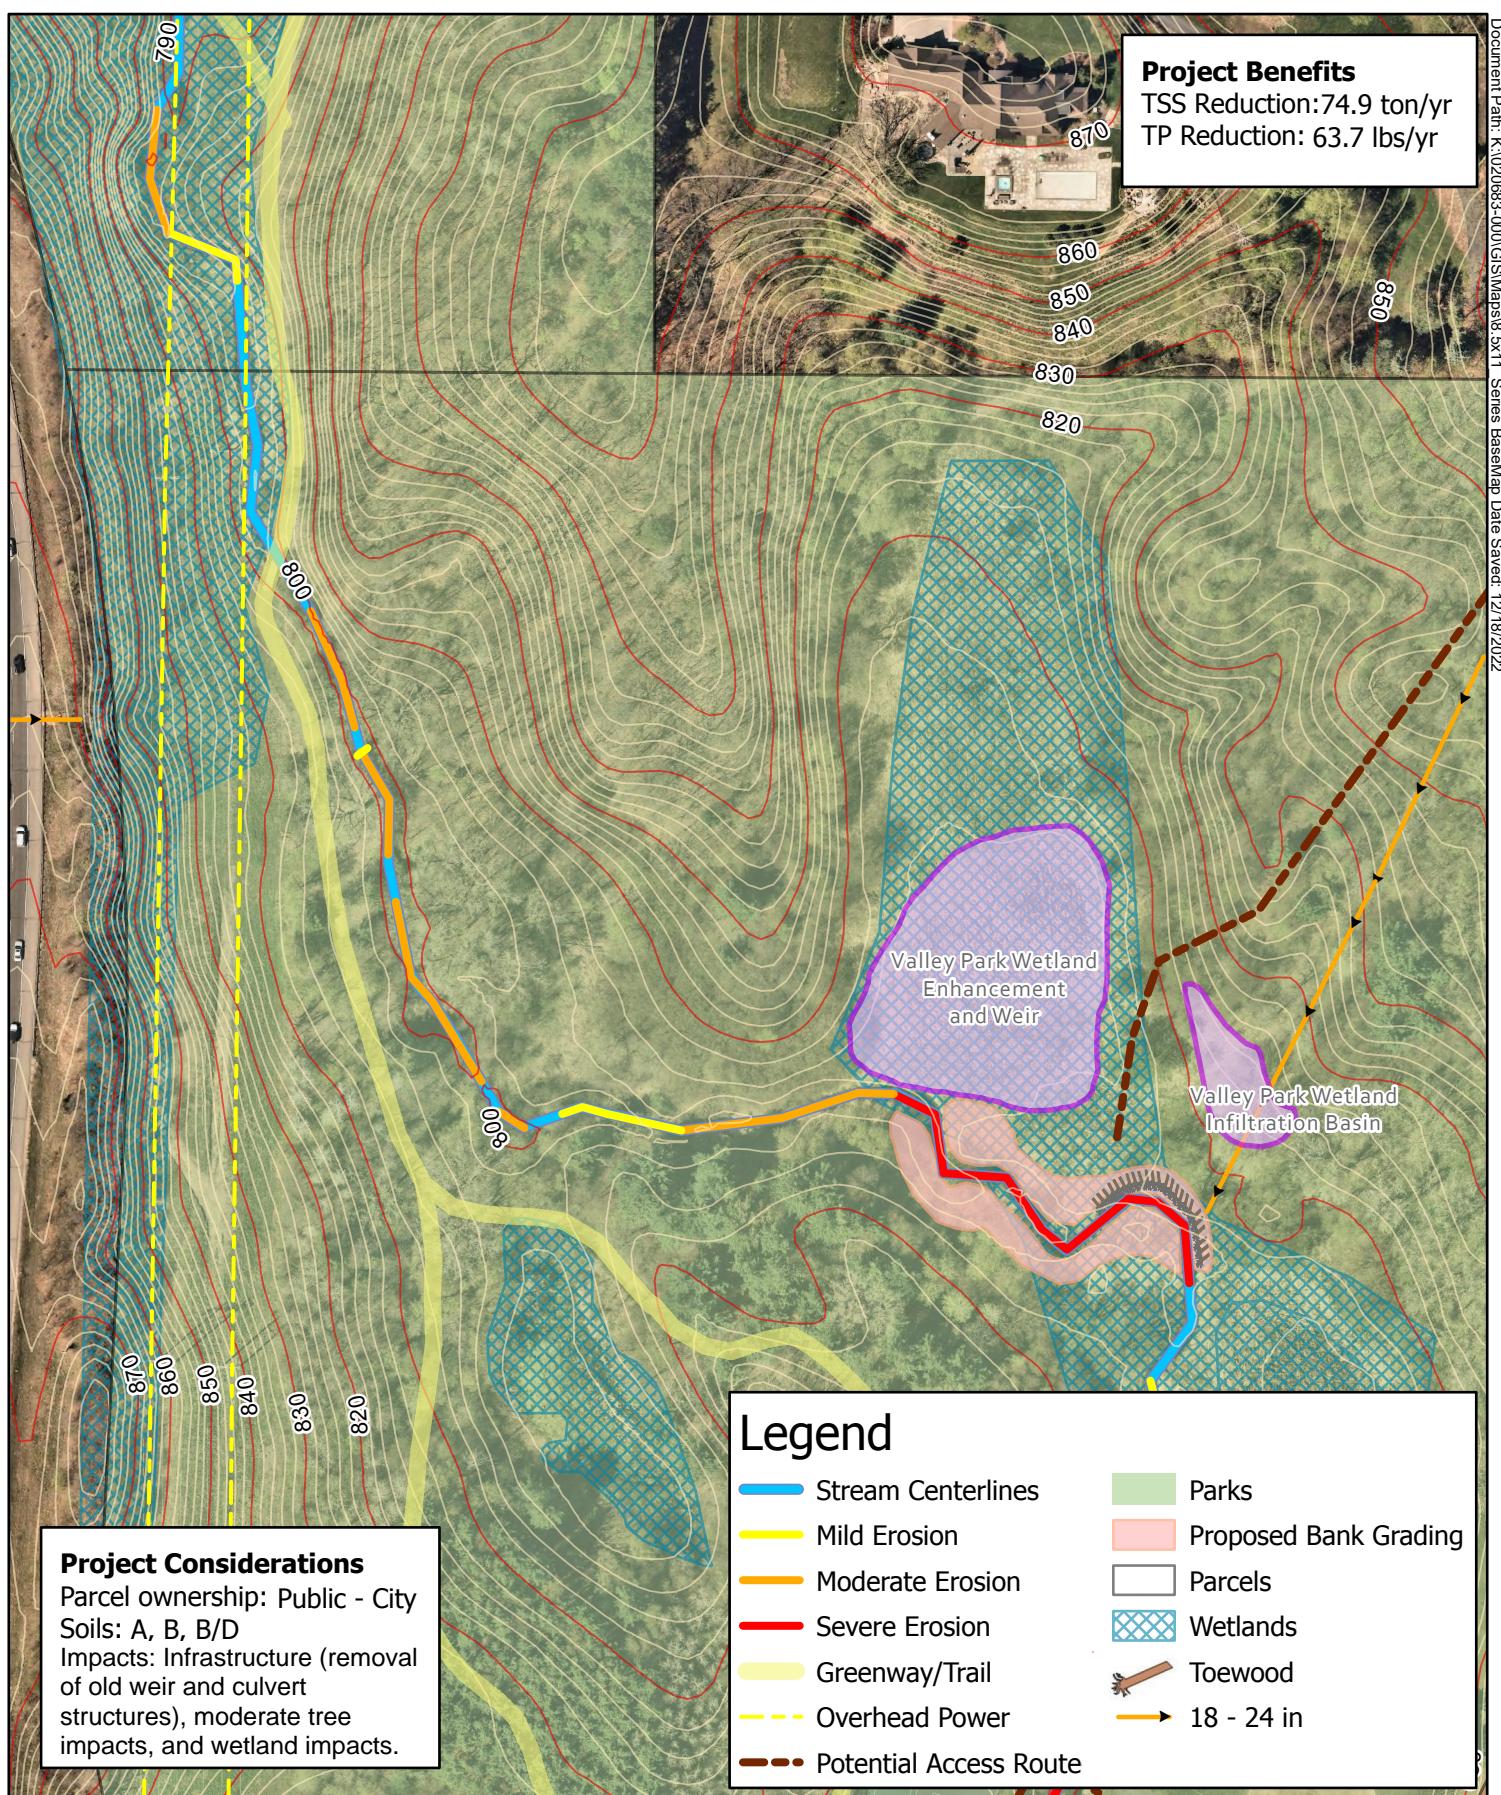
**Figure B.2 - Valley Park Wetland**

The Valley Park Wetland stabilization site is shown in **Figure B.2**. This site is upstream of where IVC crosses the River-to-River Greenway, but it is downstream of the ballfield and playground parts of Valley Park (erosion in these areas is discussed in Section F.4).

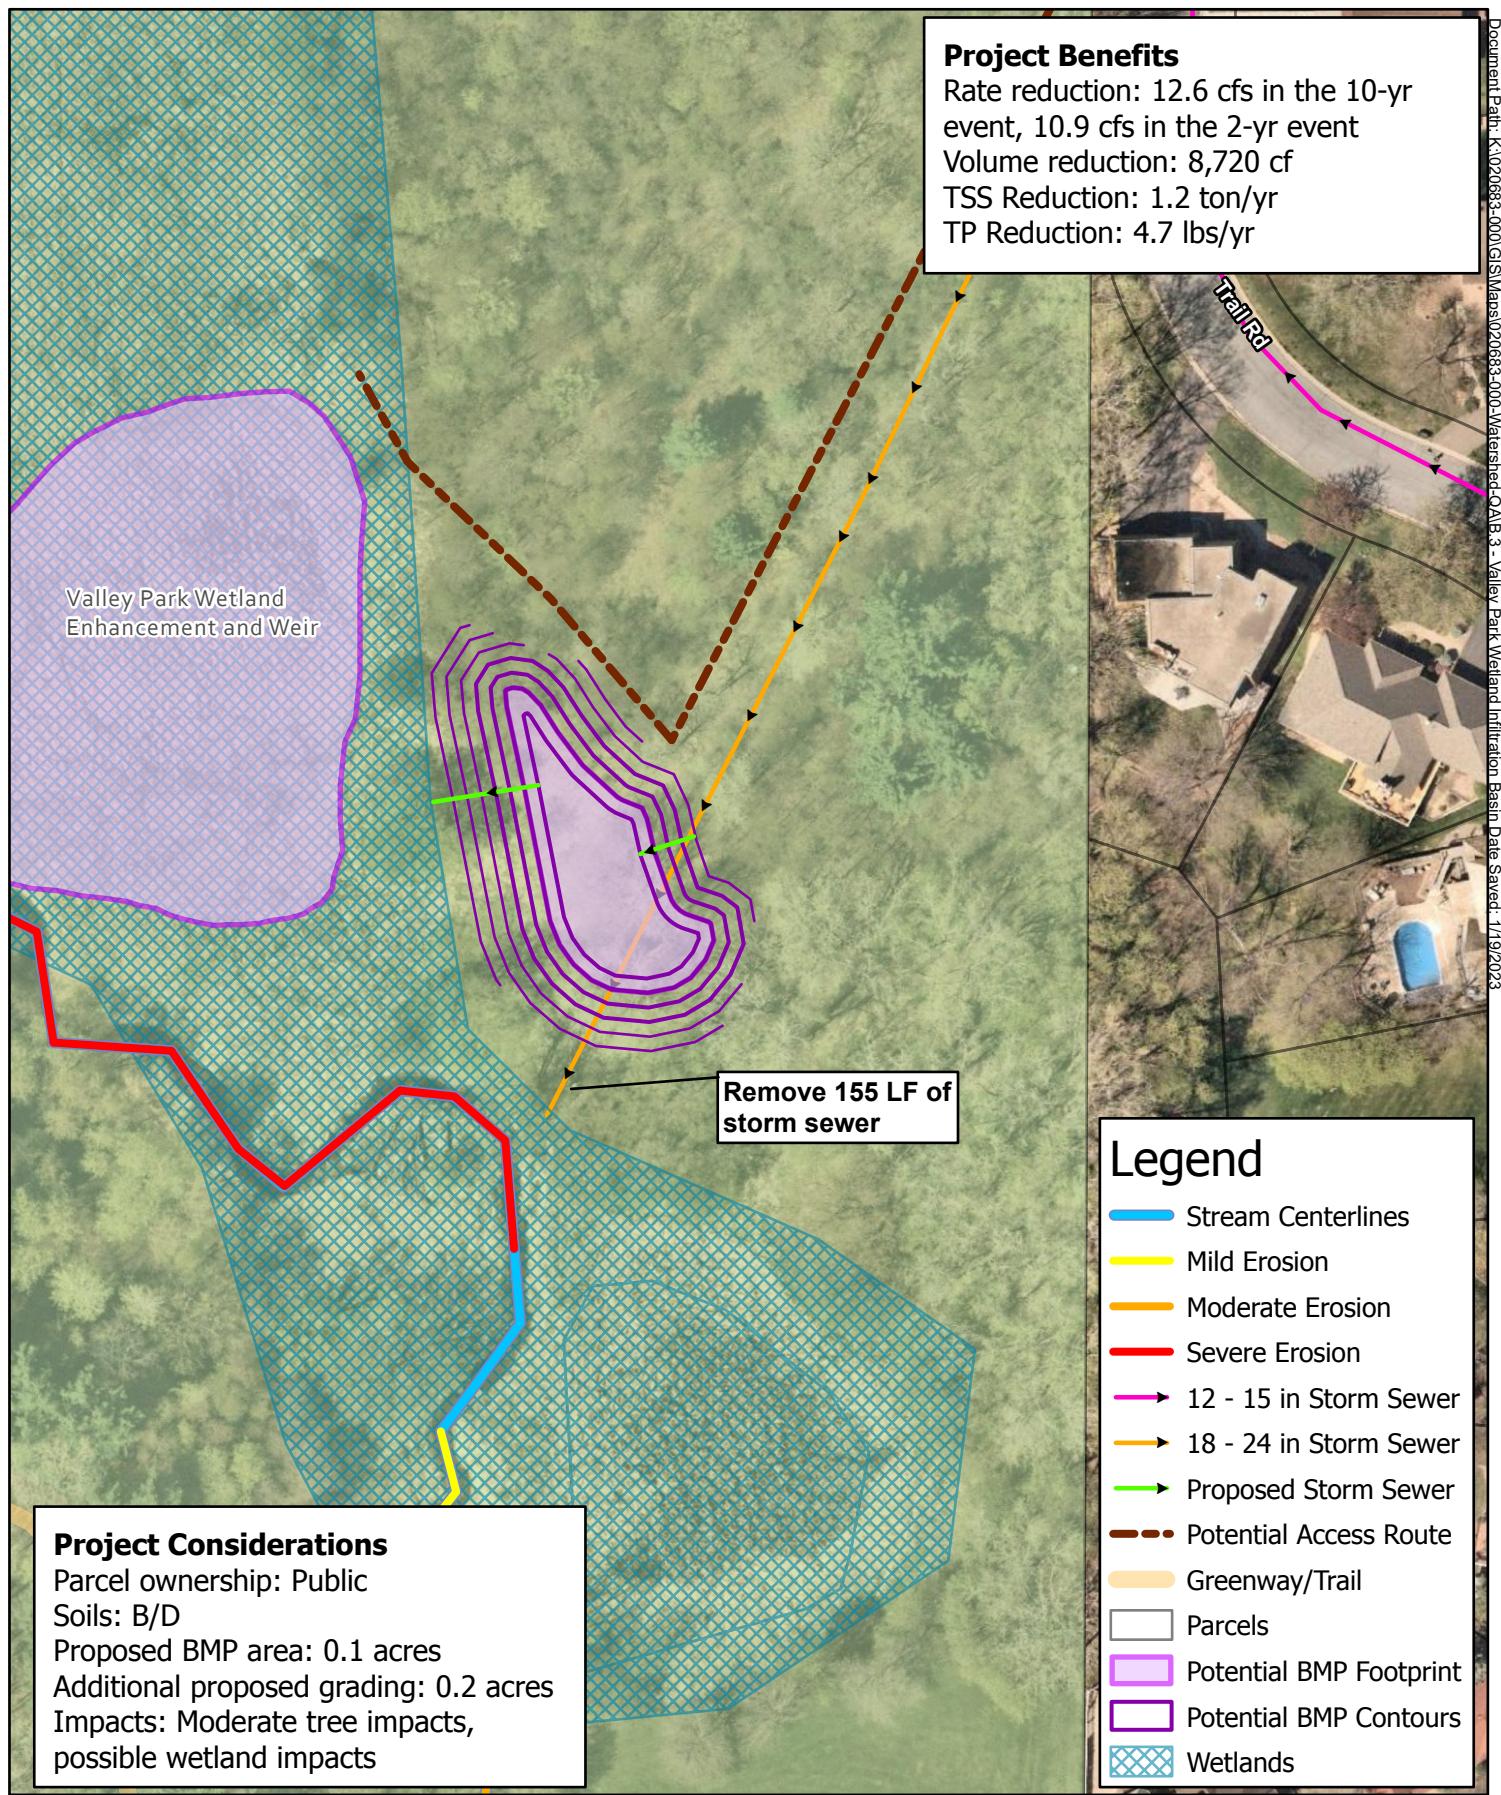
The proposed Valley Park Wetland Infiltration Basin, shown in **Figure B.3**, would provide rate volume and pollutant reductions for approximately 9.8 acres of single-family residential area that currently outlets directly to the IVC main stem from an 18-inch RC pipe. This area of IVC exhibits severe erosion as noted in the Valley Park Wetland discussion. The proposed infiltration basin is in an area with soils that are primarily HSG B/D. We are assuming that the soils in the upland area in which the infiltration basin is proposed would act like HSG B soils, which are conducive to infiltration. The outlet from the infiltration basin is proposed to drain to the wetland west of the basin and north of the IVC main stem. This gives additional opportunity for rate and pollutant reduction before the stormwater reaches the IVC main stem. Additionally, some grading and vegetation management in the wetland could be completed to create a higher quality wetland.

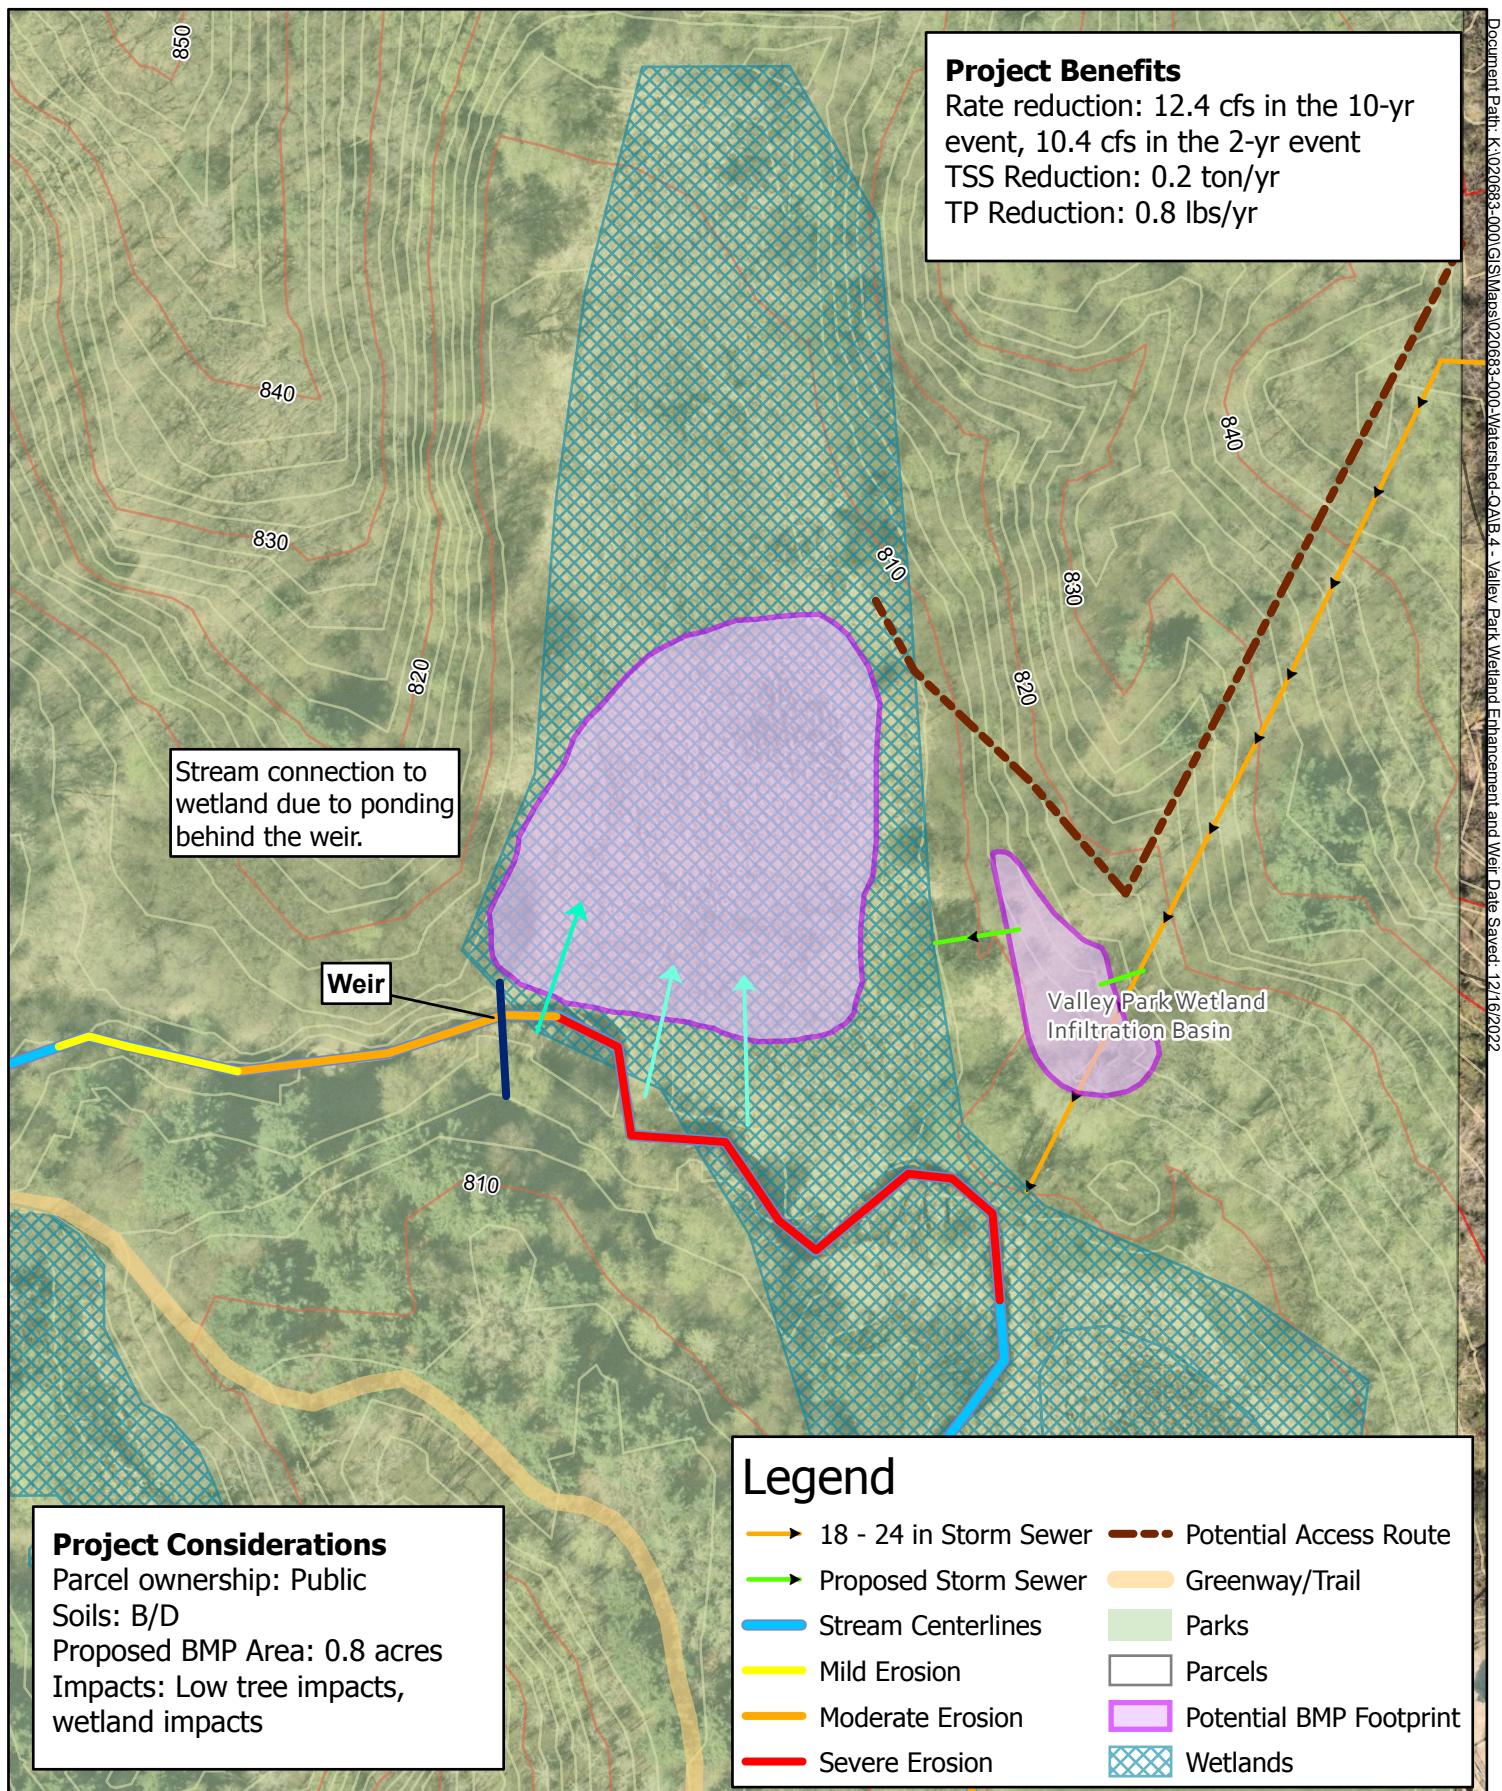
The proposed Valley Park Wetland Enhancement and Weir, shown in **Figure B.4**, reestablishes a weir that historically existed in this area and would reconnect the IVC mainstem to the wetlands and floodplain areas around it. The weir is proposed slightly downstream of where it was sited historically, in an area where the banks are not as severely down cut and less excavation would be required to reconnect the wetland to the stream. A second weir could be considered at the location of the historic weir.

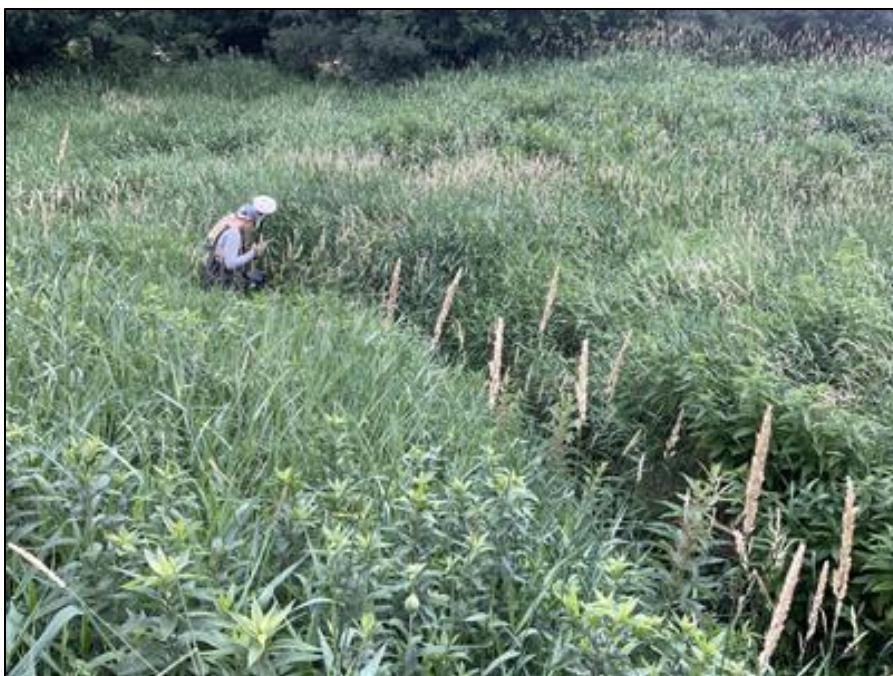
Channel erosion documented in this section is generally mild to moderate. The IVC main stem in this basin is a mostly straightened section through a wetland west of Valley Curve Road. The channel is abnormally straight through this wetland, which is atypical of wetland streams, which are usually quite sinuous. The current wetland is generally low quality and is mostly a monoculture of reed canary grass.

Photo 10: Overview of Typical Channel in Valley Park South Area

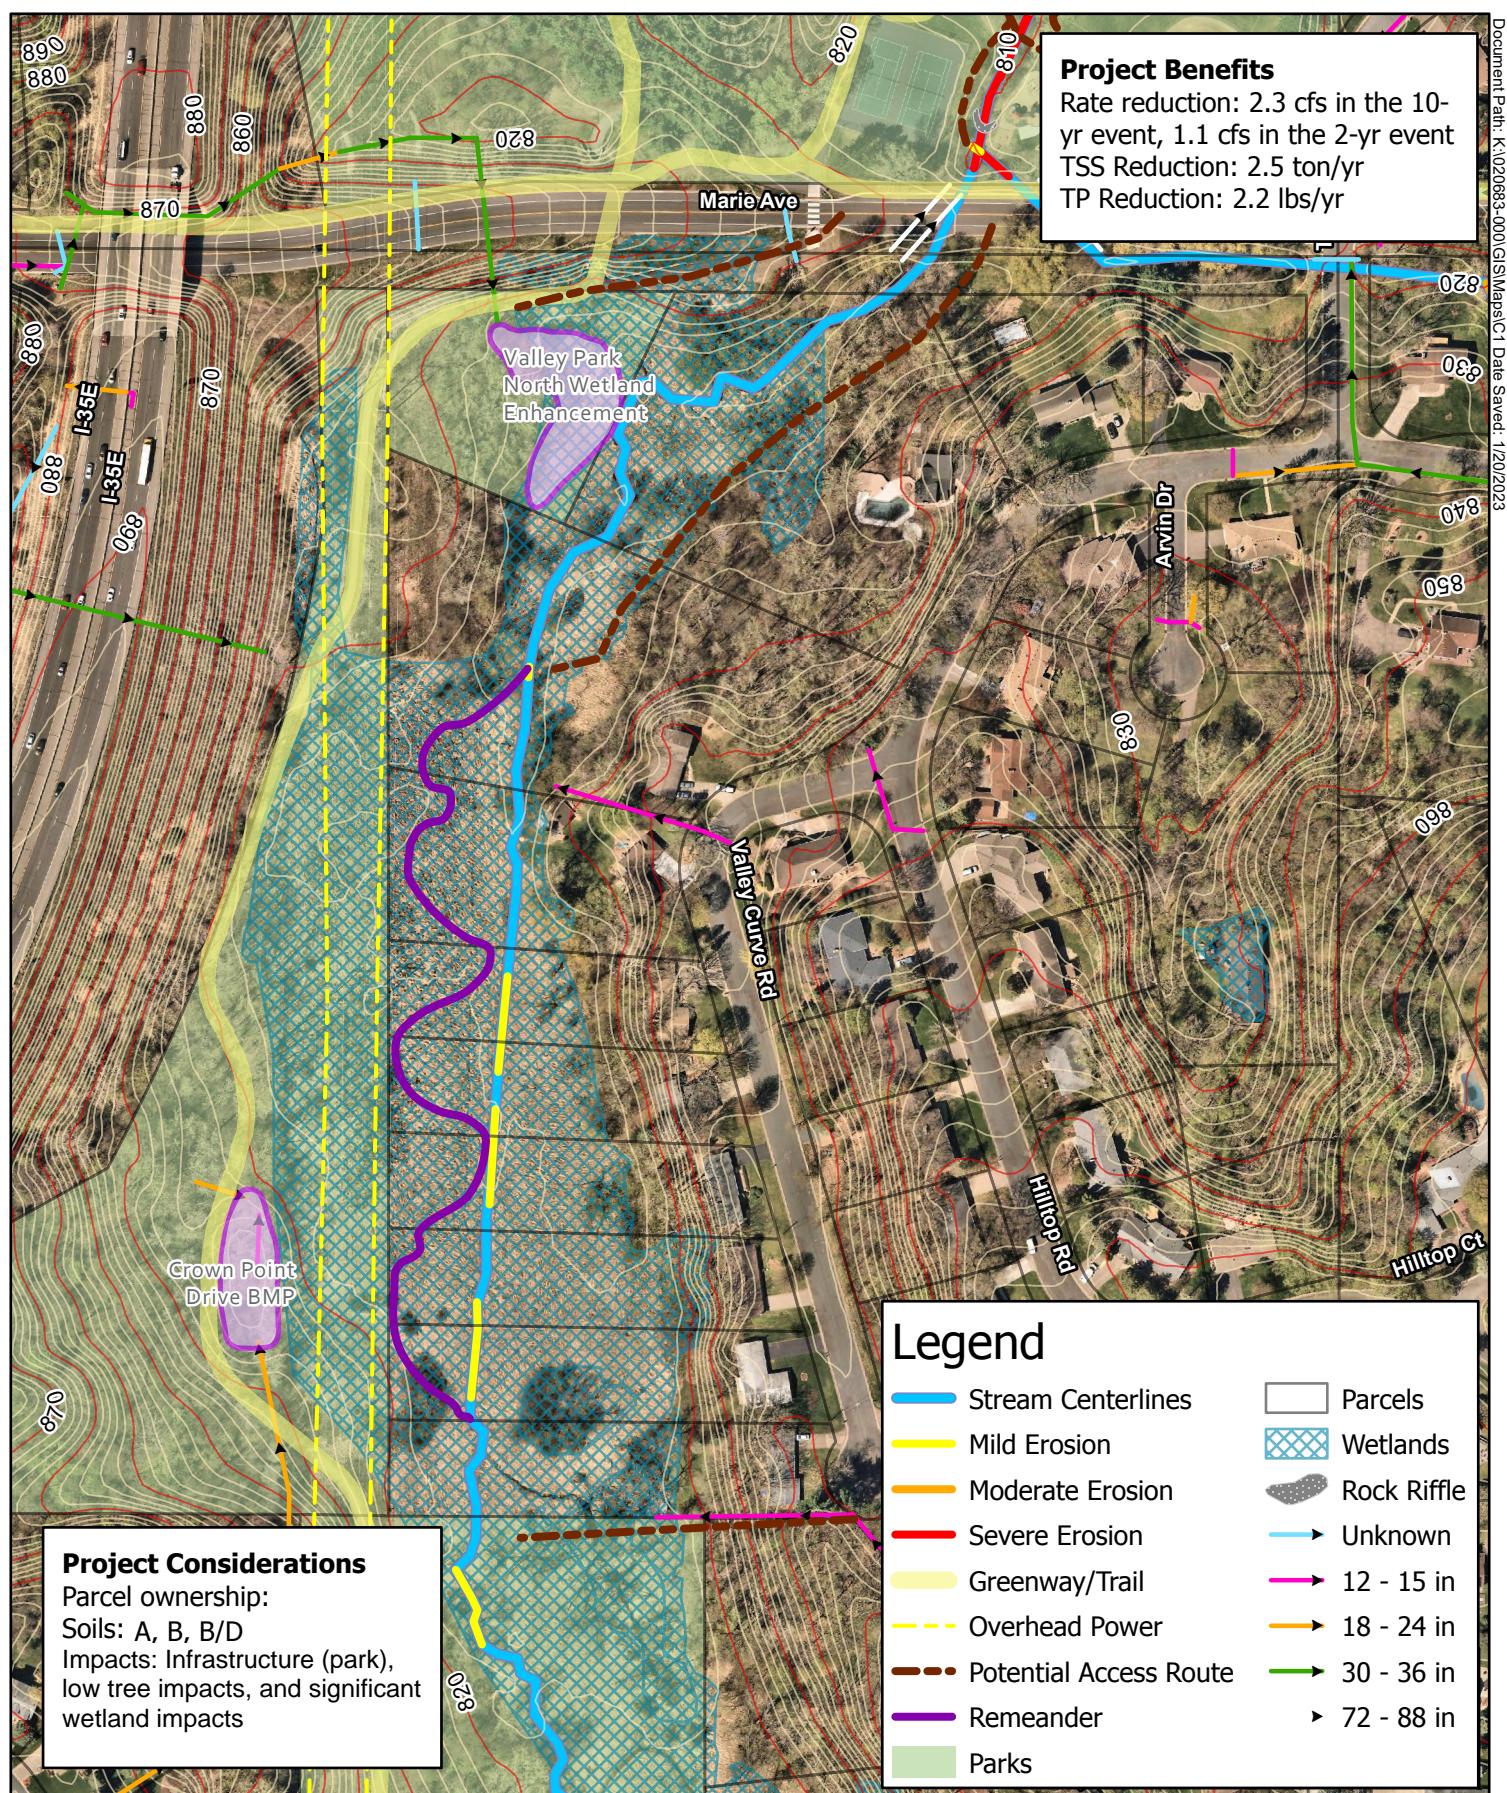
**Figure C.1 - Valley Park South**

The concept design for Valley Park South is shown in **Figure C.1**. The proposed design consists of remeandering IVC through the existing wetland corridor. The 2D model results in **Appendix E** show that this is already an area where IVC floods during storm events, and both channel and floodplain velocities are generally moderate. A longer channel with better connection to the floodplain, along with planned vegetation management, could improve the vegetative quality of the wetland, encourage infiltration, and reduce erosion in the channel.

**Figure C.1** shows that the current IVC channel alignment is primarily on private parcels. The proposed new alignment for IVC would be on both public and private parcels. The early stages of project design should include landowner outreach to determine the likelihood of each landowner granting the required easements for the project to be completed. This would also be a good opportunity for landowner education and possible partnership in maintenance of the proposed native vegetation.

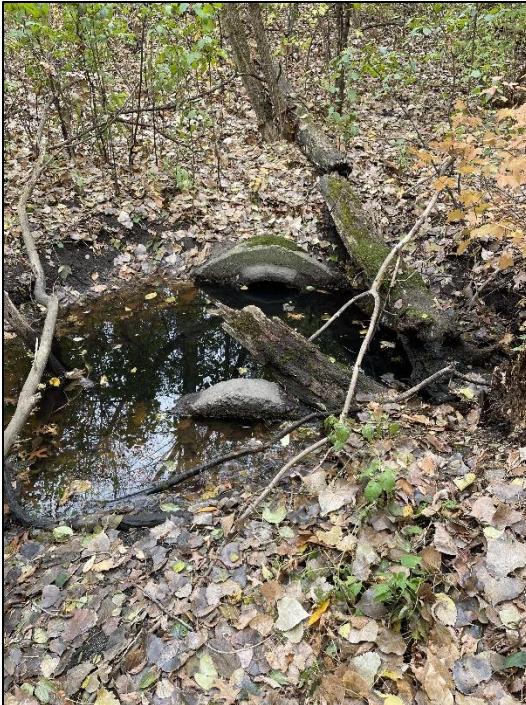
South of the Valley Park North Wetland Enhancement is a small existing BMP in need of maintenance, as shown in **Figure C.3**. The inlet into the Crown Point Drive BMP is largely submerged/buried as shown in **Photo 11**. A berm surrounds the BMP, through which the outlet pipe drains. A pipe under the adjacent RTR Greenway discharges at the same point as the discharge

**Photo 11: Inlet to Crown Point BMP**

location from the Crown Point BMP, as shown in **Photo 12**. Maintenance of the BMPs inlet pipe is recommended, which would include clearing and excavating around the outfall. However, if a larger project were desired, the berm around the BMP could be expanded to include the water that drains under the trail. This expanded BMP could provide rate reductions and pollutant removals beyond that of the existing one. Some tree impacts are likely to maintain or expand the Crown Point Drive BMP, however based on the MH NRMP, this area does not appear to have dense oak or native trees.

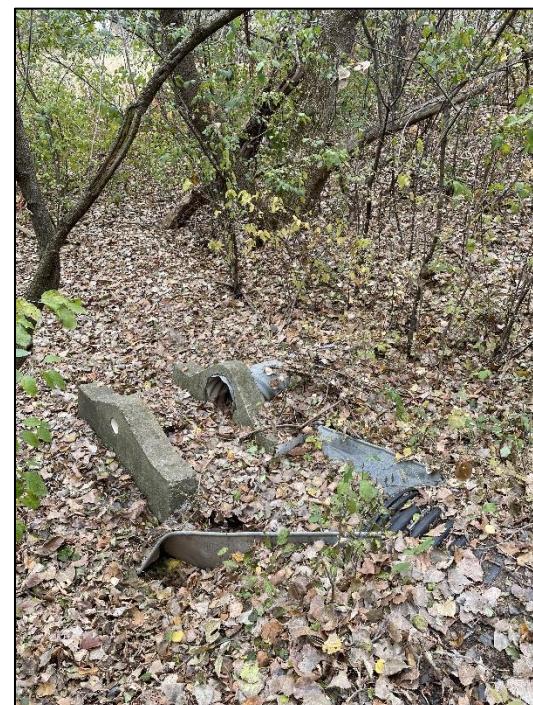
**Photo 12 - Outlet from Crown Point BMP**

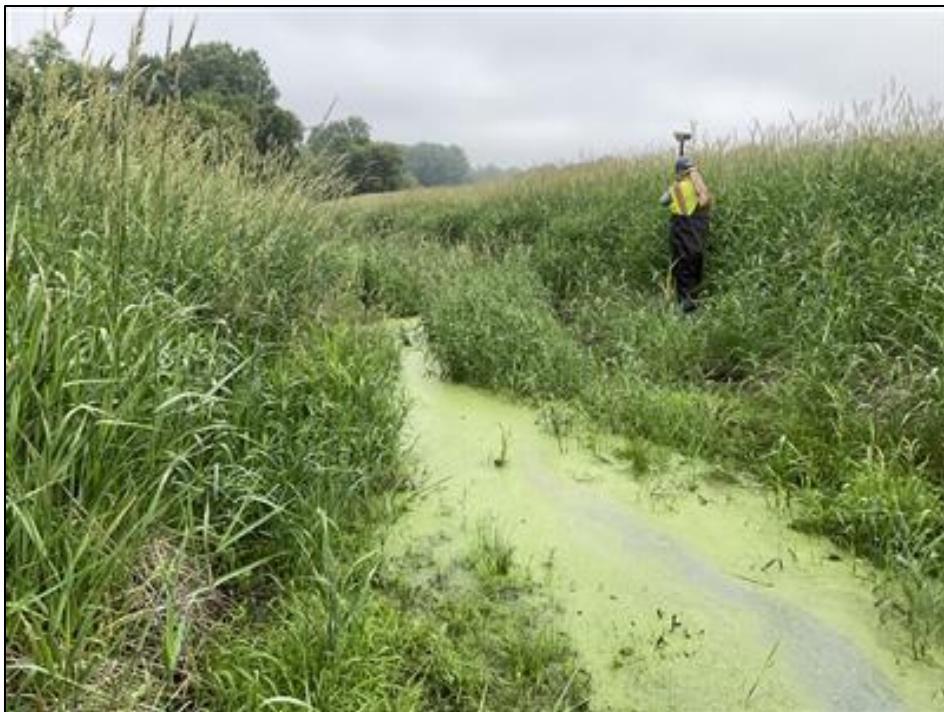
The channel erosion survey within Upper IVC Basin began at the headwaters of IVC within Friendly Marsh Park and extended to where IVC passes under TH 62. The field survey found a stable channel with no documented areas of erosion. The 2D model did not include the IVC main stem upstream of TH 62 so there are no 2D model results in this area.

Photo 13: Typical Section of IVC within Friendly Marsh Park

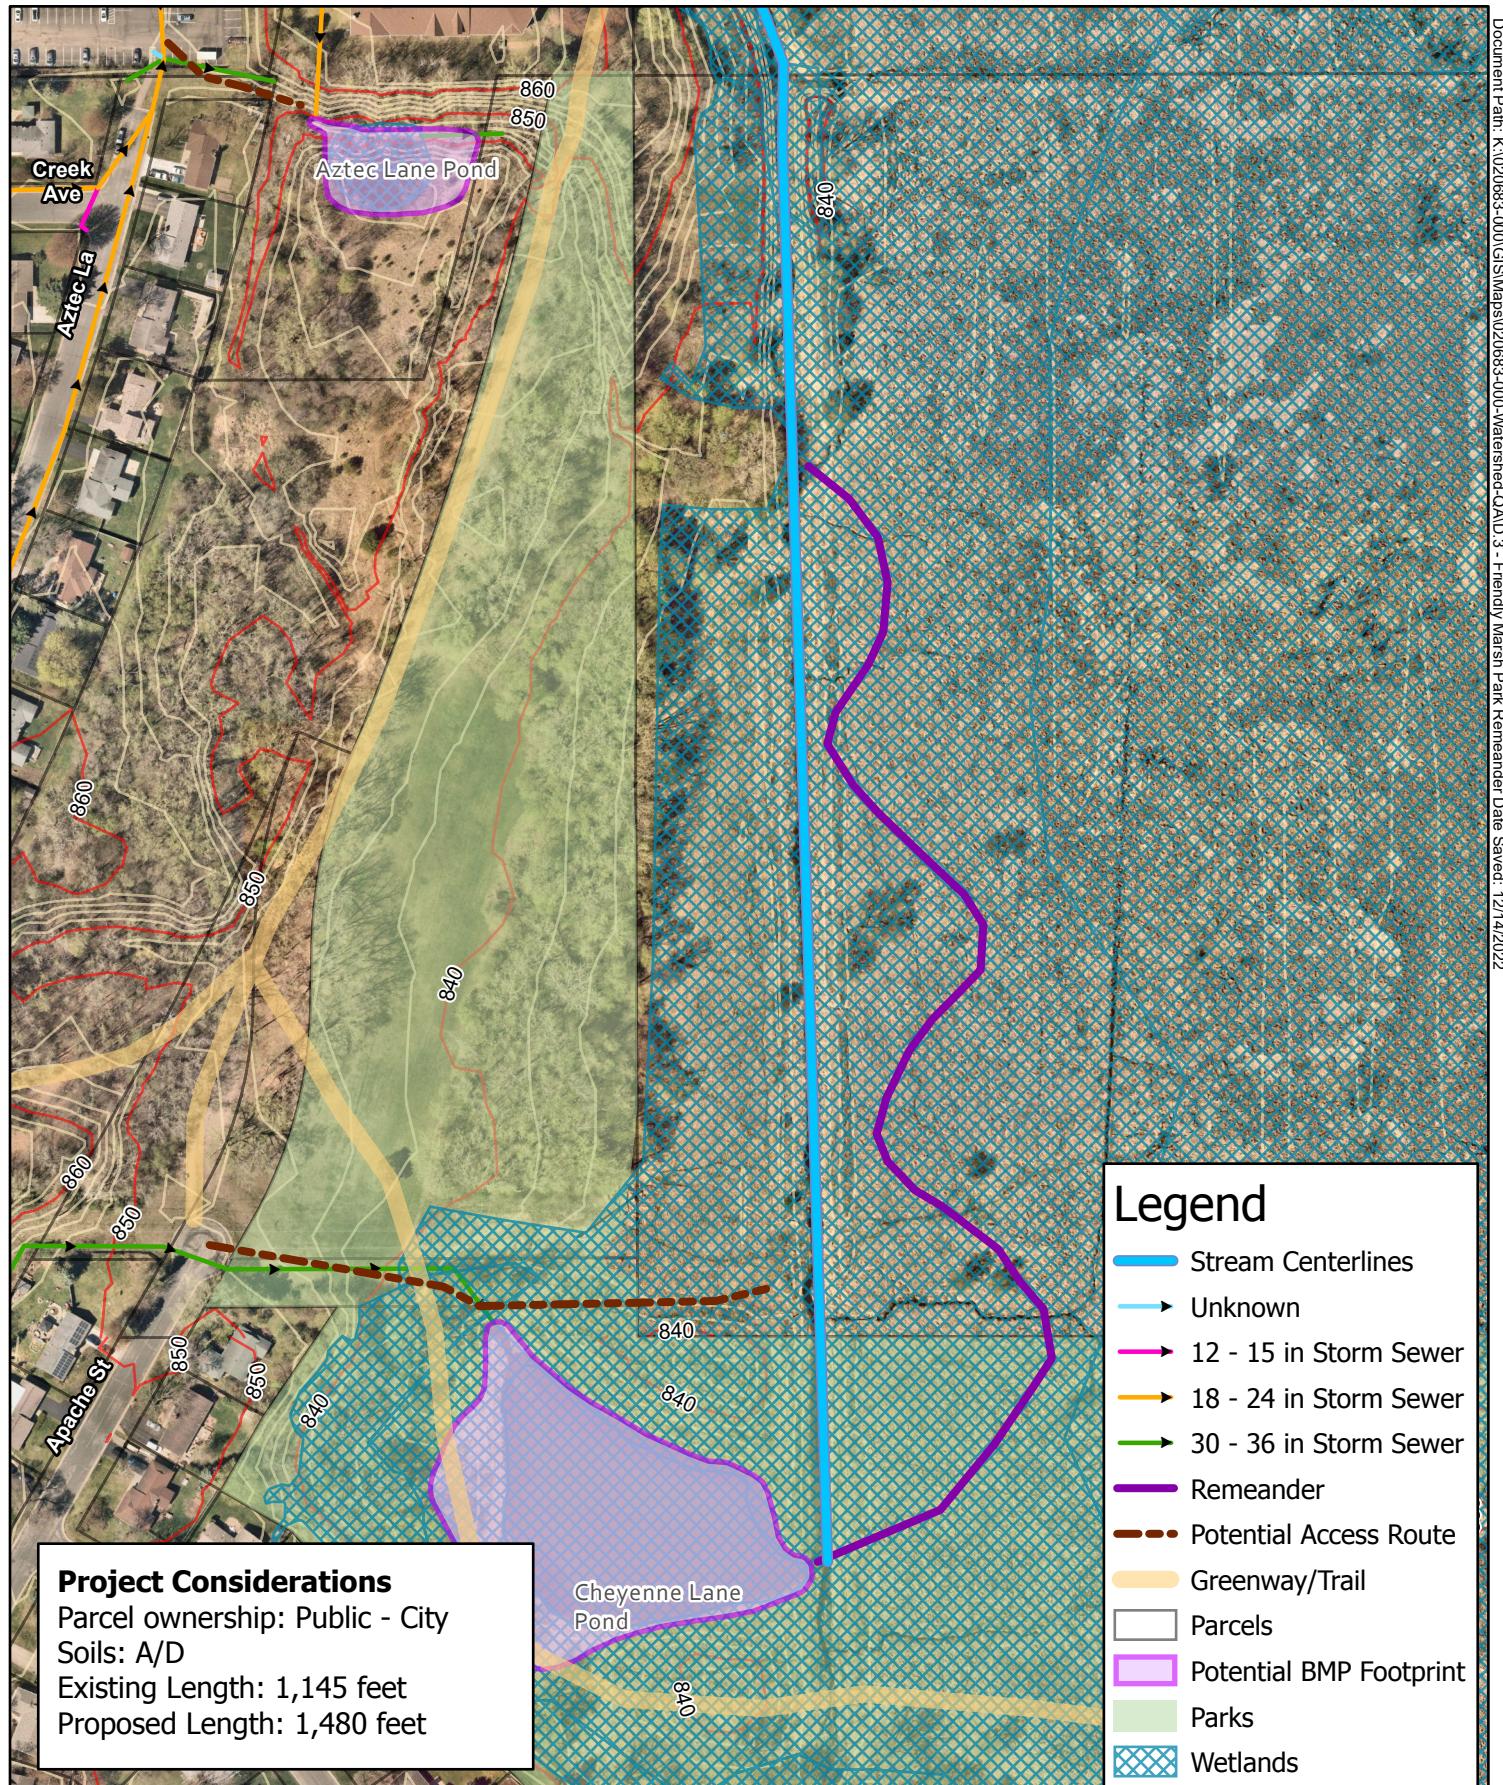
**Figure D.3** shows the Friendly Marsh Park Remeander. This ditch section of channel was constructed by the City of Mendota Heights in the 1960s. There is an opportunity to remeander this section, increasing the length from 1,145 feet to 1,480 feet, adding sinuosity of natural stream systems and connecting the main channel to more of the wetland area. While the concept shown includes an increase in length of 335 feet, if pursued, the final design for this remeander could likely increase that length further by introducing more sinuosity and extending further north into the area proposed for the Friendly Marsh Park Wetland Enhancement.
