# **LOWER MISSISSIPPI RIVER WMO—INTERSTATE VALLEY CREEK STABILIZATION AND VOLUME REDUCTION STUDY**

## **FEASIBILITY REPORT**

January 30, 2023

WSB PROJECT NO. 020683-000

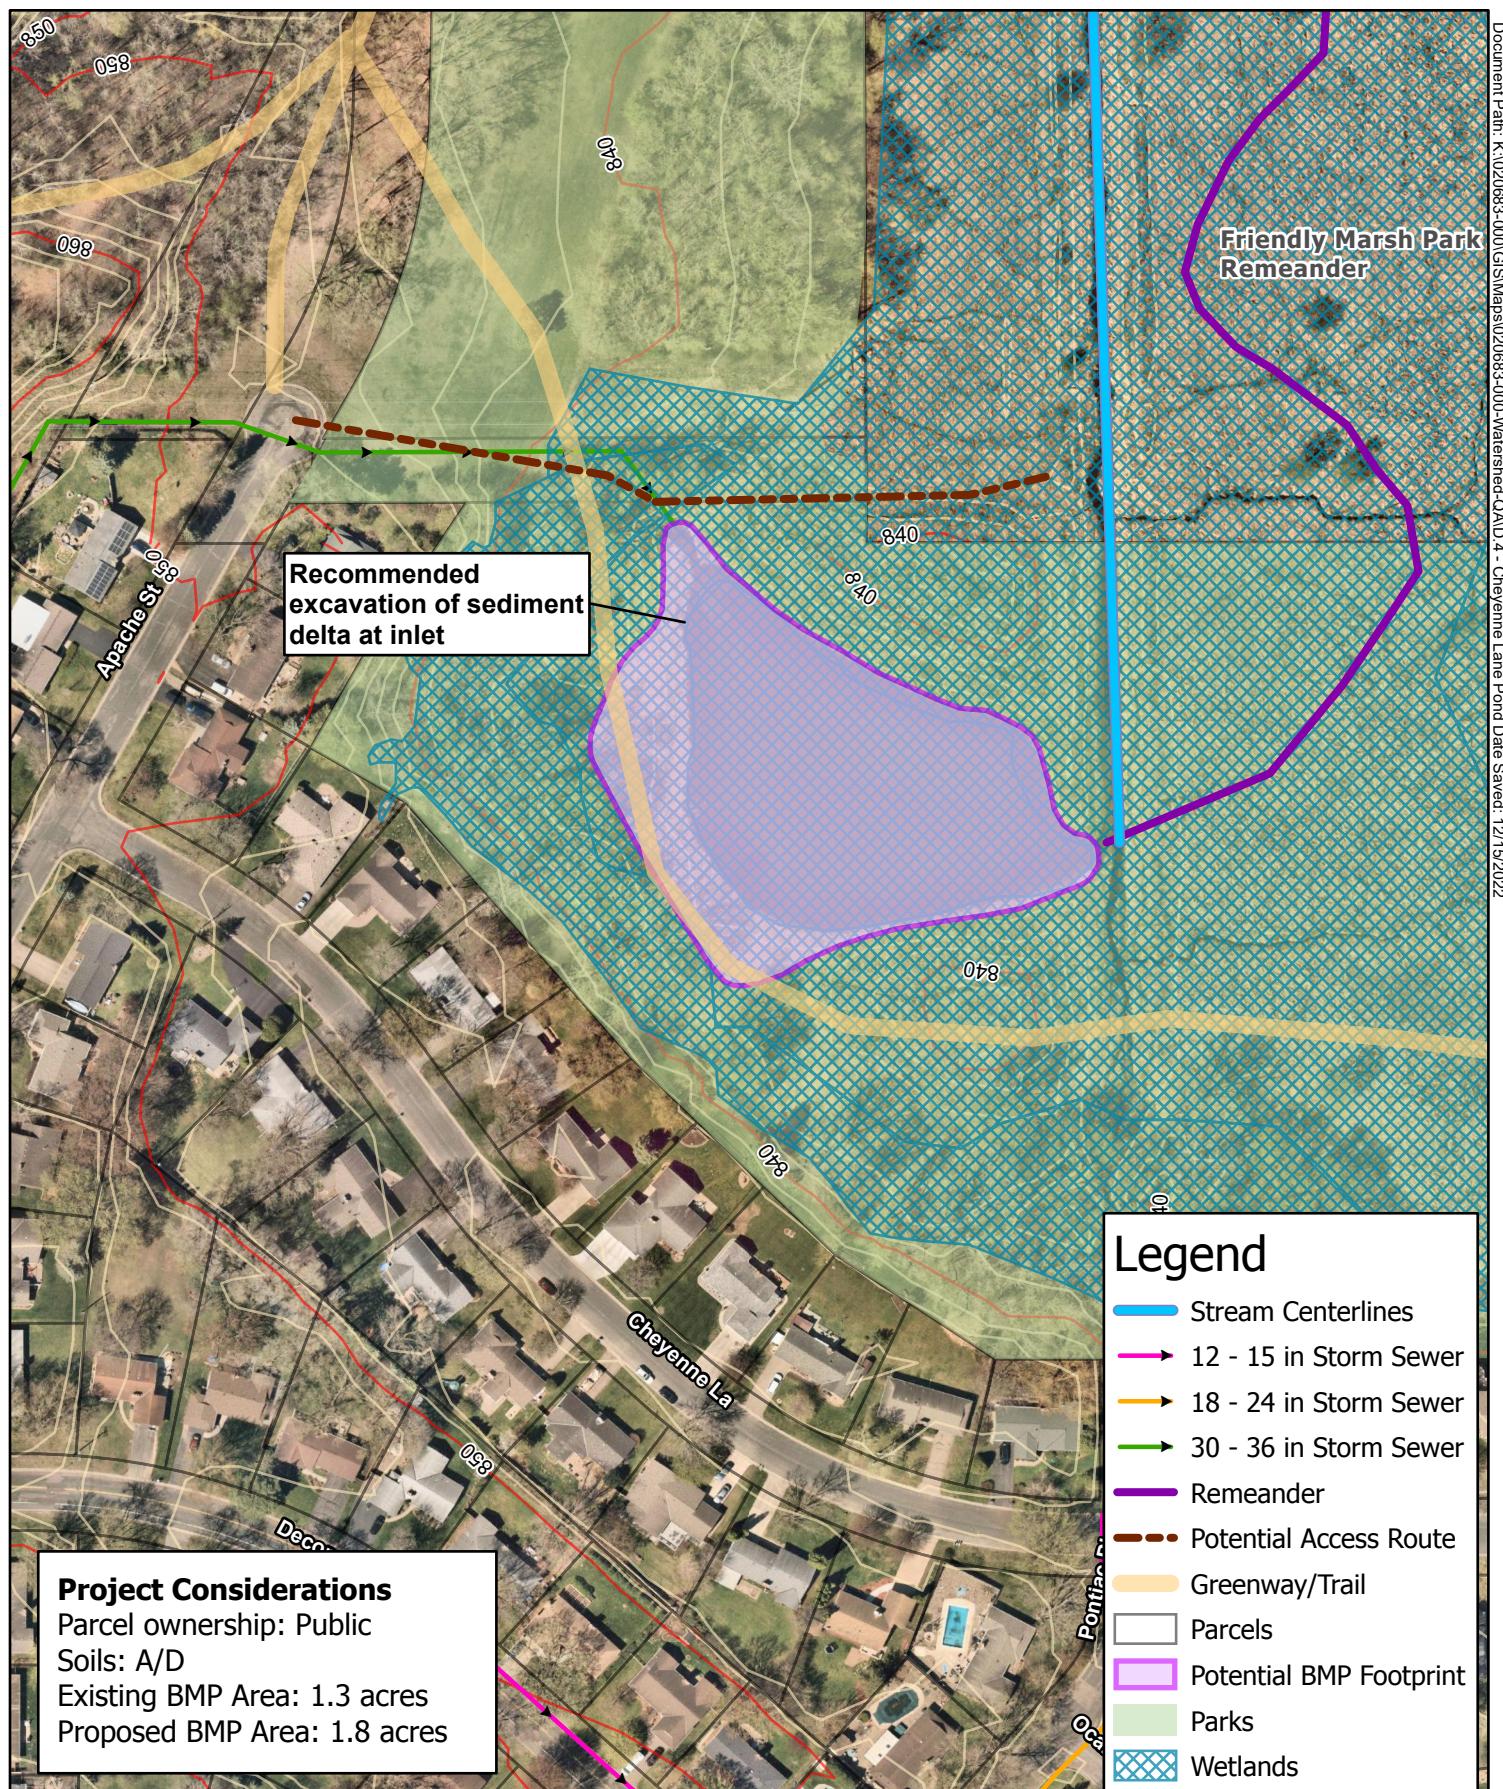
**Figure D.4** shows the Cheyenne Lane Pond. This is an existing pond that received drainage from 611 acres, 475 of which first flow through Rogers Lake. Stormwater enters the pond via a 30-inch RC pipe; the pond discharges over a weir, into the headwaters of IVC. A sediment delta has formed at this inlet into the pond. There appears to be opportunity for expansion of this pond, increasing the footprint by approximately 35 percent. This would provide an opportunity to further reduce rates before water discharges into the IVC main stem and does not appear to be a concern for flooding of the adjacent homes.

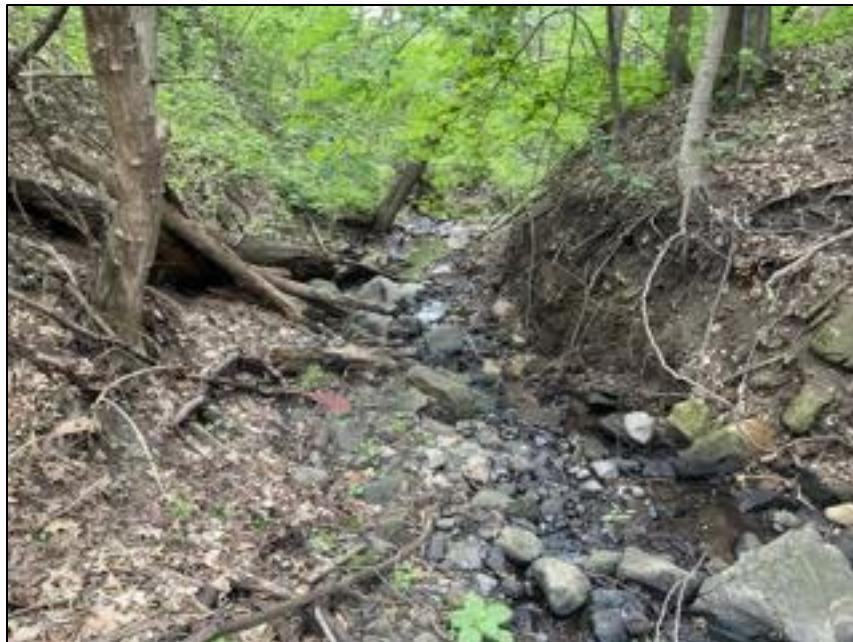
Lower Wentworth creek has approximately 150 feet of moderate erosion downstream from the crossing at Wachtler Avenue. Results from the 2D modeling in **Appendix E** indicate high velocities in this area after water crosses under Wachtler Avenue via a culvert; this is likely due to the steep slope of both the channel and the valley walls surrounding it. The proposed stabilization design for Lower Wentworth Creek is shown in **Figure E.1**. This reach of Wentworth Creek is within a mature forest with a high channel slope. There was no observed lateral erosion in this reach, so the design consists of a single rock riffle to address vertical erosion.

**Photo 14: Vertical Incision in Lower Wentworth Creek Area**

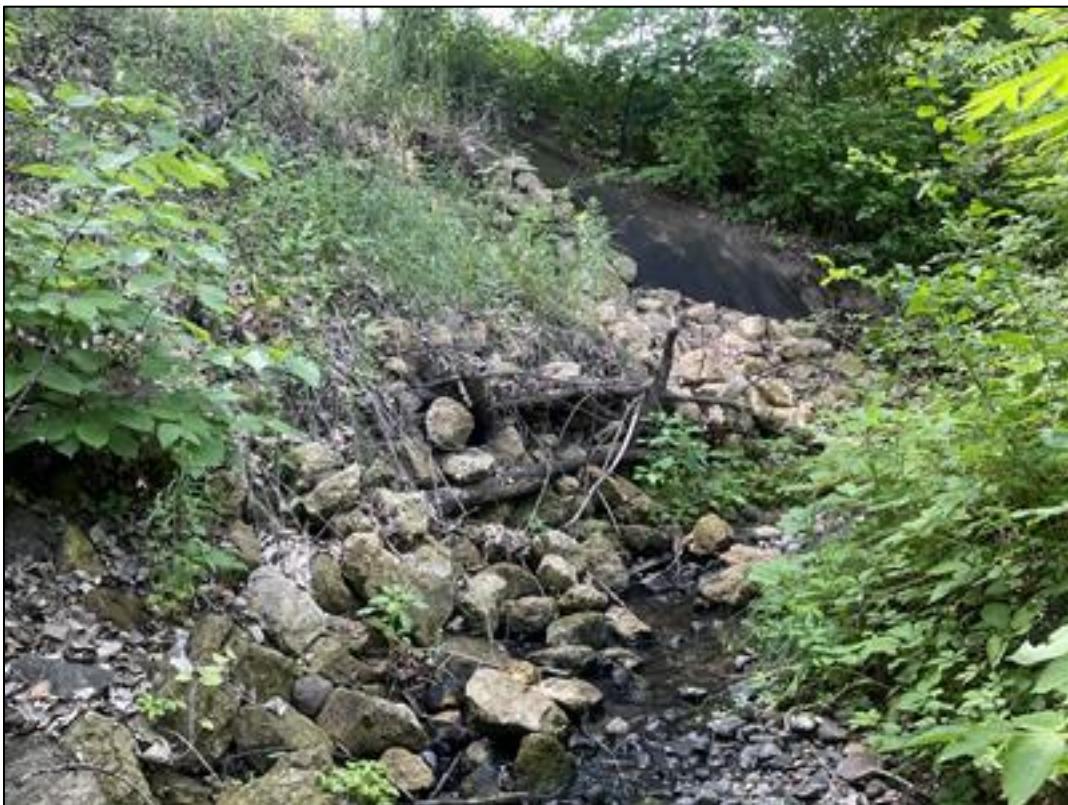
The 2D model results in **Appendix E** show relatively low velocities in the Middle Wentworth project area, but large amounts of water indicate that the culvert under Wachtler Avenue may be undersized. Stabilization in the Middle Wentworth project area must therefore be designed to handle brief periods of inundation during storm events.

**Photo 15: Severe Erosion on Middle Wentworth Creek with Evidence of Past Stabilization Efforts (Riprap over Blanket)**

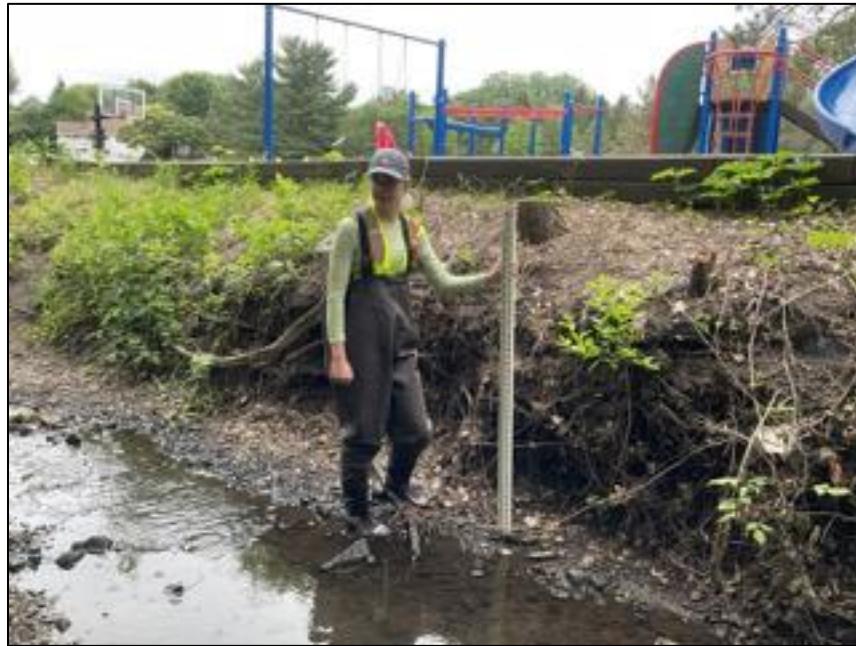
no floodplain for water to access during storms until it reaches the wetland downstream of the ball field. The result of this confinement is vertical downcutting and exposure of the new banks to high erosive pressures during storm events. Removal of trees near the playground may also cause further erosion towards the playground in the future as these tree roots decay and can no longer contribute to bank stability.

**Photo 16: Severe Erosion near Valley Park Playground**

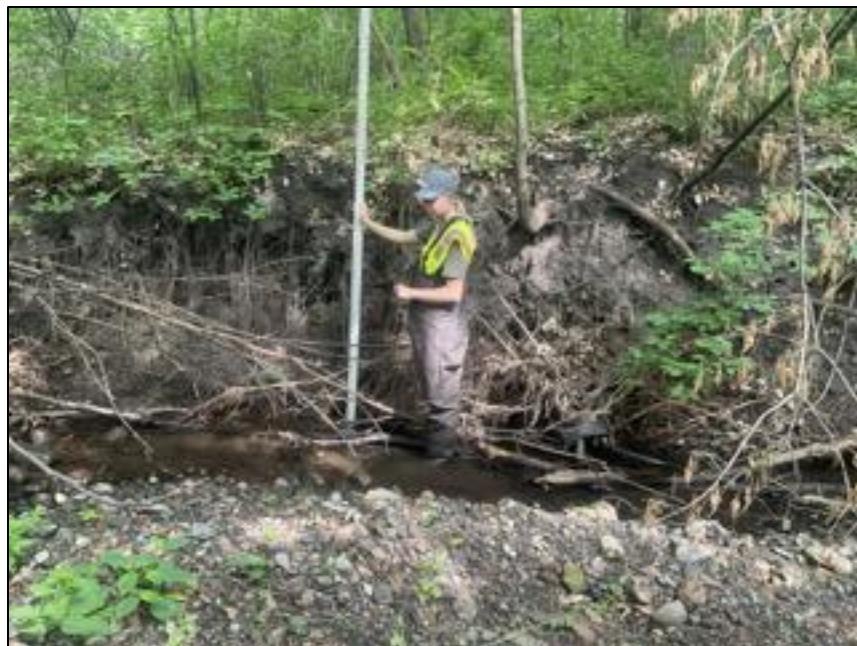
2D model results in **Appendix E** show a strong correlation between areas of locally high velocities (>10 feet per second) and areas of documented moderate erosion. During the field survey Marie Creek had a more consistent presence of base flow than either the IVC main stem or Wentworth Creek, therefore the banks are subject to more consistent erosive pressure.

**Photo 17: Moderate Erosion on Lower Marie Creek**

The recommended bioengineering method consists of logs cabled to a bank which has been graded to a stable slope and native plantings are installed between the log structures (see **Figure 7, Appendix A** for a typical construction detail). The log structures differ slightly from revetments in that they do not have branches attached, but they do use the same cabling method. WSB has used this method in creek stabilization projects in the City of Maple Grove (2020) and the City of Plymouth (2022) and can provide additional detail on the design and installation of these structures upon request.

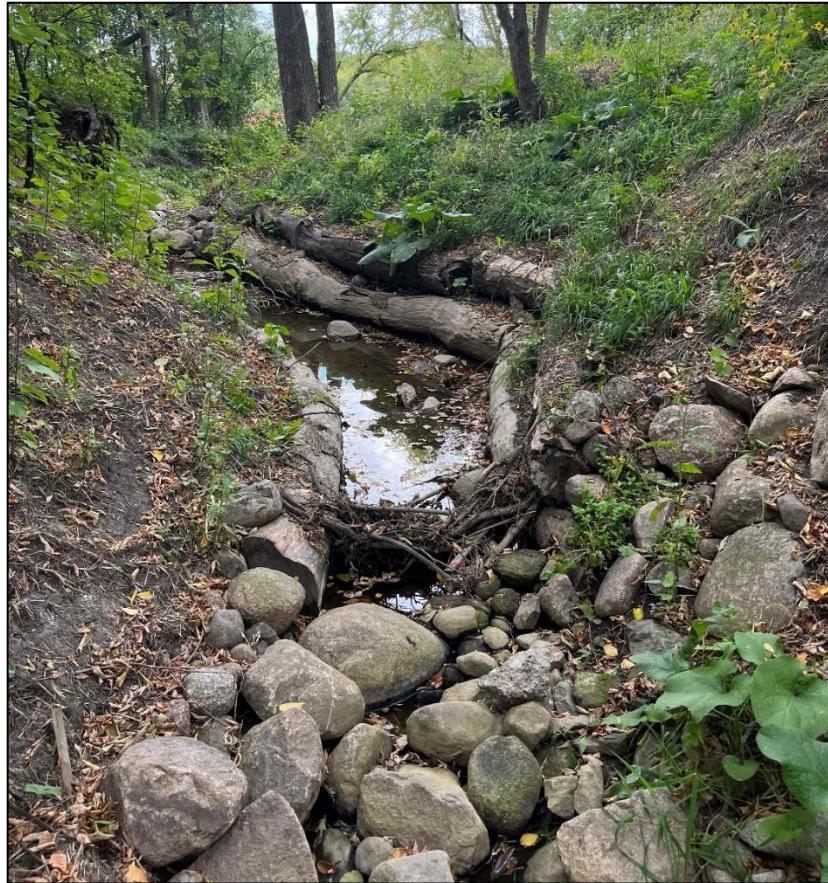
**Photo 18: Bioengineered Slope Stabilization in use in Maple Grove One Year Post Installation**

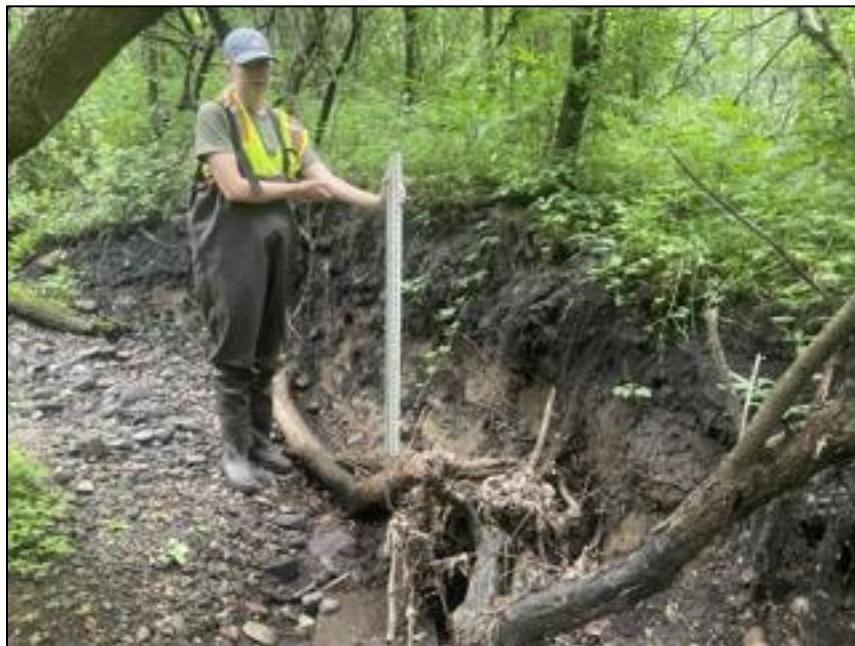
Middle Marie Creek is defined as the section of creek between Delaware Avenue and Dodd Road. Documented erosion issues on this section of the creek were all mild to moderate, therefore the most suitable sites for stabilization projects were two of the longer sections experiencing moderate erosion issues. Middle Marie Creek is upstream of the Marie Creek input to the 2D model so there are no 2D model results for these sites. These sections and the proposed stabilization plan are shown in **Figure F.3**.

**Photo 19: Moderate Erosion on Middle Marie Creek**

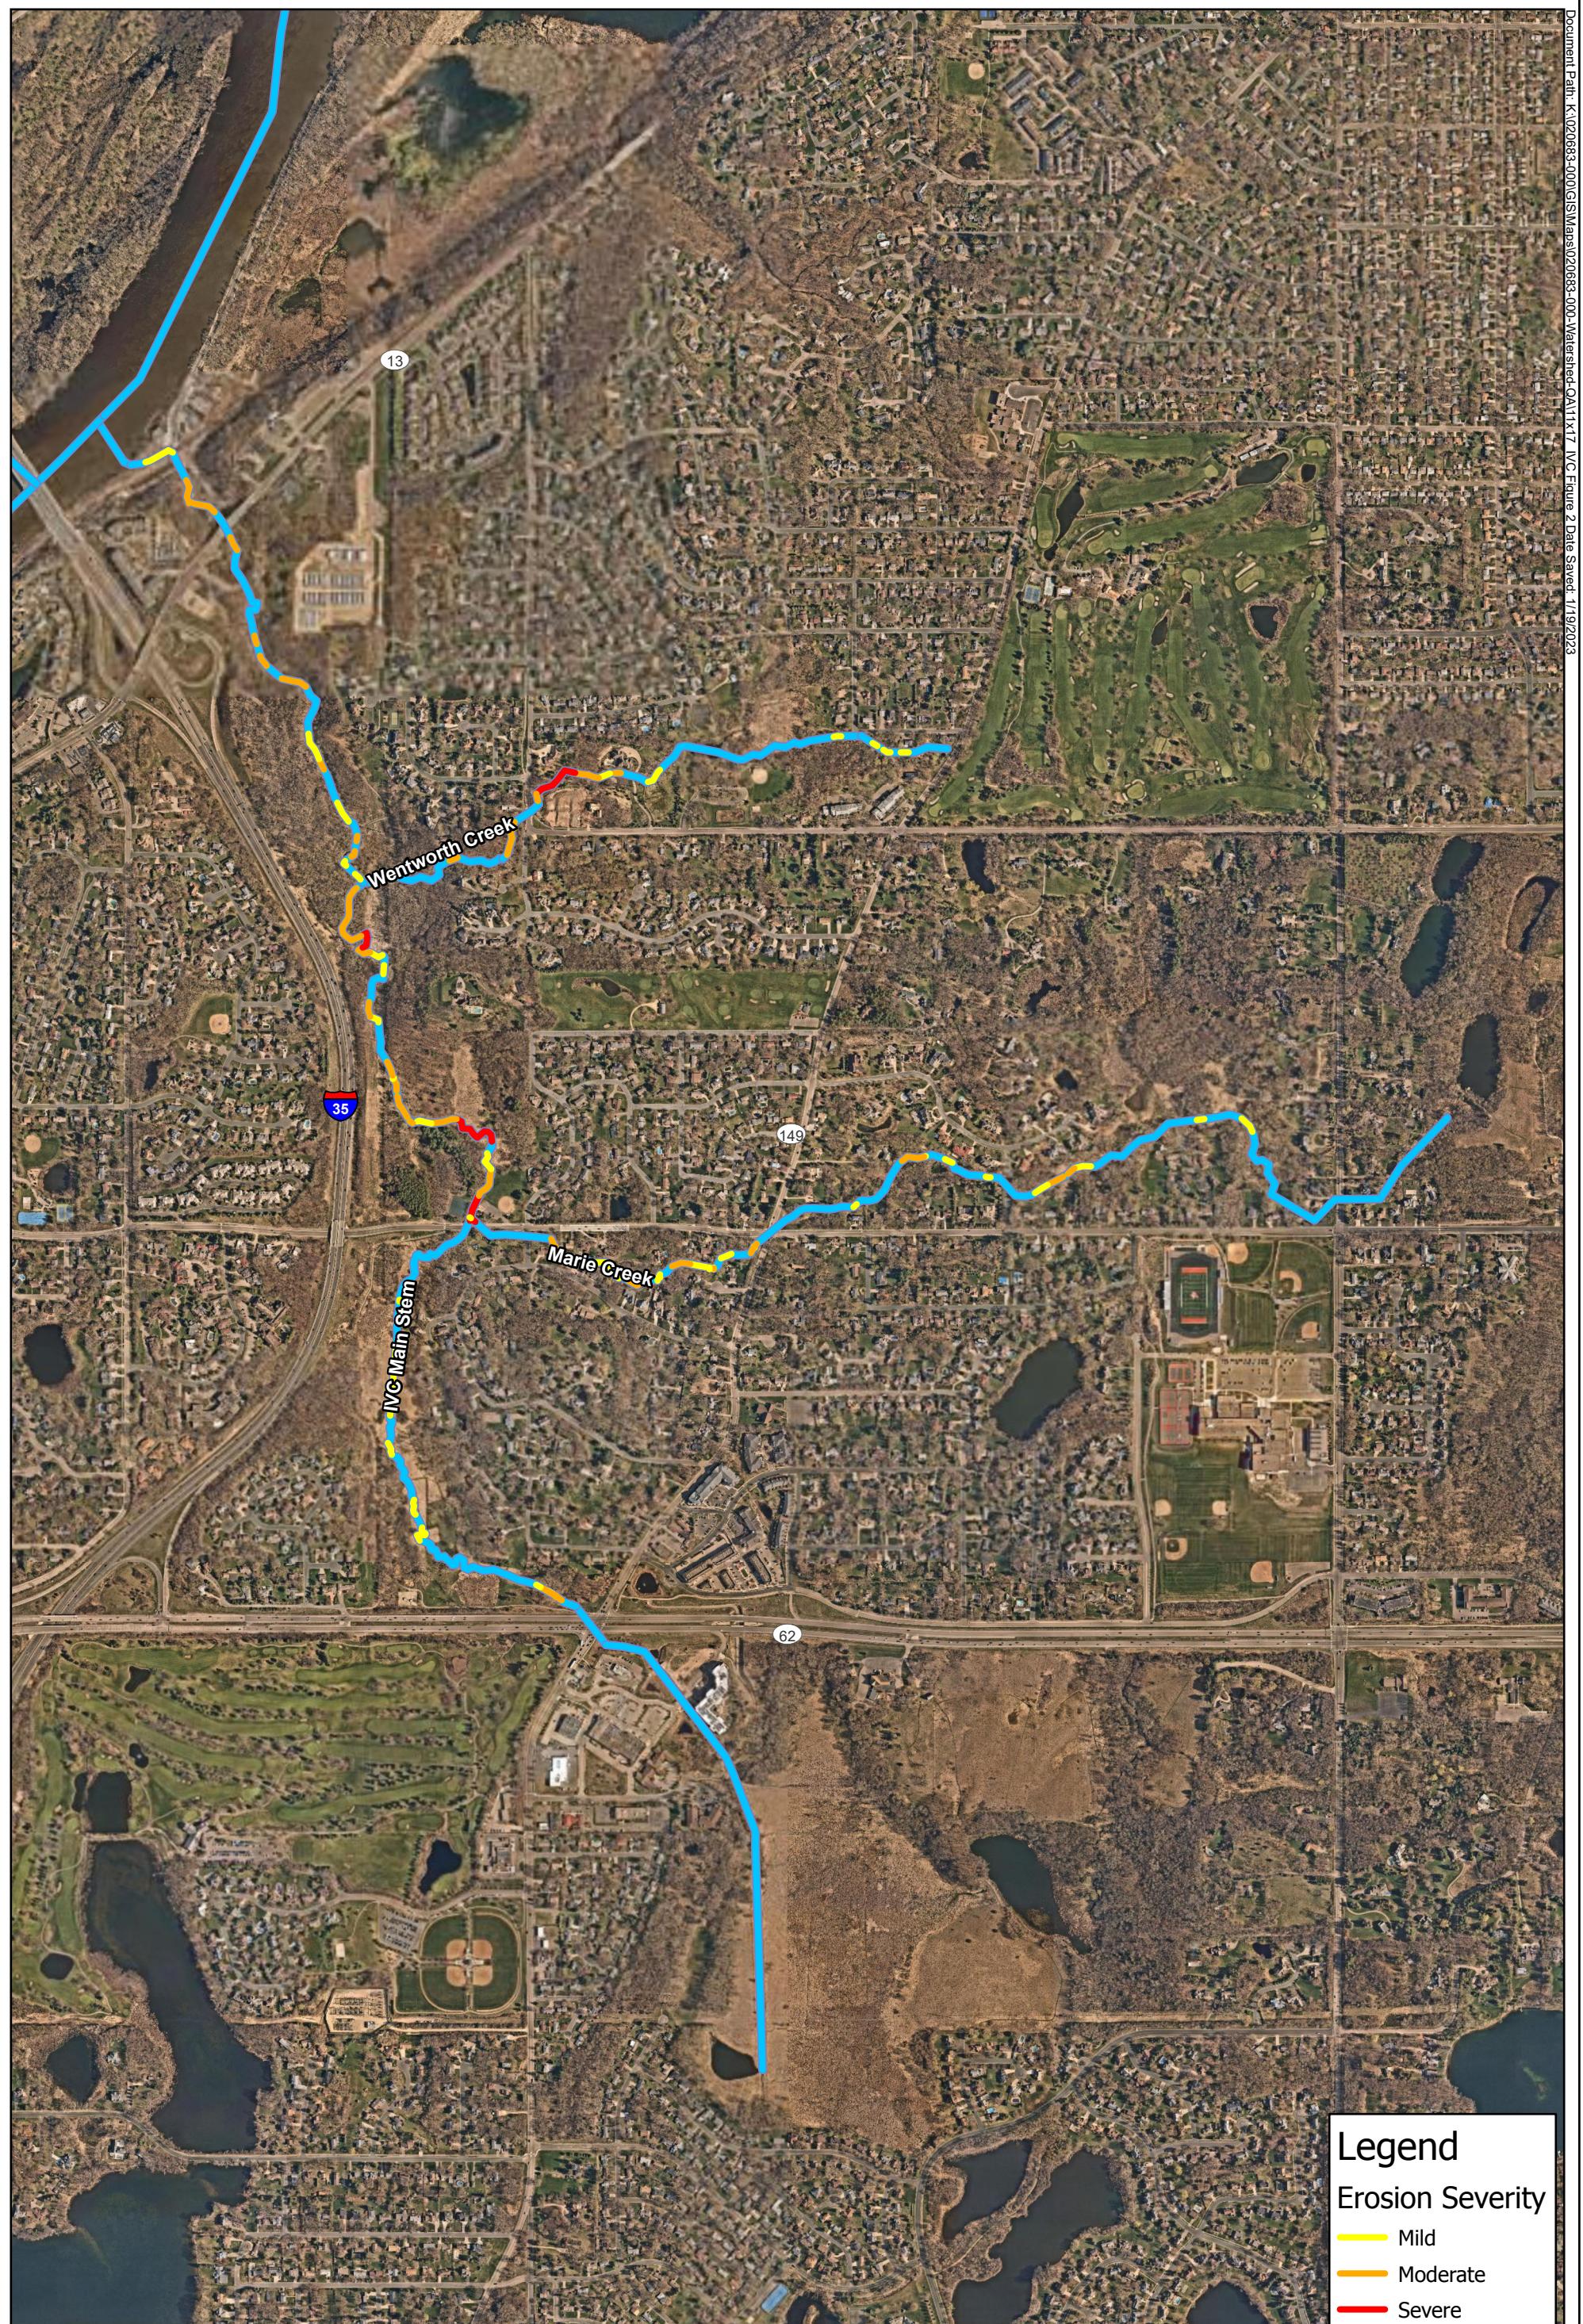
**Figure 2 – Channel Erosion Survey Overview**

WSB conducted the channel erosion survey in July 2022. WSB staff walked the entire study area shown in **Figure 2, Appendix A**. WSB visually inspected creek banks for signs of erosion, including but not limited to sloughing, undercutting, steep (slope of approximately 2H:1V or steeper) or vertical banks, and perched culverts. WSB documented existing bank conditions with photos and field notes collected using a GPS-connected iPad. Where signs of erosion were present, WSB categorized the erosion issues as minor, moderate, or severe, based on the following criteria:

Following completion of the field survey, WSB mapped all documented erosion issues and determined their approximate length. An overview of all documented erosion issues within the study area can be seen in **Figure 2, Appendix A**.

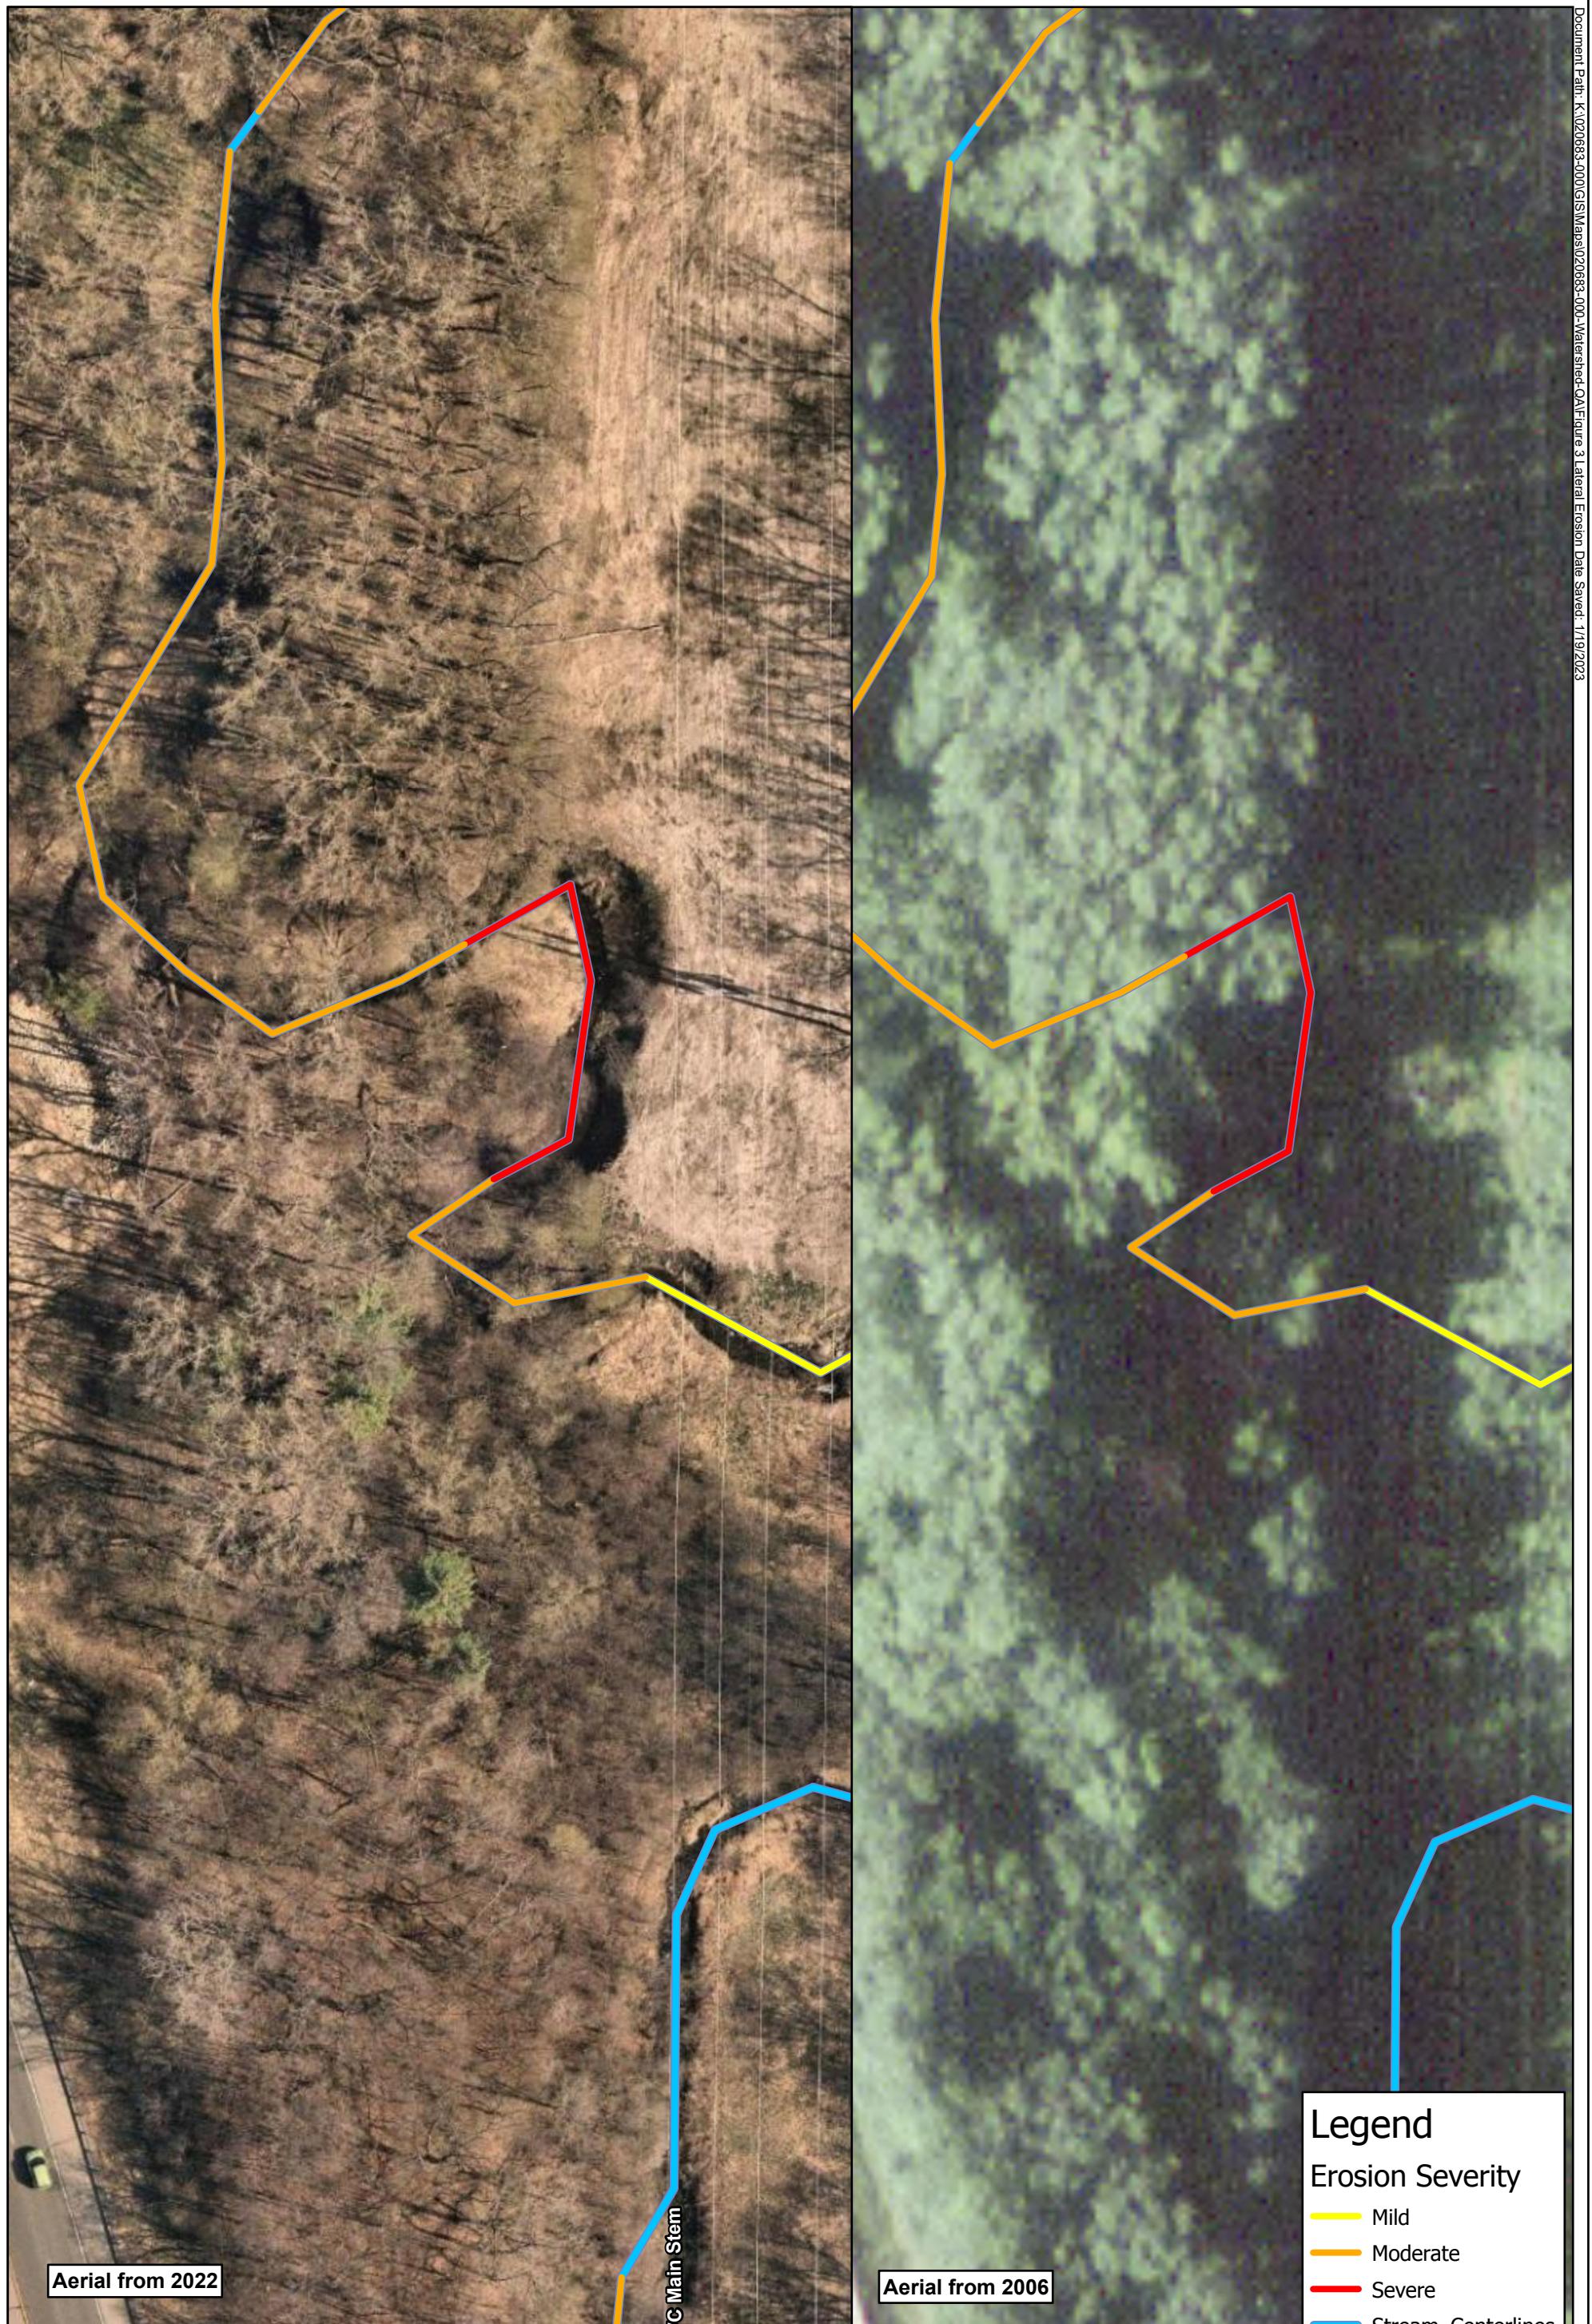
2021) at three points. These three points were averaged to provide an estimate of average lateral erosion across the site. Finally, the average lateral erosion was multiplied by the length of erosion (field estimated) and the bank height (field estimated) to create an eroded volume due to lateral erosion in cubic feet. **Figure 3, Appendix A** shows an example of lateral erosion within the project area.

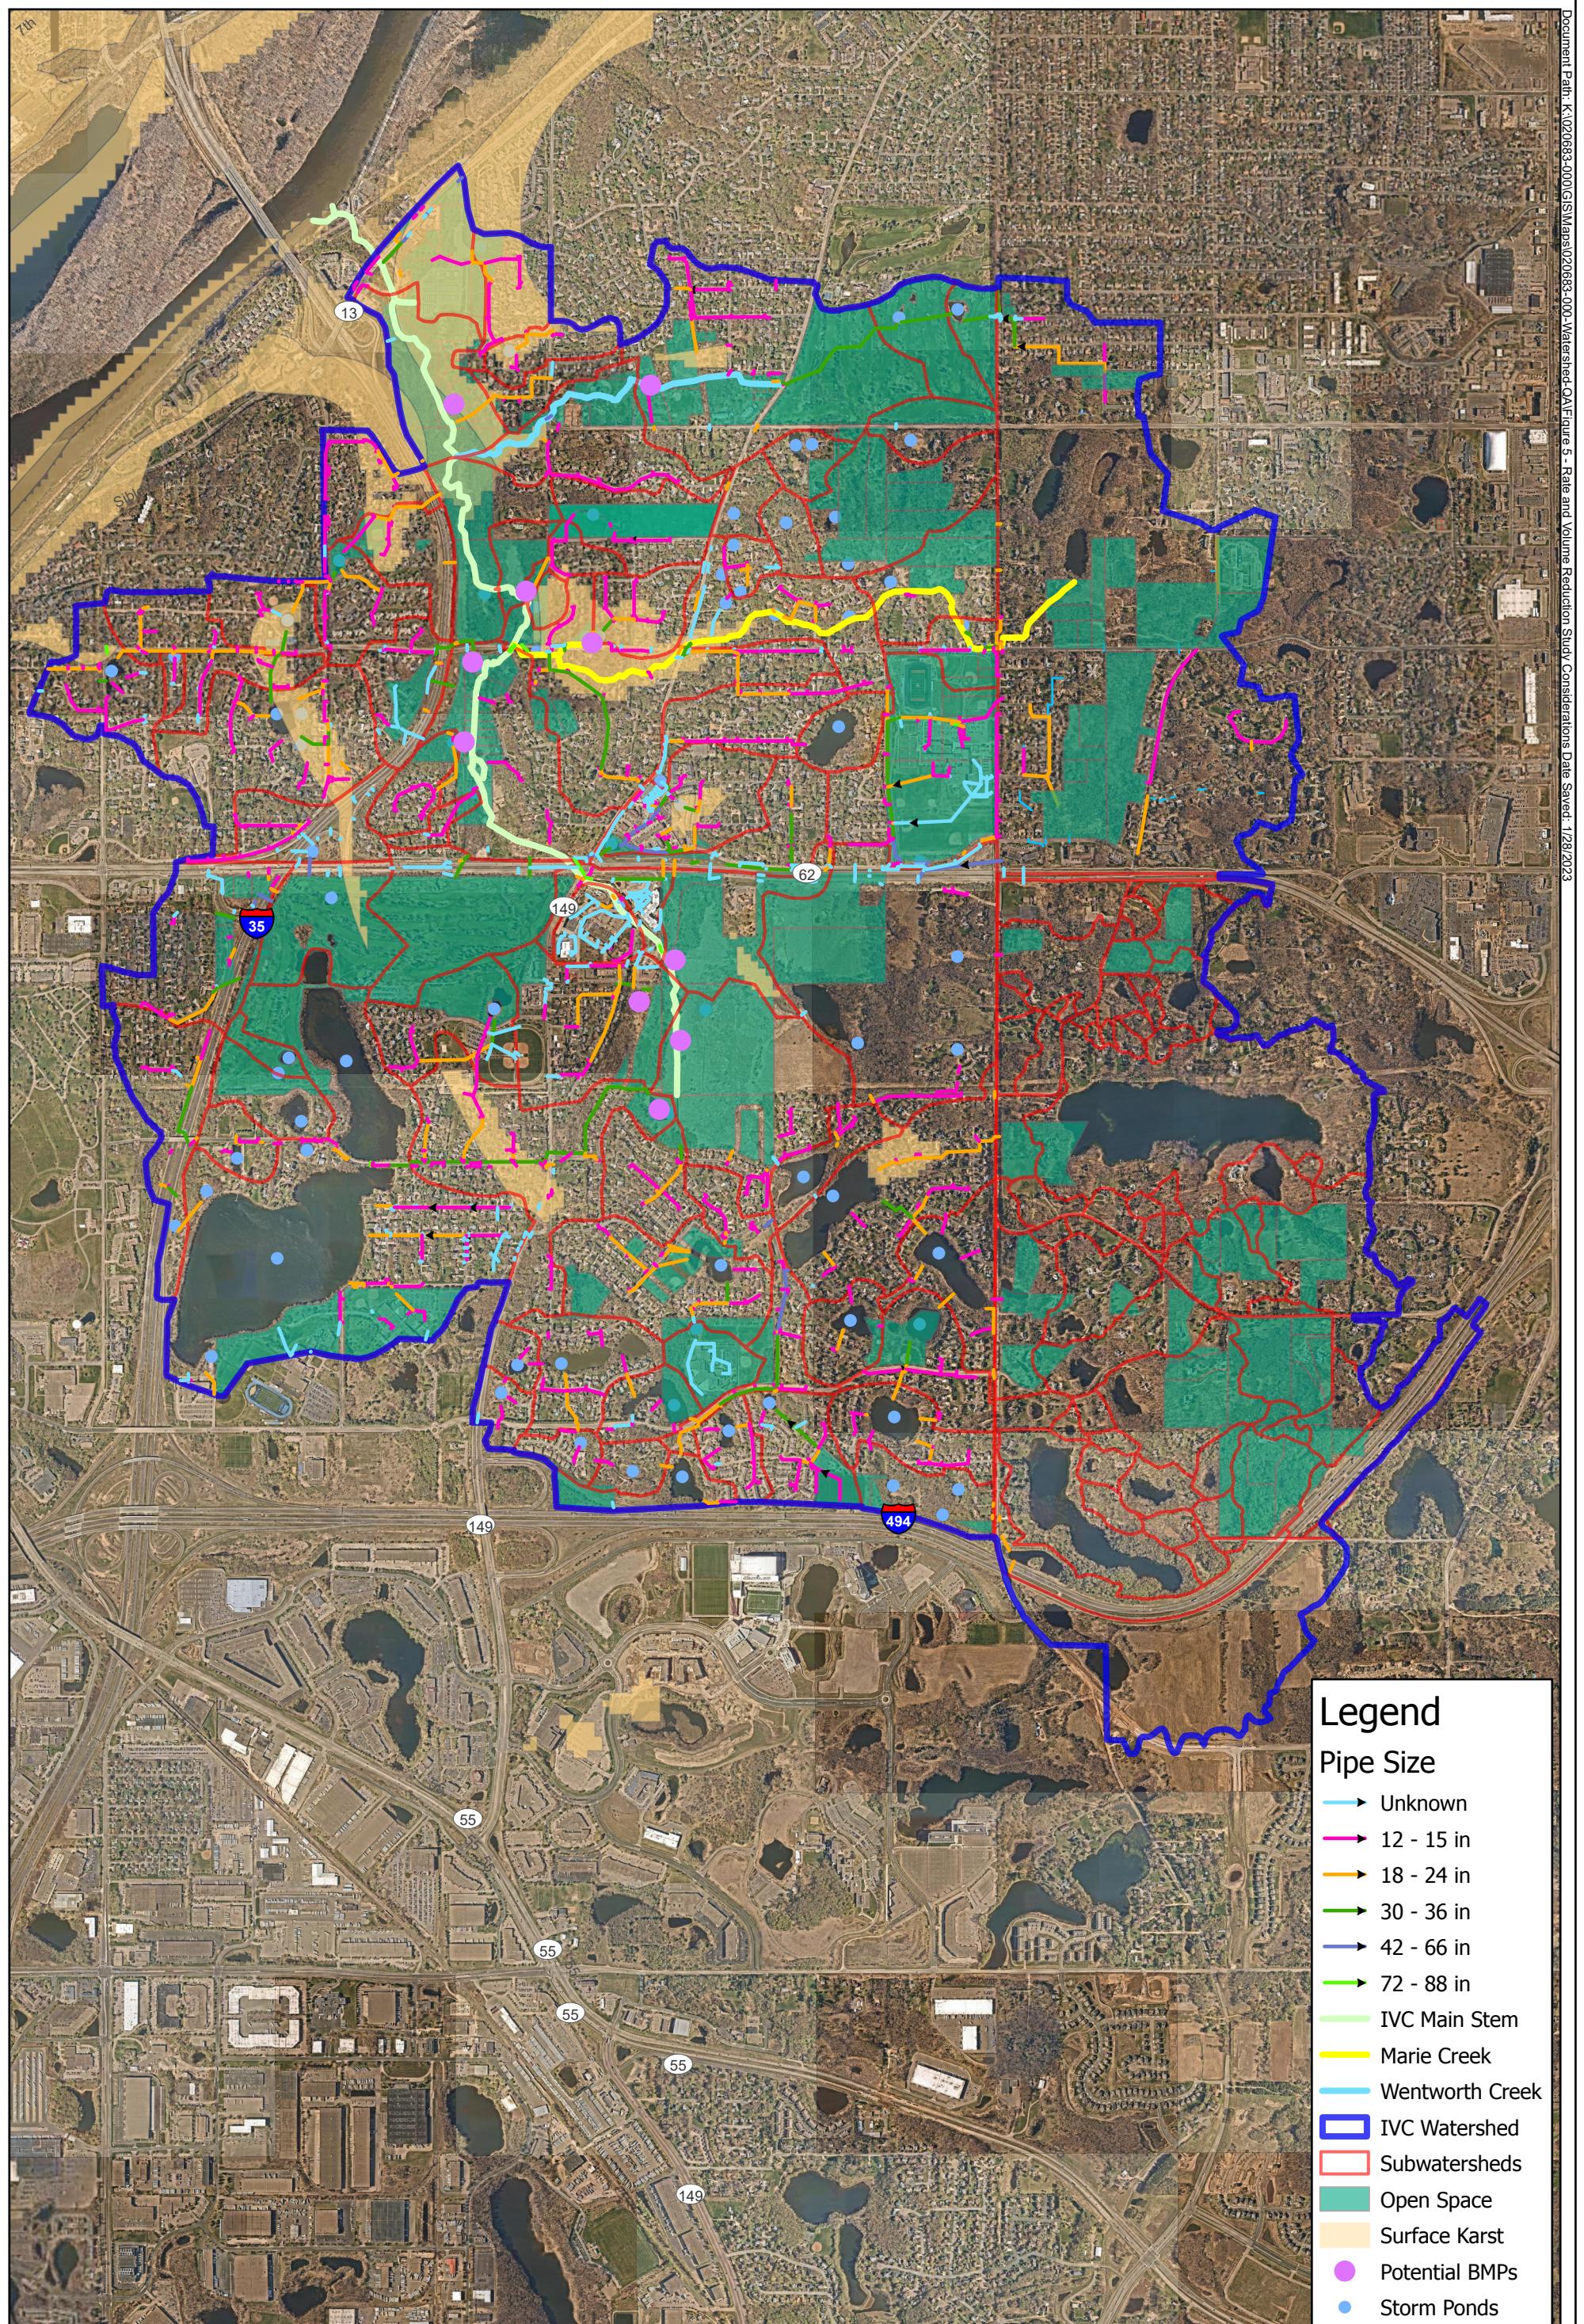
WSB completed a GIS analysis to identify potential areas for rate, volume and water quality improvements. Existing storm sewer mapping and subwatershed information, along with proximity to Interstate Valley Creek and its tributaries, were reviewed, as shown in **Figure 5, Appendix A**. Land use, parcel ownership information, utility information, topography, and tree cover were used to help identify possible locations for improvements.

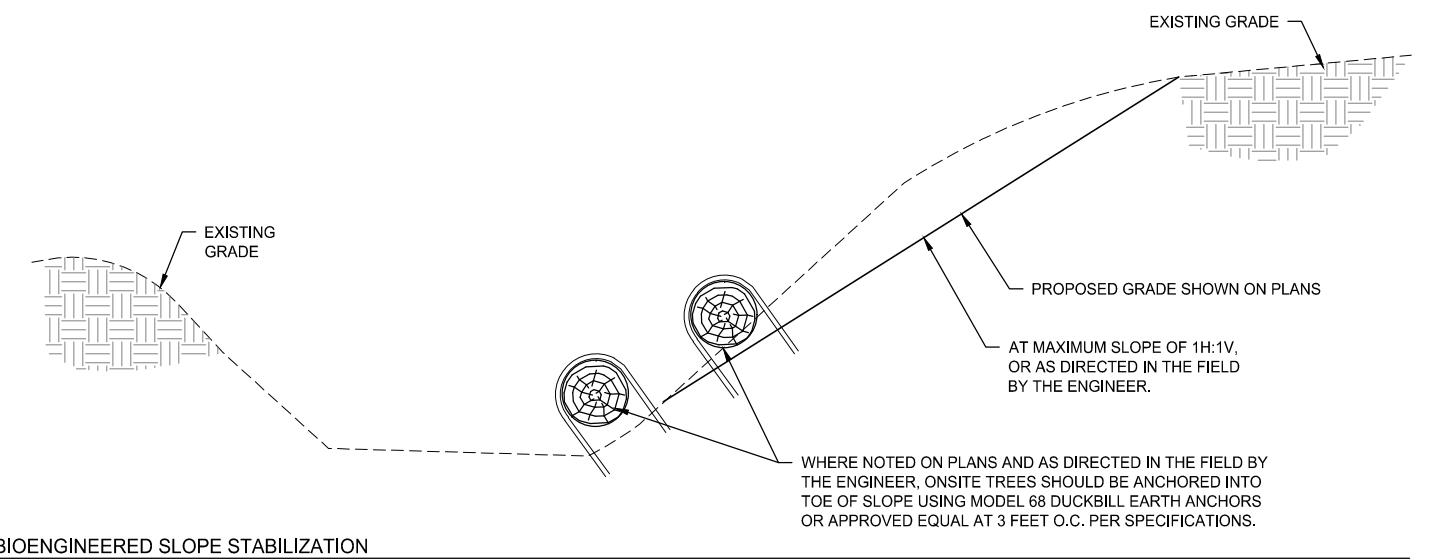
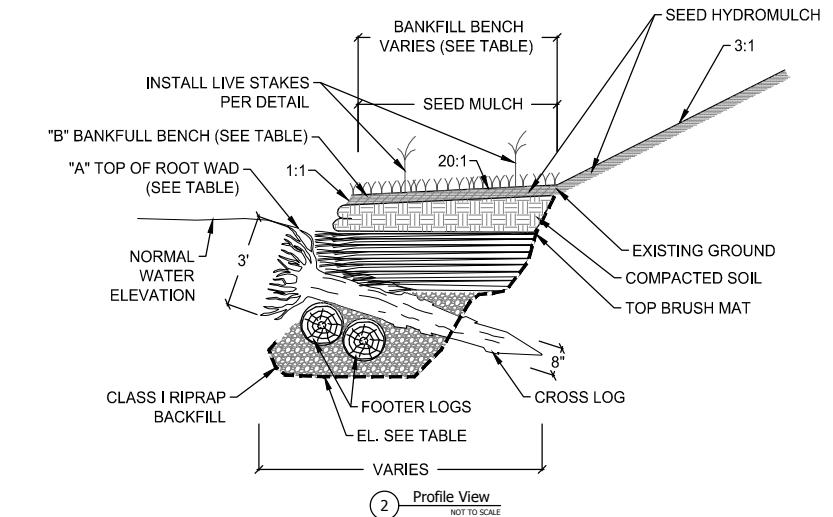
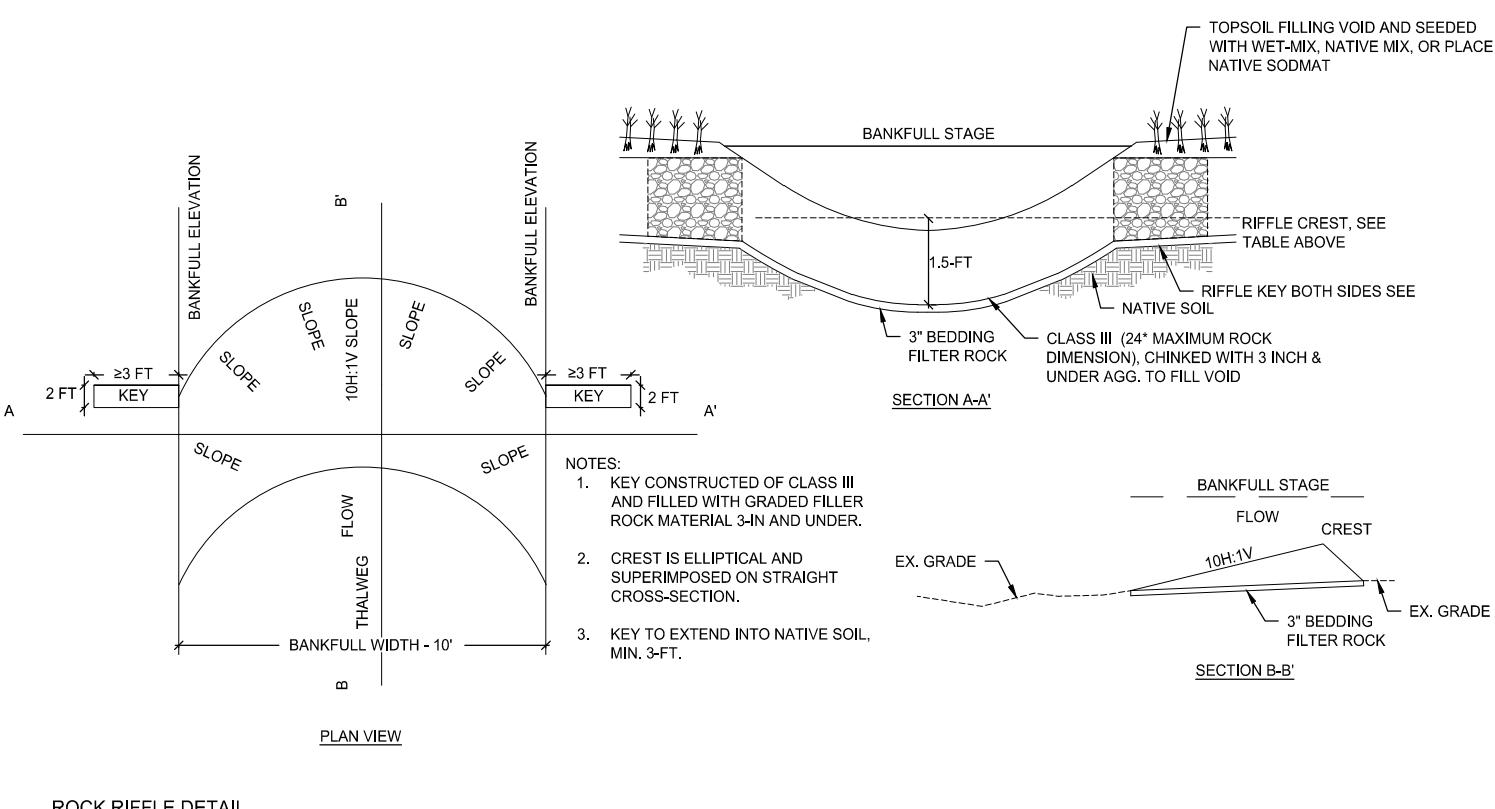
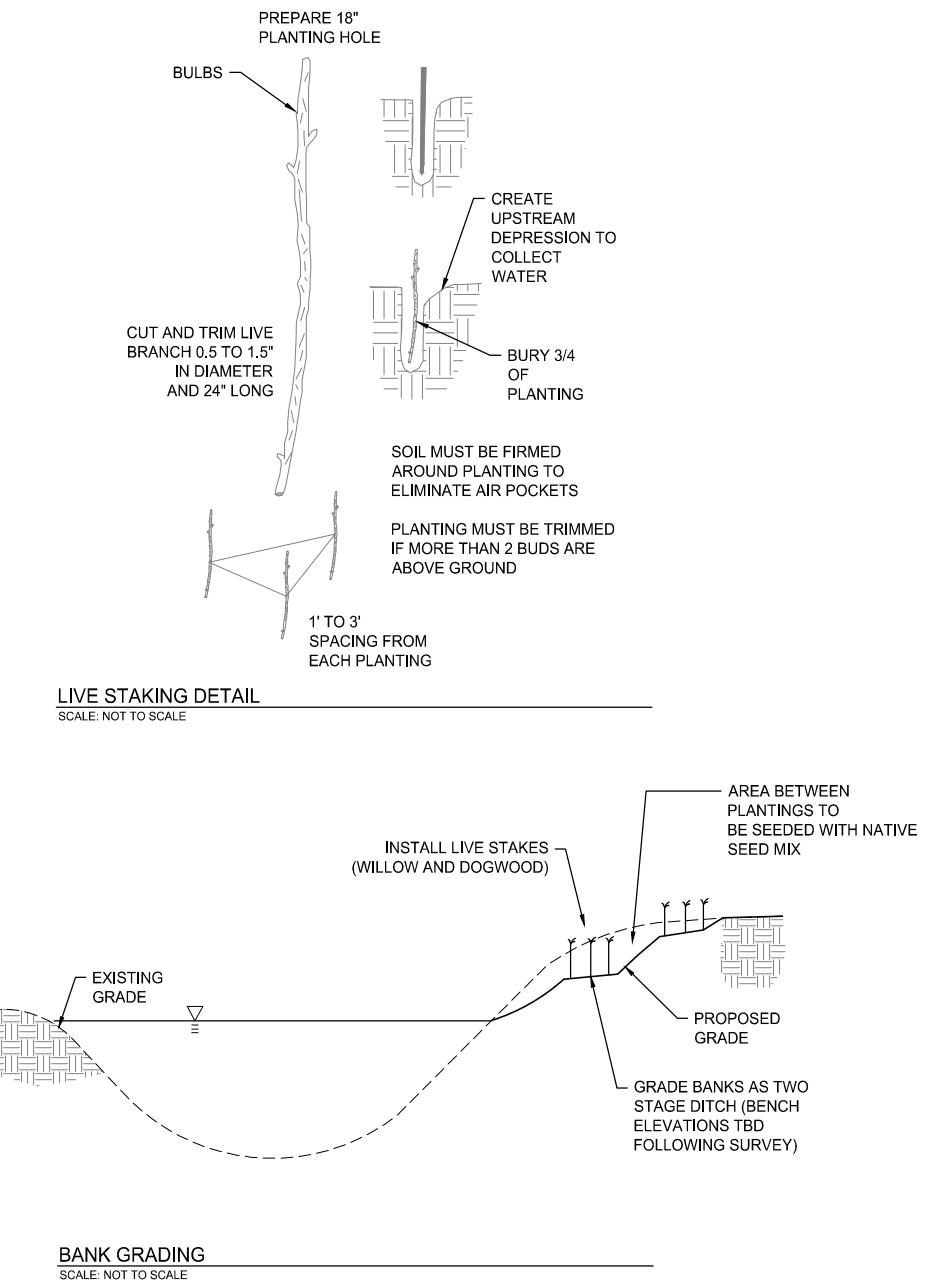
Figure 7 -  
Stabilization  
Details

This feasibility study will present its findings starting with the downstream reaches of IVC and moving upstream towards the headwaters. The IVC drainage area was split up into 9 drainage basins, as shown in **Figure 1, Appendix A**. The following sections discuss each basin in detail, including the findings and recommendations from the channel erosion and volume reduction surveys. **Figure 6, Appendix A** gives an overview of the Concept Designs and any other recommendations that resulted from this study. **Figure 7, Appendix A** contains example details for the concept stabilization design elements.
