# **LOWER MISSISSIPPI RIVER WMO—INTERSTATE VALLEY CREEK STABILIZATION AND VOLUME REDUCTION STUDY**

## **FEASIBILITY REPORT**

January 30, 2023

WSB PROJECT NO. 020683-000

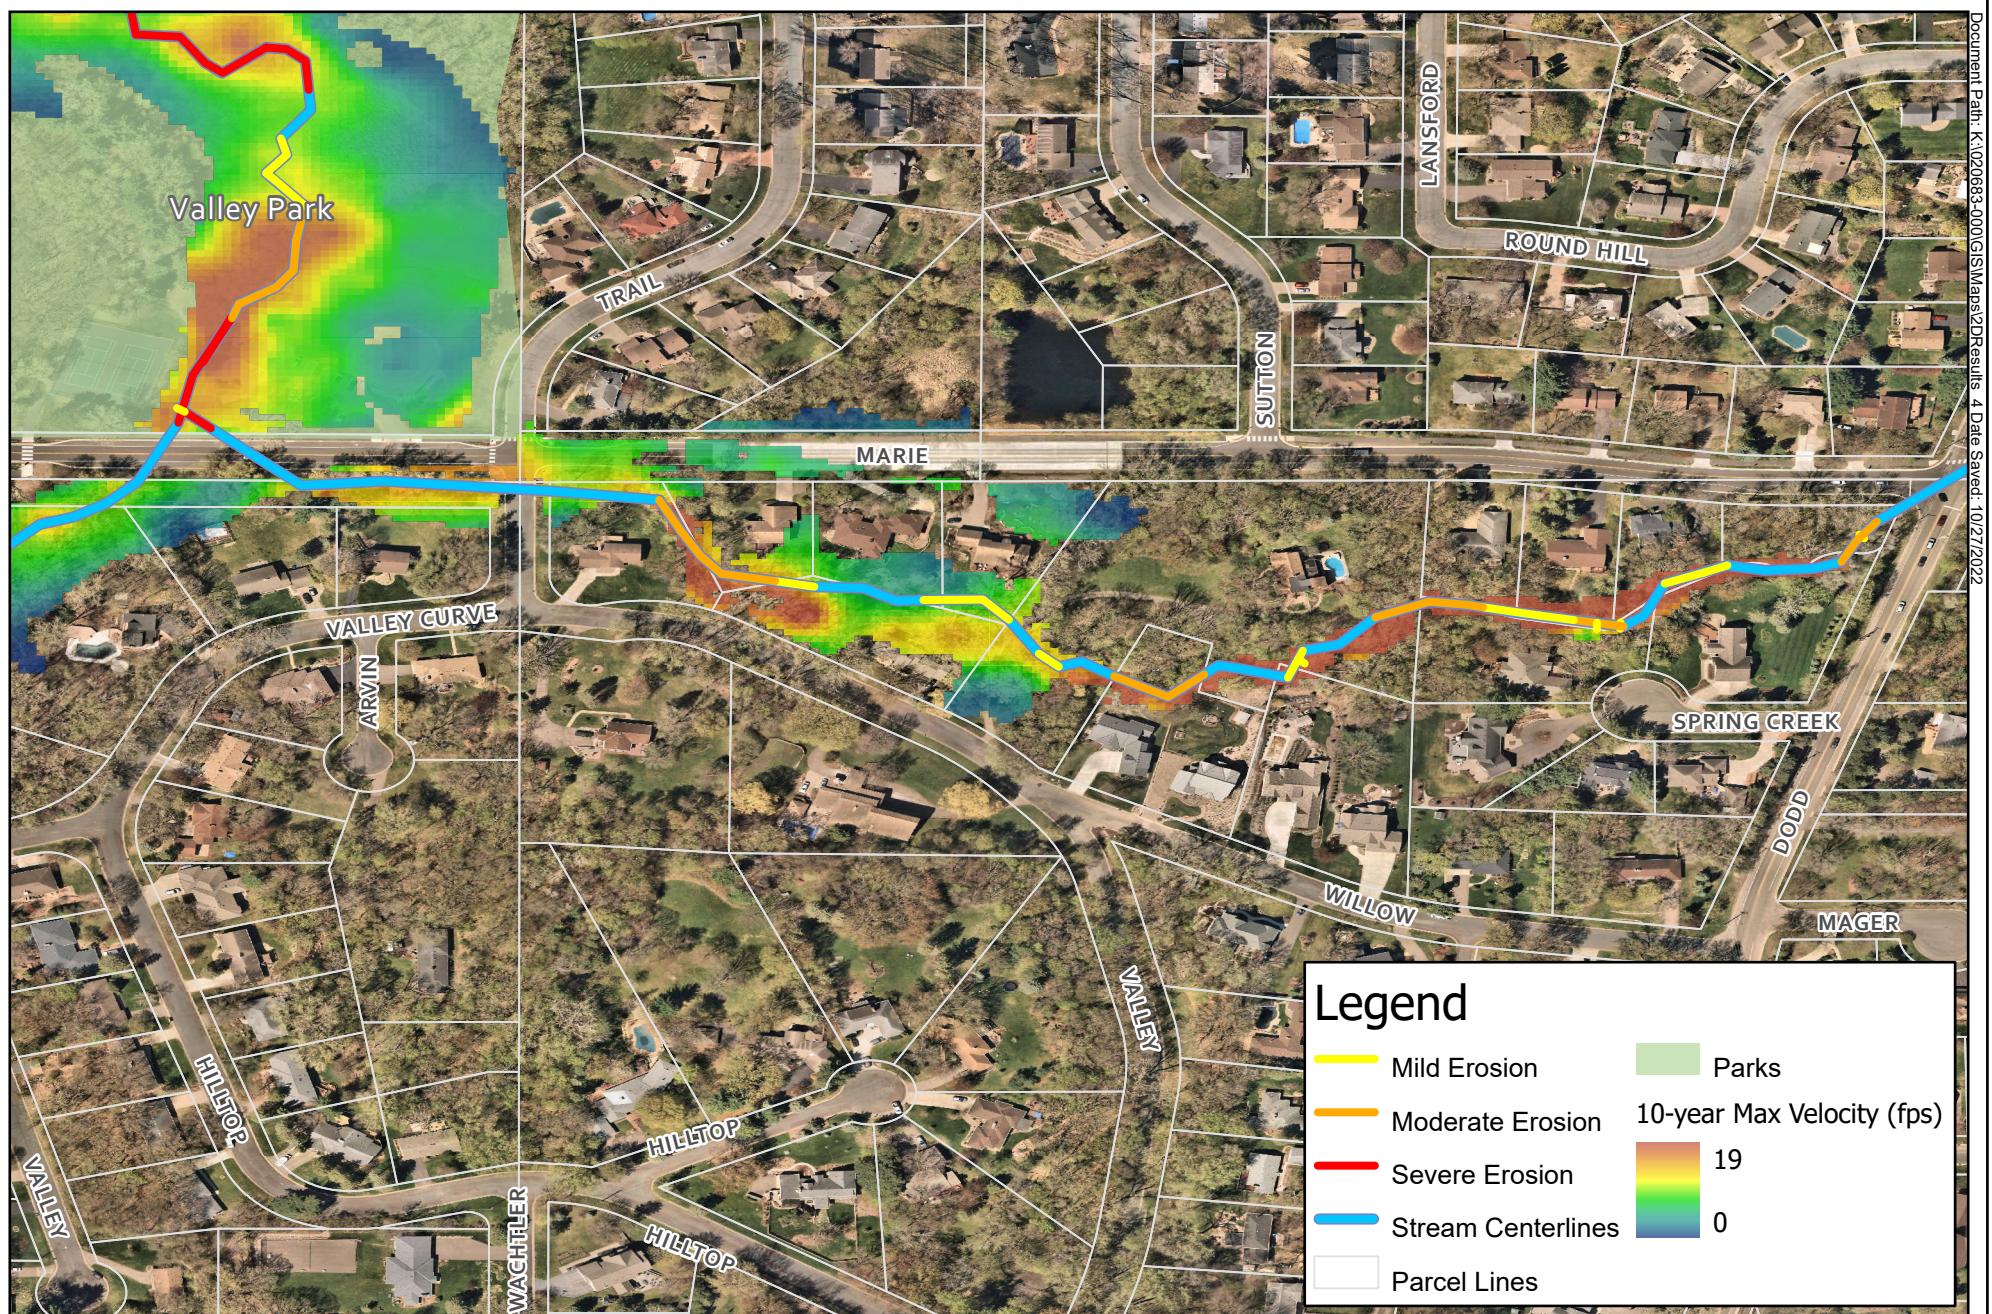
**Figure AE.4, 10 Year Max Velocities, Lower Marie Creek**

2D model results in **Appendix E** show a strong correlation between areas of locally high velocities (>10 feet per second) and areas of documented moderate erosion. During the field survey Marie Creek had a more consistent presence of base flow than either the IVC main stem or Wentworth Creek, therefore the banks are subject to more consistent erosive pressure.

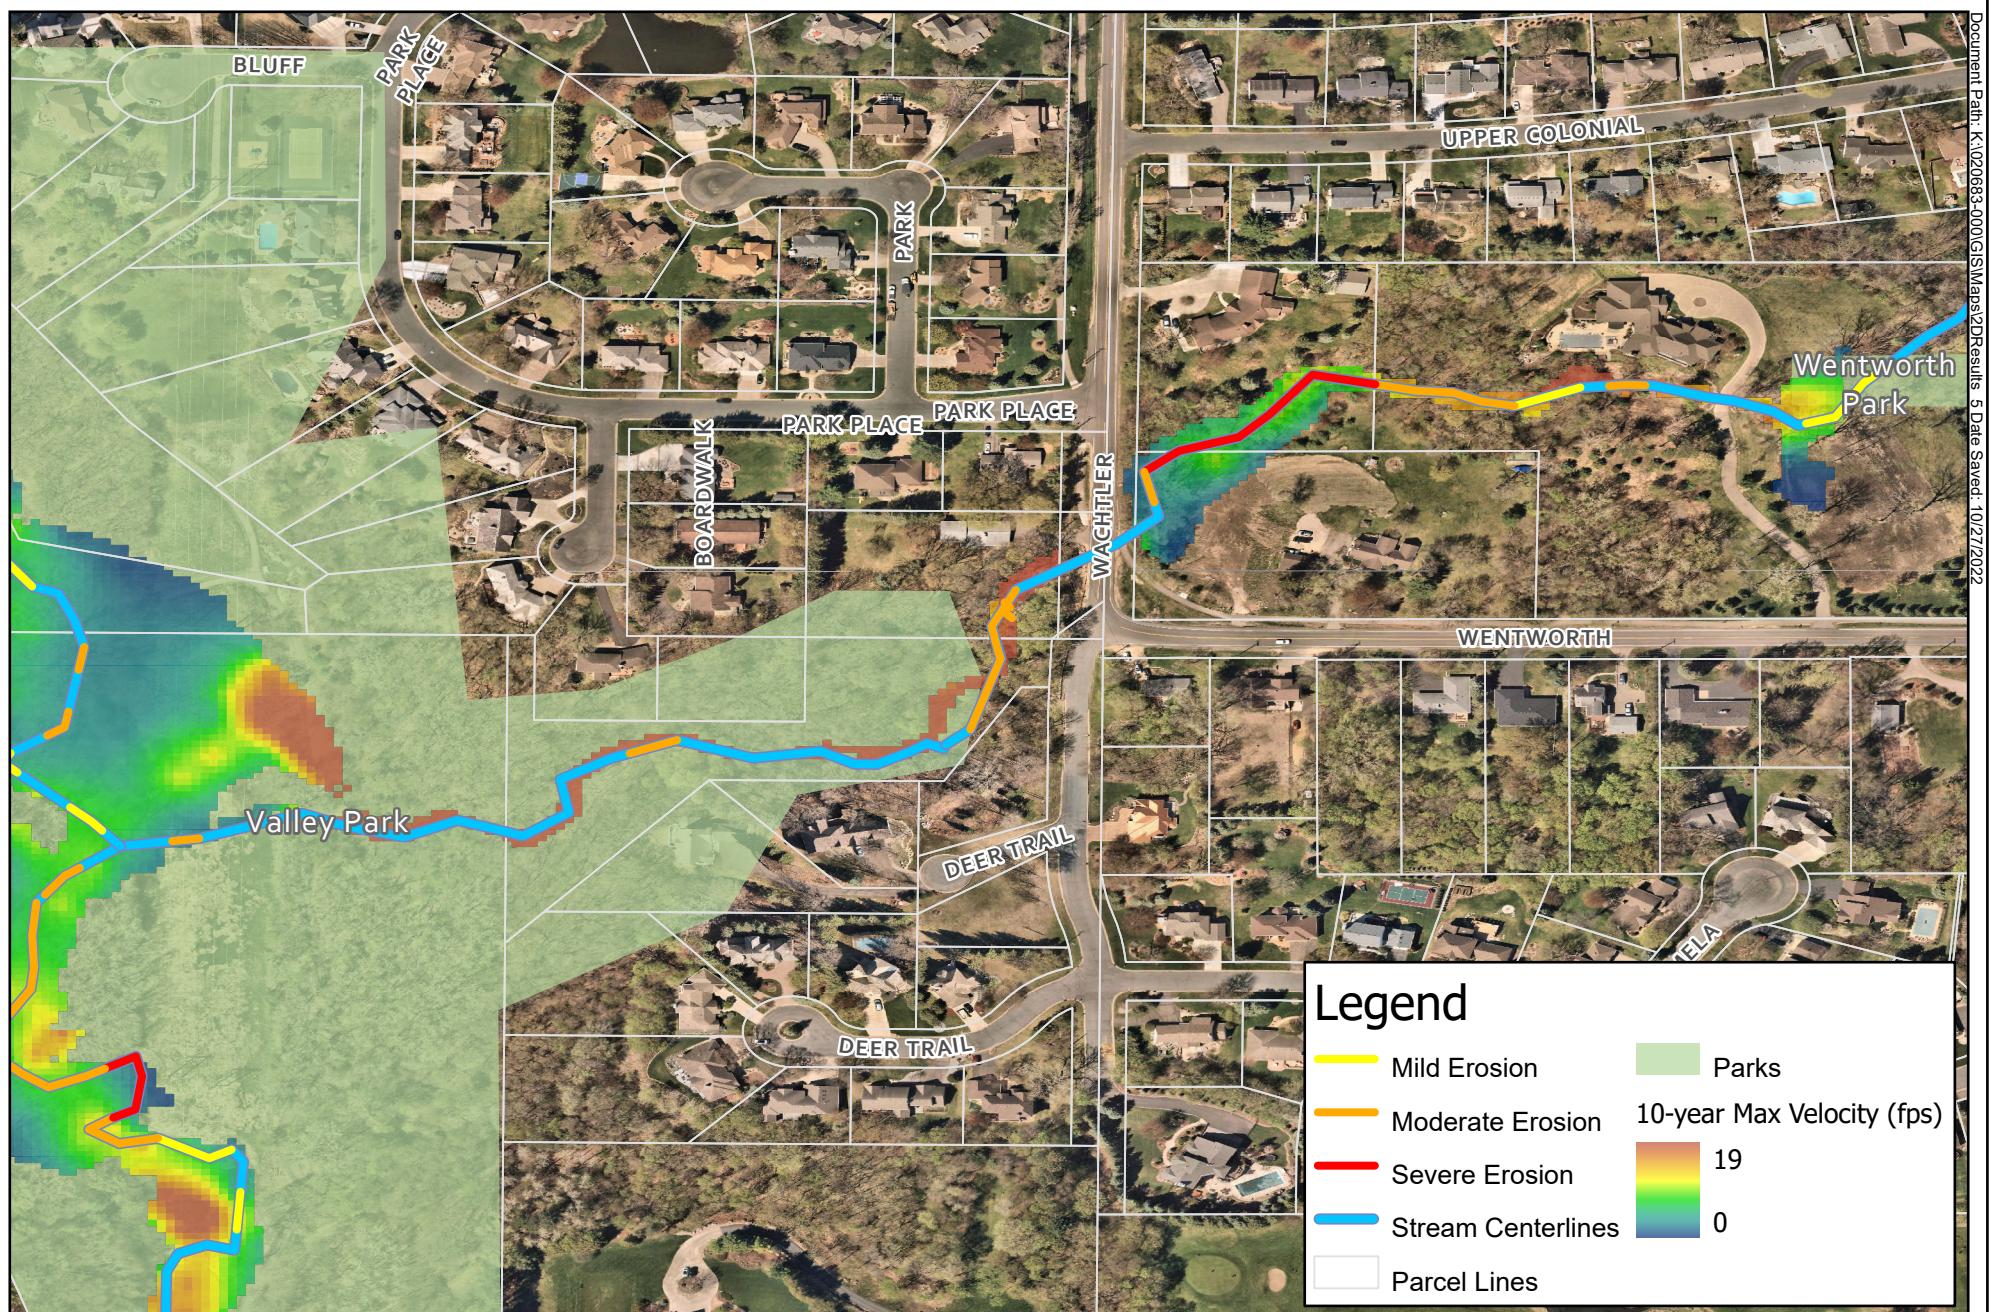
## Figure AE.5, 10 Year Max Velocities, Lower and Middle Wentworth Creek

The 2D model results in **Appendix E** show relatively low velocities in the Middle Wentworth project area, but large amounts of water indicate that the culvert under Wachtler Avenue may be undersized. Stabilization in the Middle Wentworth project area must therefore be designed to handle brief periods of inundation during storm events.
